# Service Information Bulletins

# 1998

**GRUNDIG**

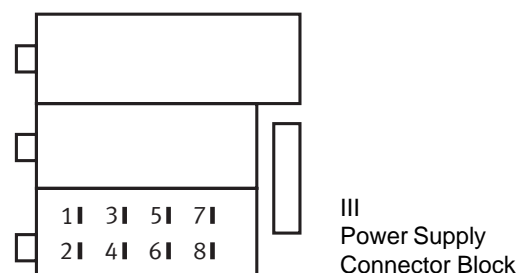
Car radio connector block

When fitting a Grundig car radio into a motor car manufactured by VW (car models Golf and Passat from year of manufacture 4/98), the following fault symptoms may appear dependent on the type of radio:

VW company have changed the pinning of the car's ISO power supply connector for the car radio. Contact 5 was previously provided for a positive voltage switched by the car radio (for antenna/booster). From 4/98 models onwards, an unswitched positive voltage may be applied to this contact.

Please ensure that no unswitched positive voltage is applied to contact 5 of the motor car otherwise remove the contact from the connector block and insulate it appropriately.

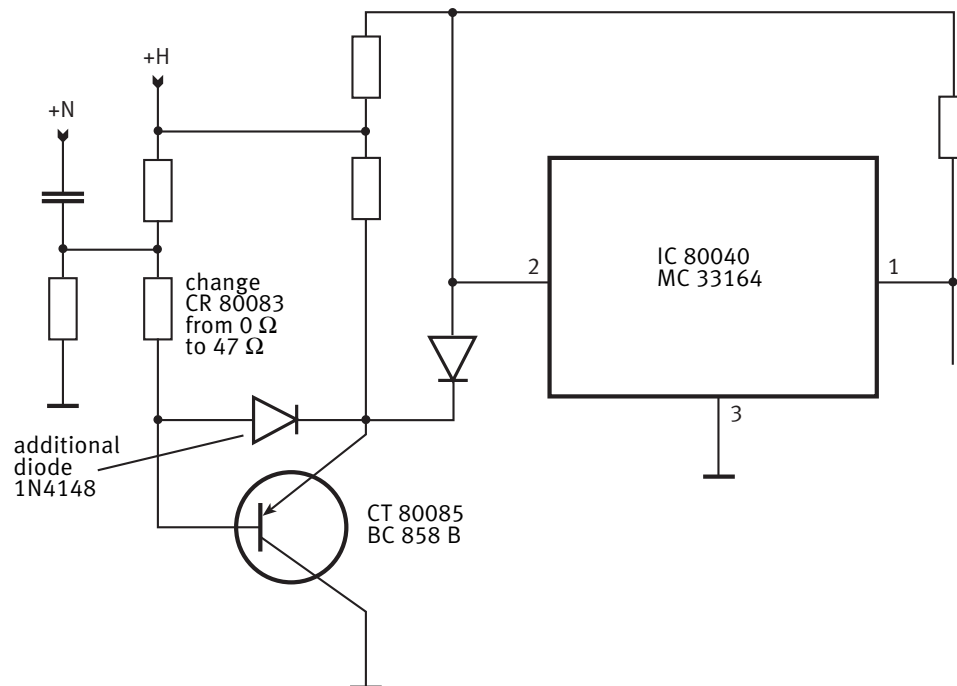
When switching on with the mains switch the television receiver goes to Standby and cannot be switched on again with the remote control handset.

Failure of transistor CT 80085 BC 858B (position X=148, Y=18).

On replacement of the transistor, solder an additional diode 1N4148 from the base to the emitter (anode to base) of CT 80085 and change the resistor CR 80083 from 0 Ω to 47 Ω 5% (structural shape 0805).

The additional diode can be fitted to the solder side between the base of CT 80085 and the cathode of diode CD 80081.

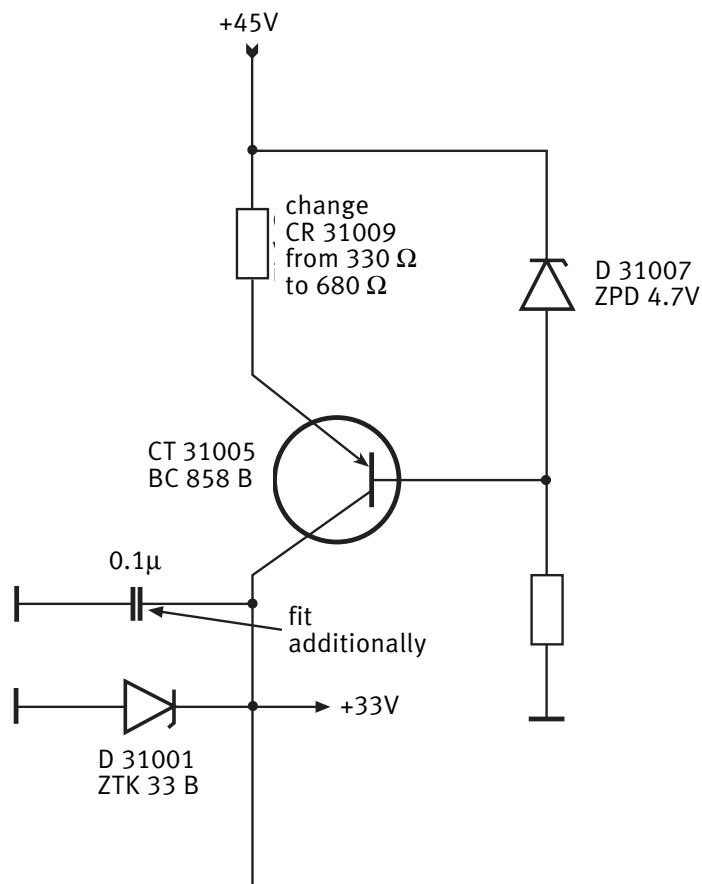
No programmes receivable.

Failure of diode D 31001 ZTK 33B caused by too high a Zener current.

On replacement of the the Z-diode ZTK 33B, change additionally the SMD resistor CR 31009 from 330 Ω to 680 Ω 5% (structural shape 0805) and solder an additional 0.1μF foil capacitor in parallel with Z-diode ZTK 33B.

When the Z-diode failed, change the resistor (position X=78, Y=10) and solder an additional capacitor.

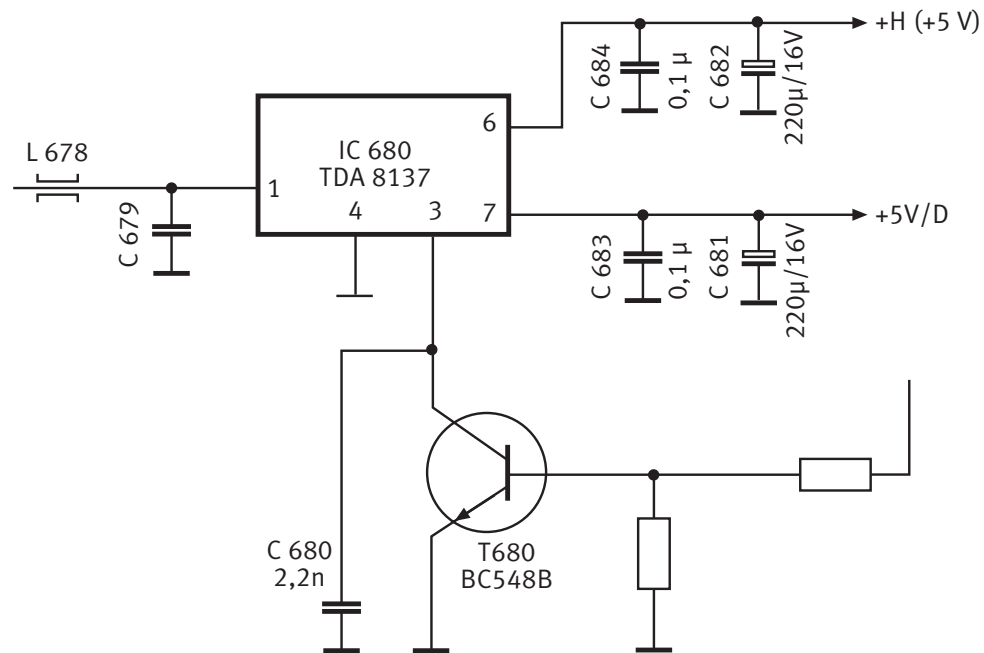
Tearing of the displayed menus and teletext pages.

Failure of the capacitors C 683 and C 684 of 0.1  $\mu$ F each.

Change the electrolytic capacitors C 681 and 682 of 220  $\mu$ F/16 V each in addition to the capacitors C 683/684.

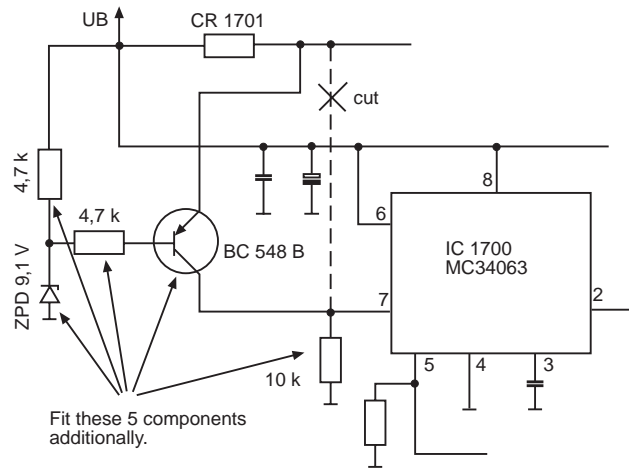
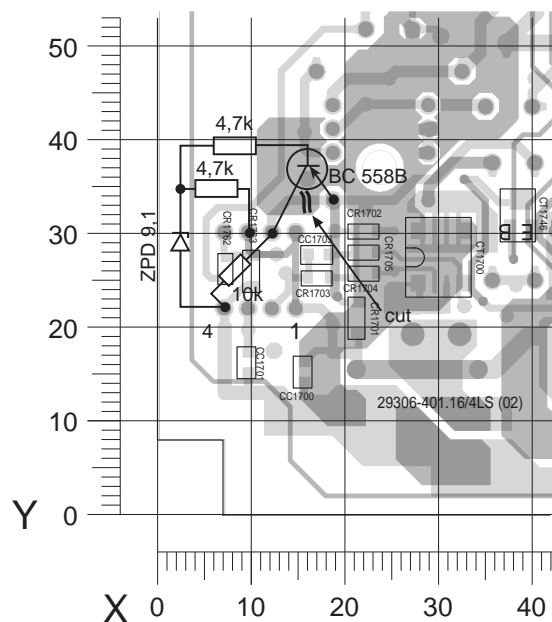
Failure of the transistor CT 1700 Si 9955 caused by a voltage supply (battery operation) below 9V.

When CT 1700 failed, fit the following additional components (see diagram):
