LUX Audio of America Ltd.

TO: ALL LUX SERVICE STATIONS

SUBJECT: ADJUSTMENT FOR UNSTABLE SPEED ON PD-441/PD-444

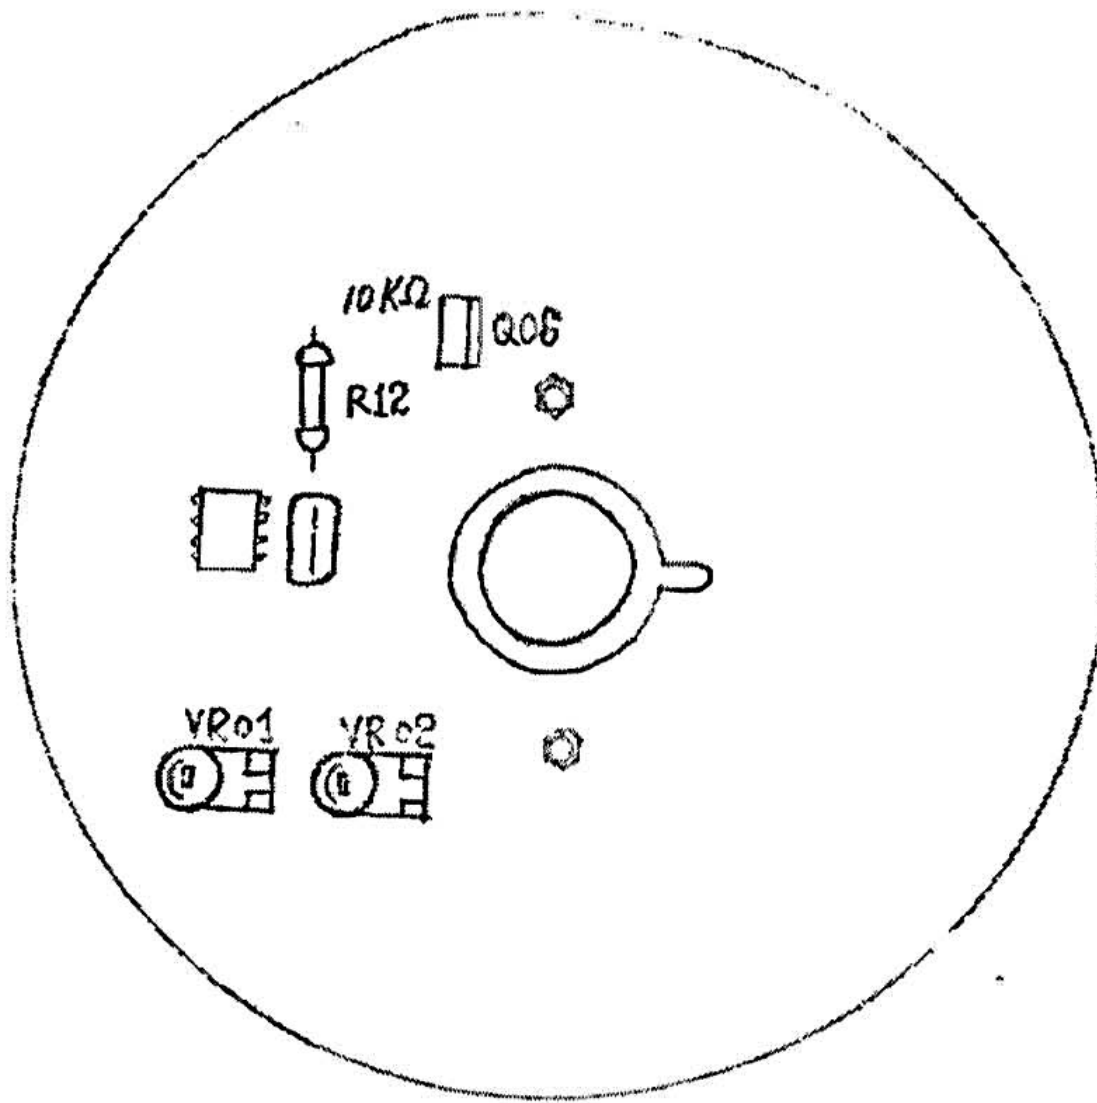
It has been brought to our attention that occasionally, the servo lock system may become intermittent or cut out completely on the PD-441 and PD-444. Should you encounter this situation, the remedial action is as follows:

1. Remove the name plate from the motor cover located on the under-side of the unit.
2. Remove the motor cover (be careful not to damage the rubber bushing).
3. Adjust the D.C. voltage on both sides of R12 on the circular Printed Circuit Board to equal:

<u>Speed</u>	<u>Adjustment</u>	<u>Voltage</u>
45 rpm	VR02	8.5v at 10°C (50°F)
33 1/3 rpm	VR01	7.5 volts at 20°C (68°F) 6.0v at 30°C (86°F)

Note: Variable Resistor (VR) must be turned very slowly. 33 1/3 rpm should be set first and then 45 rpm. Also, the platter of the unit must be in place and turning when making this adjustment. I realize that this is difficult but possibly having the unit right side up and reaching underneath to make the adjustment and measurements.
