<b>marantz®</b> <b>SERVICE BULLETIN</b>		Date: 10-Dec.-2004	Model: CD5400
		Page: 1 / 1	REF.NBR: MZ04-082
Level		Application:	
★ ★ ★		See below	
		Subject: The sound jump sometimes occurs during Playback CD.	
		Int.ref:

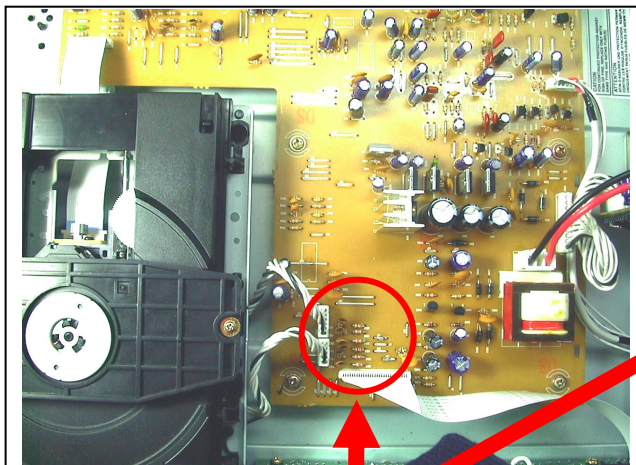
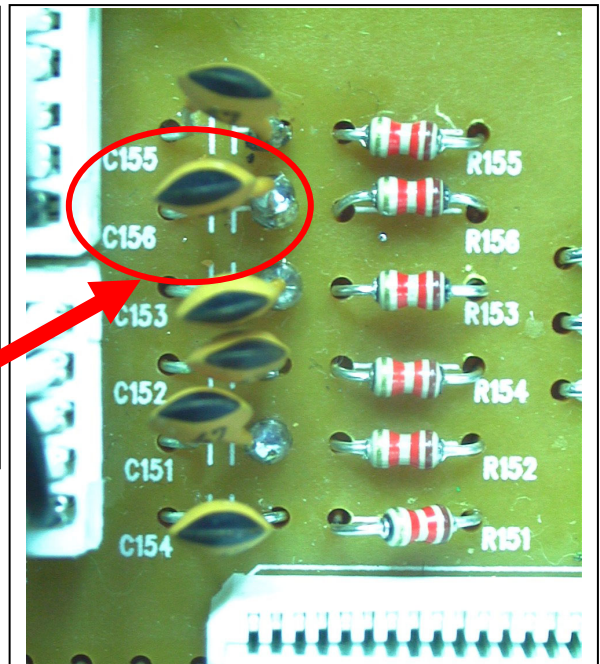
When playback CD, the sound jump sometimes occurs.

C156 Capacitor connected to the CLOCK line of DSP changed the signal, and microprocessor cannot recognize correct data.

**POS.NO C156 (Ceramic Capacitor 47pF) is removed.**

**Remove C156**
