| marantz® SERVICE BULLETIN | | Date: 15-May.-2003 | Model: DR6000, DR6050, CDR631, CDR500 |
| Circulation: | Application: | Subject: Replace the Chip capacitor on the CDR module of MAR770/MAR775. | |

| | | Subject: Improvement for inoperable all buttons | |

| | | Subject: Miss clamp problem of CD single | |

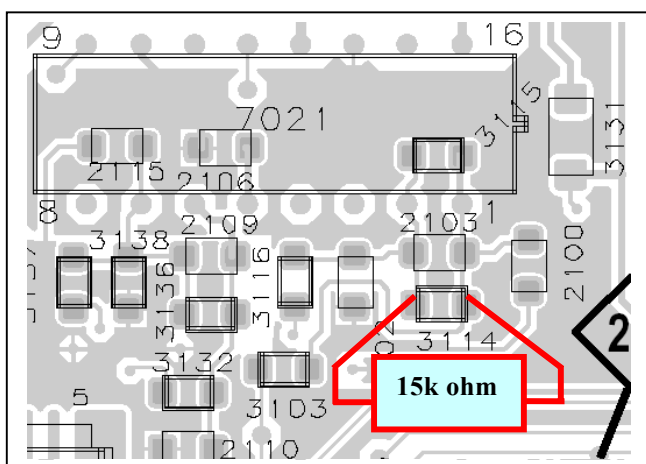
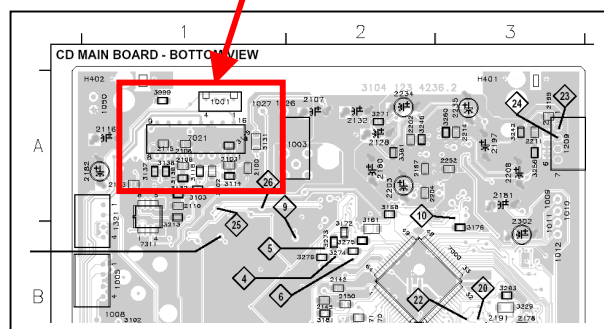
This is Pos.No.3114

The OPEN/CLOSE movement of disc tray is fast, It may become a CD single [8cm(3in.)] clamp defect.

15k ohm resistor is soldered to the **Pos.No.3114** in parallel.

The object of PCB: CD MAIN BOARD of CD Module MAR1250
(Refer to the CDR500 service manual 2-13 page of MAR1250.)
