<b>marantz®</b> <b>SERVICE BULLETIN</b>		Date: 15-May.-2003	Model: DV4300
		Page: 1 / 1	REF.NBR: MZ03-014
Circulation:		Subject:	
Application:		The unit doesn't work pushed ON/ OFF button of the remote controller RC3200.	
x for information customer complaint in case of service mandatory .....		Int.ref:	
See Below

<b>marantz®</b> <b>SERVICE BULLETIN</b>		Date: 25-Feb.-2004	Model: DV4300
		Page: 1 / 2	REF.NBR: MZ04-016
Circulation:		Subject:	
Application:		By crack of Laser Pickup slide shaft, Pickup stops moving and cannot playback the Disc.	
x for information customer complaint in case of service mandatory .....		Int.ref:	
See below

<b>marantz®</b> <b>SERVICE BULLETIN</b>		Date: 30-June-2003	Model: DV4300
		Page: 1 / 1	REF.NBR: MZ03-027
Circulation:		Subject:	
Application:		FFC and Top Cover short-circuit, and the unit can't be operated.	
x for information customer complaint in case of service mandatory .....	See Below	Int.ref:

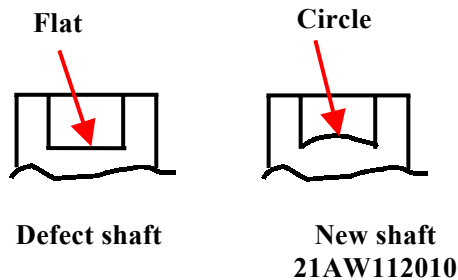
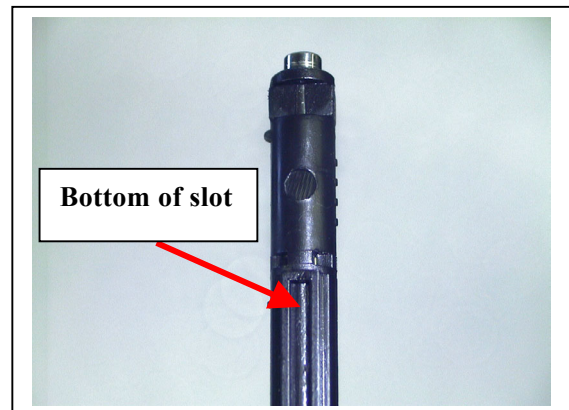
The part defect of the Laser Pickup slide shaft.  
(It occurs only in specific serial number because defective plastic part mixing.)

Difference of a shaft, the bottom form of slot is different.

- 1) **Replace the Laser Pickup slide shaft** of Loader Assy.
- 2) **Old Loader Assy Type no. RL-A700 corresponds.**
- 3) New Loader Assy Type no.DSL-710A does not correspond.

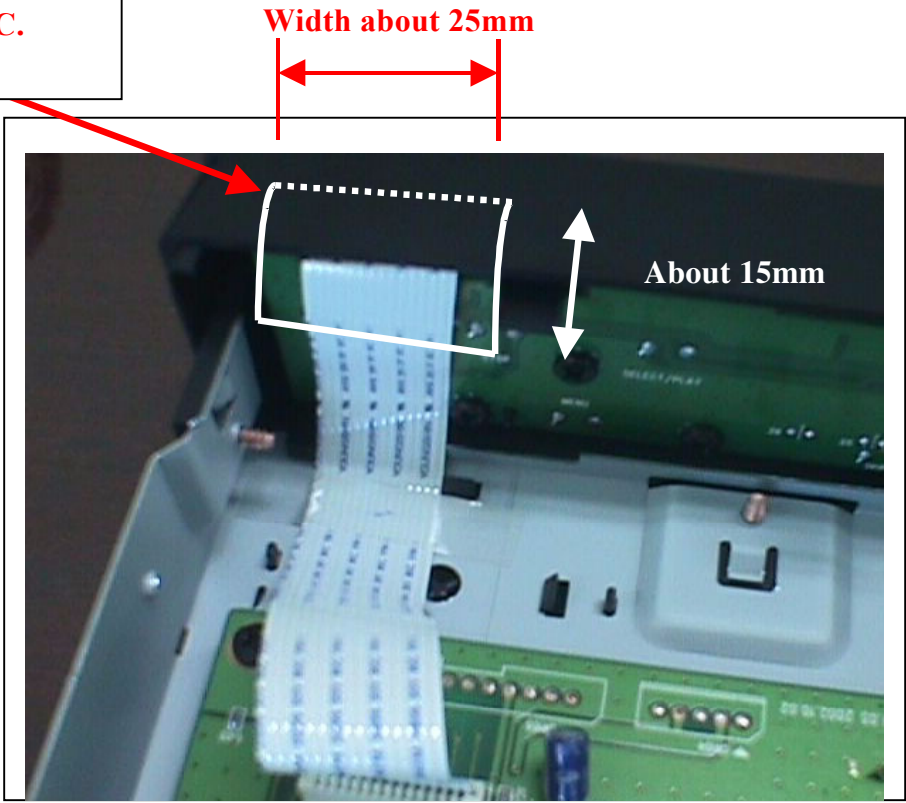
The insulation of Flexible Flat cable can be torn, and it short-circuits with Top cover, then can't be operated. Specially, the insulation of FFC which touches the tip of the Top Cover can be torn.

The insulator tape put on FFC.  
Especially, the place where the tip of the Top Cover touches FFC.  
The tape to use is **3M Scotch Filament Tape #895-2-206 or the equivalent.**

**You must put 3M Scotch tape in the point where the tip of the Top cover touches FFC.**
