marantz® SERVICE BULLETIN		Date: 27-Feb.-2004	Model: DV8400
		Page: 1 / 1	REF.NBR: MZ04-017
Circulation:		Subject:	
Application:		Output signal distortion.	
x for information customer complaint in case of service mandatory			
		See Below

marantz® SERVICE BULLETIN		Date: 15-May-2003	Model DV8400
		Page: 1/1	REF.NBR: MZ03-016
Circulation:		Subject:	
Application:		1. Slow mode problem	
x for information customer complaint in case of service mandatory		2. RC232C command problem in the condition of "No Disc."	
Before MZxxxxxx02xxxx		Int.ref:

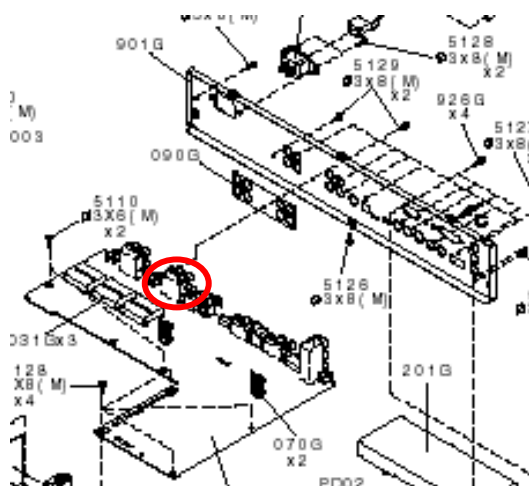
- 1) FRONT L/R 1 2 and SURR.L/R, CENTER L/R, SUB W L/R of AUDIO OUTPUT are simultaneously Connected to amplifier.
- 2) If the Amplifier which used the electronic switch is turned off, another sound will be distorted.

FRONT L/R 1 2 are connected parallel, therefore, if the Amplifier input of another side short-circuits, it will influence

Solder side of FRONT L/R 1 2 (Jack RCA) 1 k ohm

1. Resistor 1k ohm is added to 2 of FRONT L/R 1 2.
2. Cut pattern.

Carbon film fixed resistor, 1k ohm +5% 1/6W (part no. **GD05102160**)

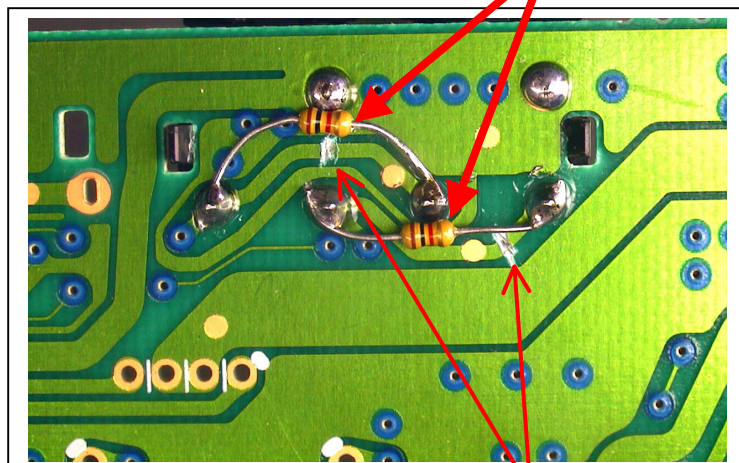
Cut pattern
