<b>marantz®</b> <b>SERVICE BULLETIN</b>		Date: 31-Oct.-2003	Model: SR4300/SR4400
		Page: 1 / 3	REF.NBR: MZ03-047
Circulation:		Subject:	
Application:		The problem of the Speaker protection circuit.	
x for information customer complaint in case of service mandatory .....			
		Service code XE00 XE00xxxxxxxxxx

<b>marantz®</b> <b>SERVICE BULLETIN</b>		Date: 30-June-2003	Model: SR4300,SR4400
		Page: 1 / 1	REF.NBR: MZ03-025
Circulation:		Application:	
x for information customer complaint in case of service mandatory .....		See Below	
		Int.ref:

<b>marantz®</b> <b>SERVICE BULLETIN</b>		Date: 30-June-2003	Model: SR4300,SR4400
		Page: 1 / 1	REF.NBR: MZ03-023
Circulation:		Subject:	
Application:		The sound is interrupted, when the playback DIGITAL of CD-R/RW of the SCMS signal.	
x for information customer complaint in case of service mandatory .....	See Below	Int.ref:

<b>marantz®</b> <b>SERVICE BULLETIN</b>		Date: 30-June-2003	Model: SR4300
		Page: 1 / 3	REF.NBR: MZ03-026
Circulation:		Application:	
x for information customer complaint in case of service mandatory .....		See Below	
		Subject: Noise is conspicuous by the conditions.	
		Int.ref:

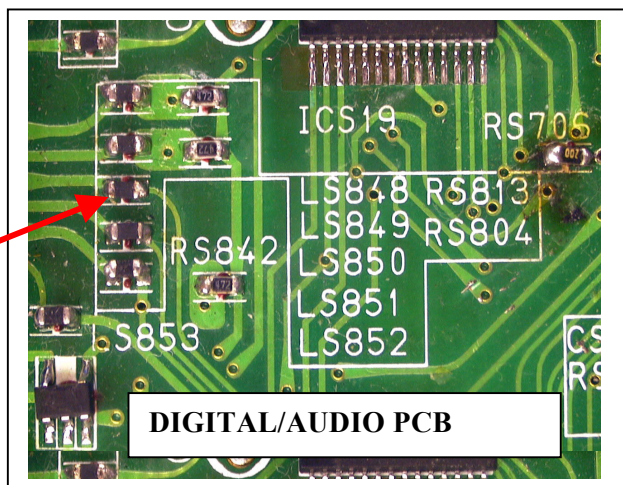
### SR4300

- 1) The protection circuit does not work when the power transistor was damaged.
- 2) When the power transistor was damaged, about 40 V outputs to speaker out.
- 3) The protection circuit function does not operate, then the unit will not be in POWER STANDBY mode and the speaker output RELAY does not work.

- 1) When the transistor is damaged before turn on the unit, the micro processor can not detect protection signal (Protect2).
- 2) Turn on the unit, the down edge of a protection signal (Protect2) is undetectable for about 2 seconds after the micro processor reset

LS850 is changed to  
Part no. \*HD201810R

**Caution**  
JFS08 (FPC CONNECTOR) side is  
CATHODE

**Adhesives:**  
SC608LVZ (Sony Chemical Corp. – Self-extinguishing adhesive) or the equivalent

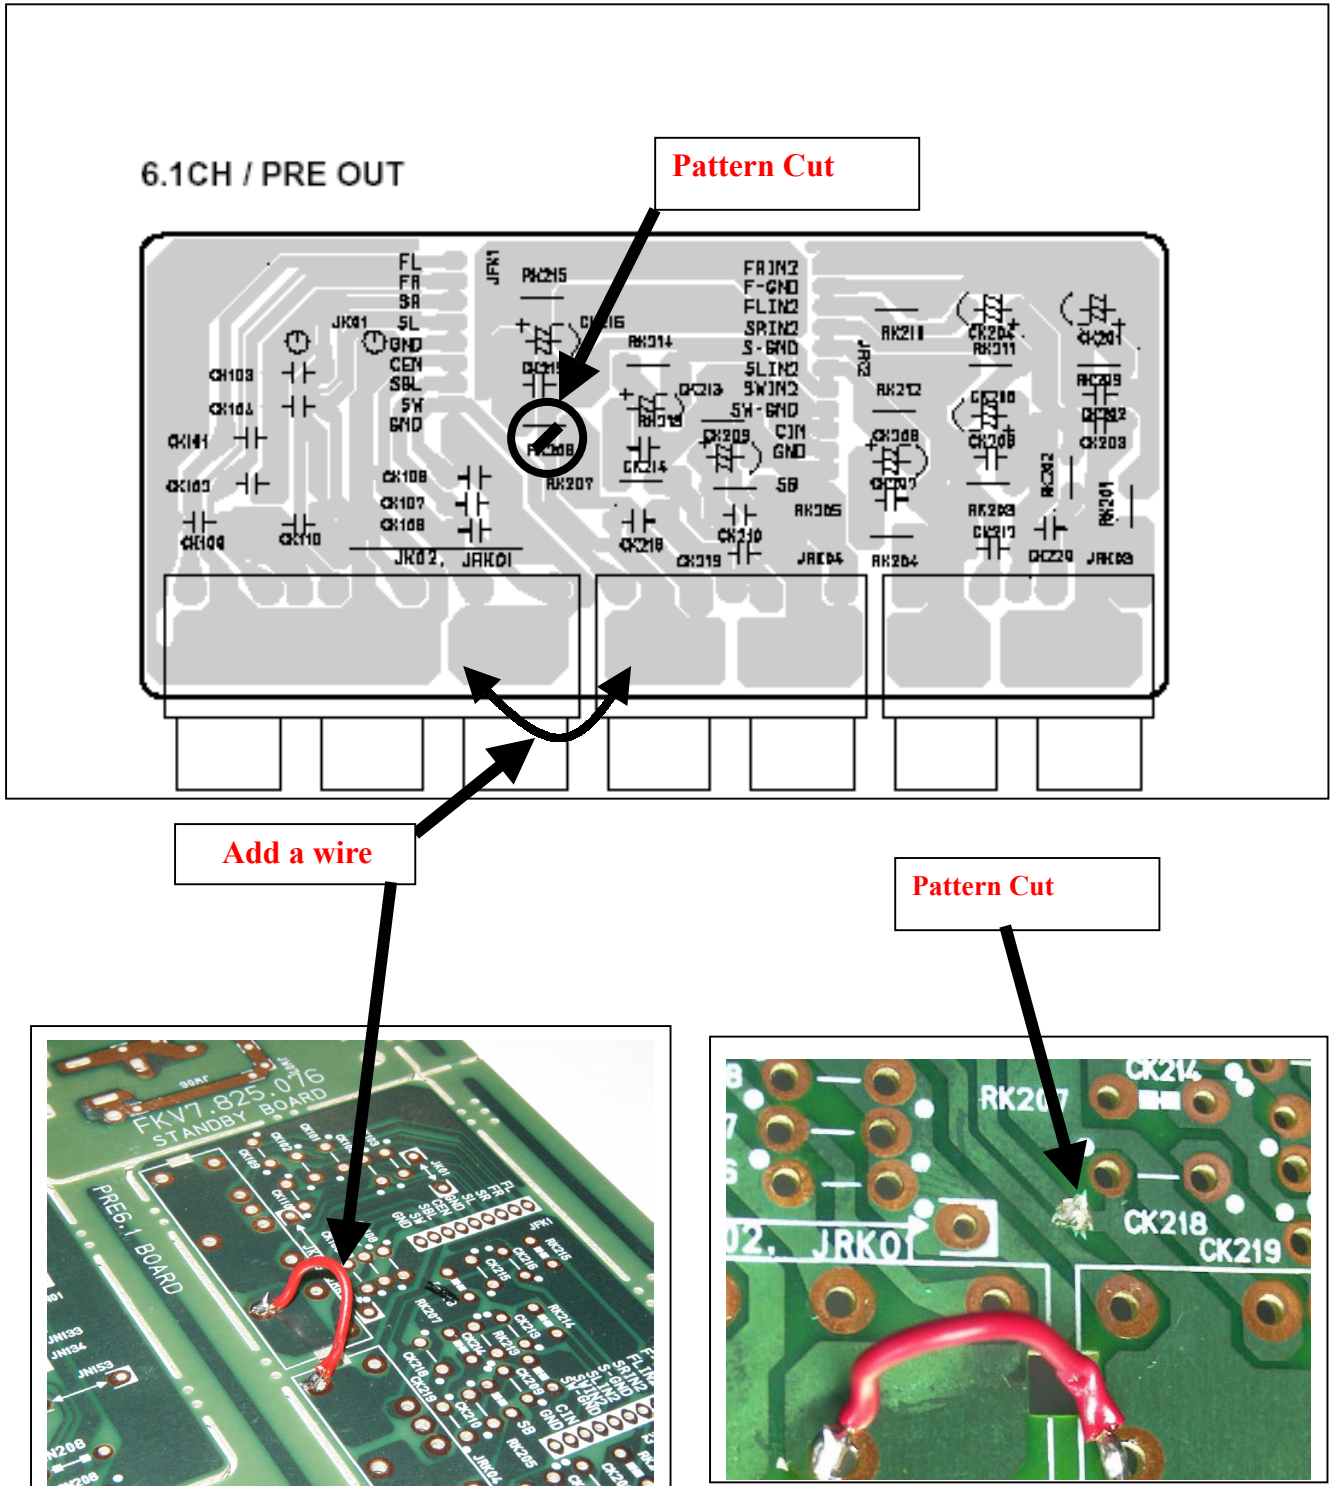
Fig.1

Noise is conspicuous PREAMP OUTPUTS and SPEAKER OUTPUTS by the conditions.

3. Cut a pattern. (please see Fig.1)
  4. Add a wire. (please see Fig.1)
  5. Twist the wire 5 times. (please see Fig.2)
- The 9pin wires are connected to JFS05(DIGITAL/AUDIO PCB) from JFK1(6.1CH/PRE OUT PCB)

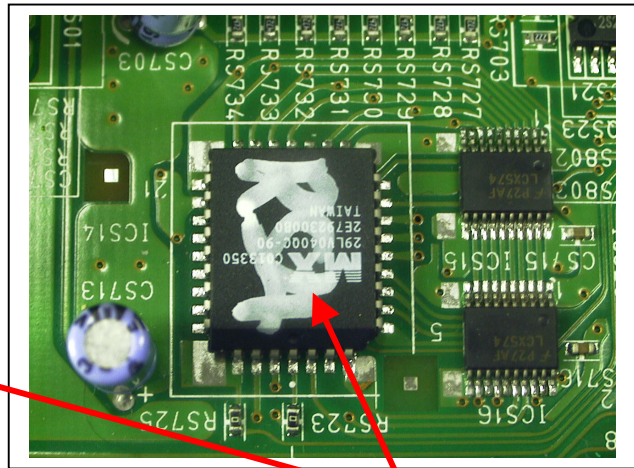
**ICS14**

Treble is slightly distorted when the level of TruBass is increased in CSII mode. (only in case of Rch)

Replace IC (ICS14) on the **DIGITAL/AUDIO CIRCUIT BOARD**.

POS.NO ICS14 Part no. \*HS09AWX2R MX29LV040QC-90 **Factory part no. OICMX29LV040QC90**  
 [OLD part no. \*HS09AWX0R Factory part no. OICMX29LV040QC90 ]
