marantz® SERVICE BULLETIN		Date: 30-June-2003	Model: SR4300,SR4400
		Page: 1 / 1	REF.NBR: MZ03-023
Circulation:		Subject:	
Application:		The sound is interrupted, when the playback DIGITAL of CD-R/RW of the SCMS signal.	
x for information customer complaint in case of service mandatory	See Below	Int.ref:

marantz® SERVICE BULLETIN		Date: 31-Oct.-2003	Model: SR4300/SR4400
		Page: 1 / 3	REF.NBR: MZ03-047
Circulation:		Subject:	
Application:		The problem of the Speaker protection circuit.	
x for information customer complaint in case of service mandatory			
Service code XE00 XE00xxxxxxxxxx

marantz® SERVICE BULLETIN		Date: 30-June-2003	Model: SR4300,SR4400
		Page: 1 / 1	REF.NBR: MZ03-025
Circulation:		Application:	
x for information customer complaint in case of service mandatory		See Below	
		Subject: FM(with RDS) signal is received, Frequency Indication becomes the setup of default by the remote control operation . (only N and A version occurs)	
		Int.ref:

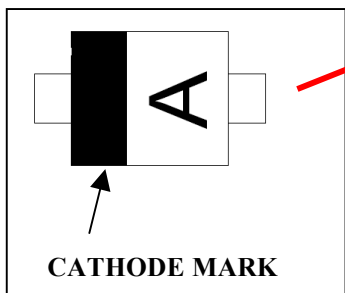
SR4300

Caution
JFS08 (FPC CONNECTOR) side is
CATHODE

- 1) Chip Resistor **LS850** (100 ohm 1/16W part no. NN05101610) is changed to **Silicon Diode (Part no. *HD201810R--- 1SS400 POHM: EMD2, EIAJ: SC-79, JEDEC: SOD-523)**.

LS850 is changed to
Part no. *HD201810R

Adhesives:
SC608LVZ (Sony Chemical Corp. – Self-extinguishing adhesive) or the equivalent

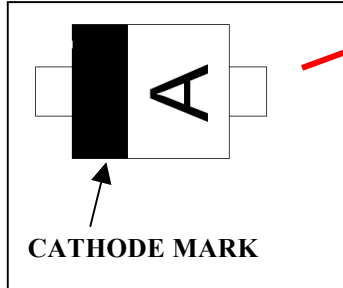
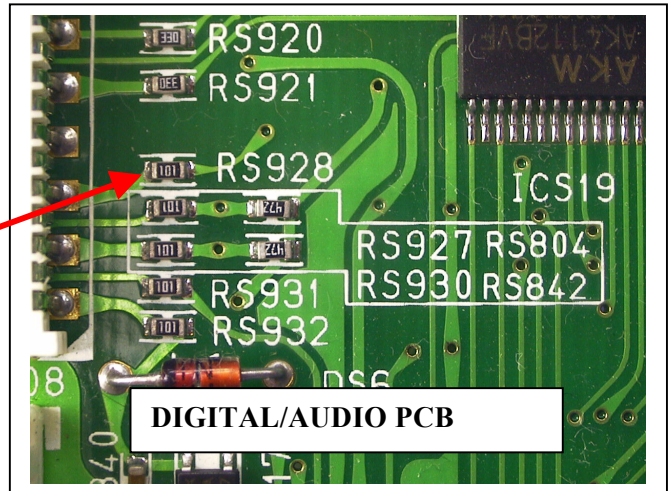
SR4400

Caution
JFS08 (FPC CONNECTOR) side is
CATHODE

- 1) Chip Resistor **RS928** (100 ohm 1/16W part no. NN05101610) is changed to **Silicon Diode (Part no. *HD201810R--- 1SS400 POHM: EMD2, EIAJ: SC-79, JEDEC: SOD-523)**.

RS928 is changed to
Part no. *HD201810R

Adhesives:
SC608LVZ (Sony Chemical Corp. – Self-extinguishing adhesive) or the equivalent
