marantz® SERVICE BULLETIN		Date: 27-Sep-2004	Model: SR4500
		Page: 1 / 1	REF.NBR: MZ04-065
Level		Application:	
★ ★		See below	
		Subject: The reading accuracy improvement of the continuation code of the Remote Controller.	
		Int.ref:

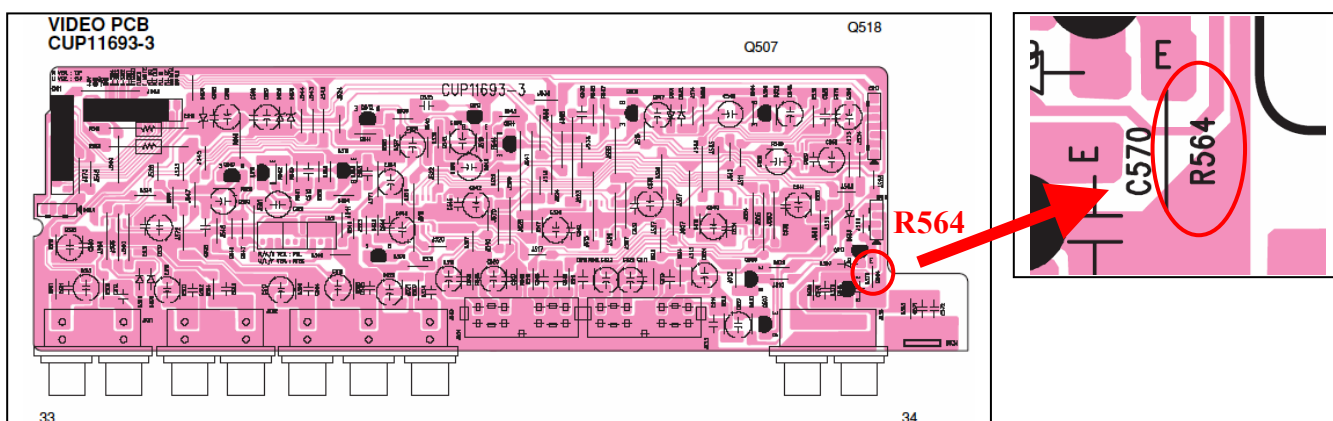
A reading leak occurs in the continuation code of the Remote Controller.
(It is especially UP / DOWN of the Volume.)

The protection circuit operates by Impulse Noise.

1. POS.NO **R564** RESISTOR (47K OHM) is changed to RESISTOR **15K OHM +5% 1/6W** (Part no. **00MGD05153160**) on the VIDEO PCB.
