<b>marantz®</b> <b>SERVICE BULLETIN</b>		Date: 15-May-2003	Model: SR5200/SR6200/SR7200
		Page: 1/2	REF.NBR: MZ02-033
Circulation:		Subject:	
Application:		Hum noise can be heard from Headphone out.	
x for information customer complaint in case of service mandatory			
		See below

<b>marantz®</b> <b>SERVICE BULLETIN</b>		Date: 15-May-2003	Model: SR5200/SR6200/SR7200
		Page: 1/6	REF.NBR: MZ02-032
Circulation:		Application:	
x for information customer complaint in case of service mandatory		See below	
		Subject:  Pop noise	
		Int.ref:

<b>marantz®</b> <b>SERVICE BULLETIN</b>		Date: 27-Sep-01	Model: SR5200/6200/7200
		Page: 1/2	REF.NB MZ01-016
Circulation:		Application:	
x for information customer complaint in case of service mandatory .....		<b>Refer to following.</b>	
		Subject:  The noise (stripes) occur on the picture.	
		Int.ref

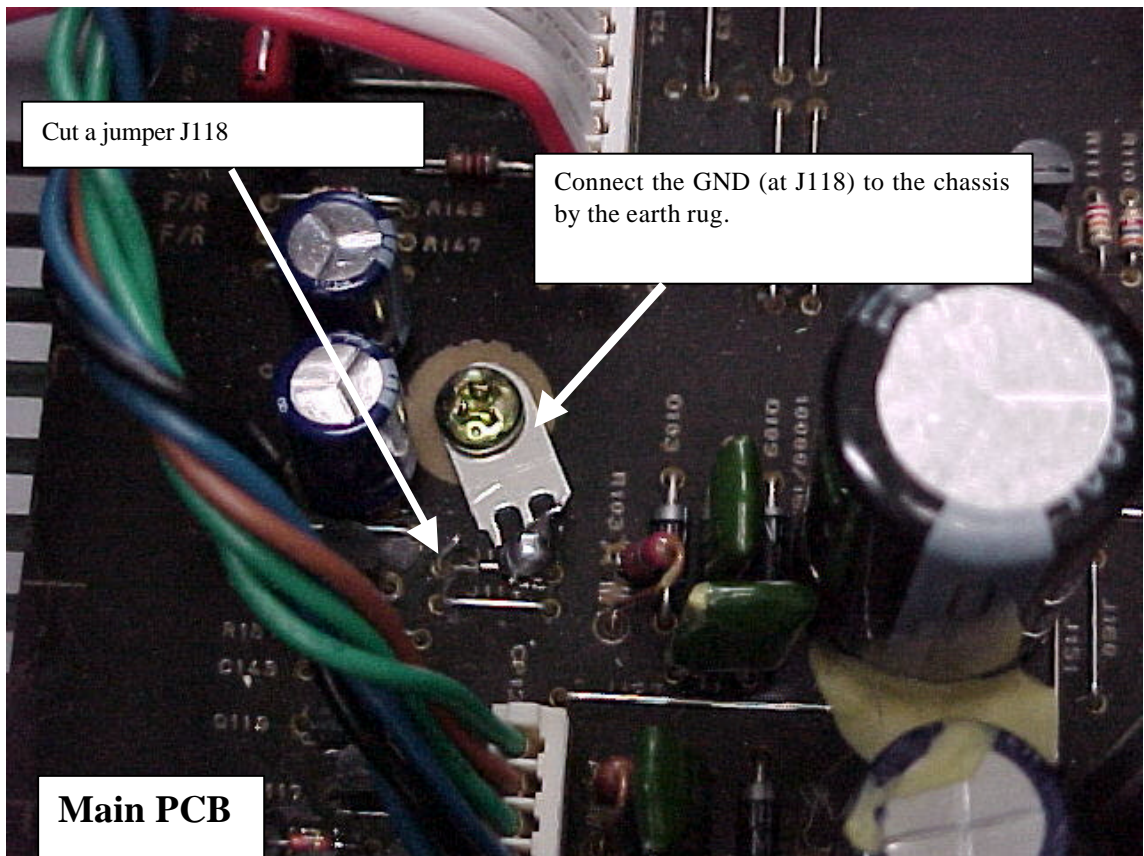
Hum noise can be heard from Headphone out

Caused by ground loop of the headphone out.

Please apply the following solution.

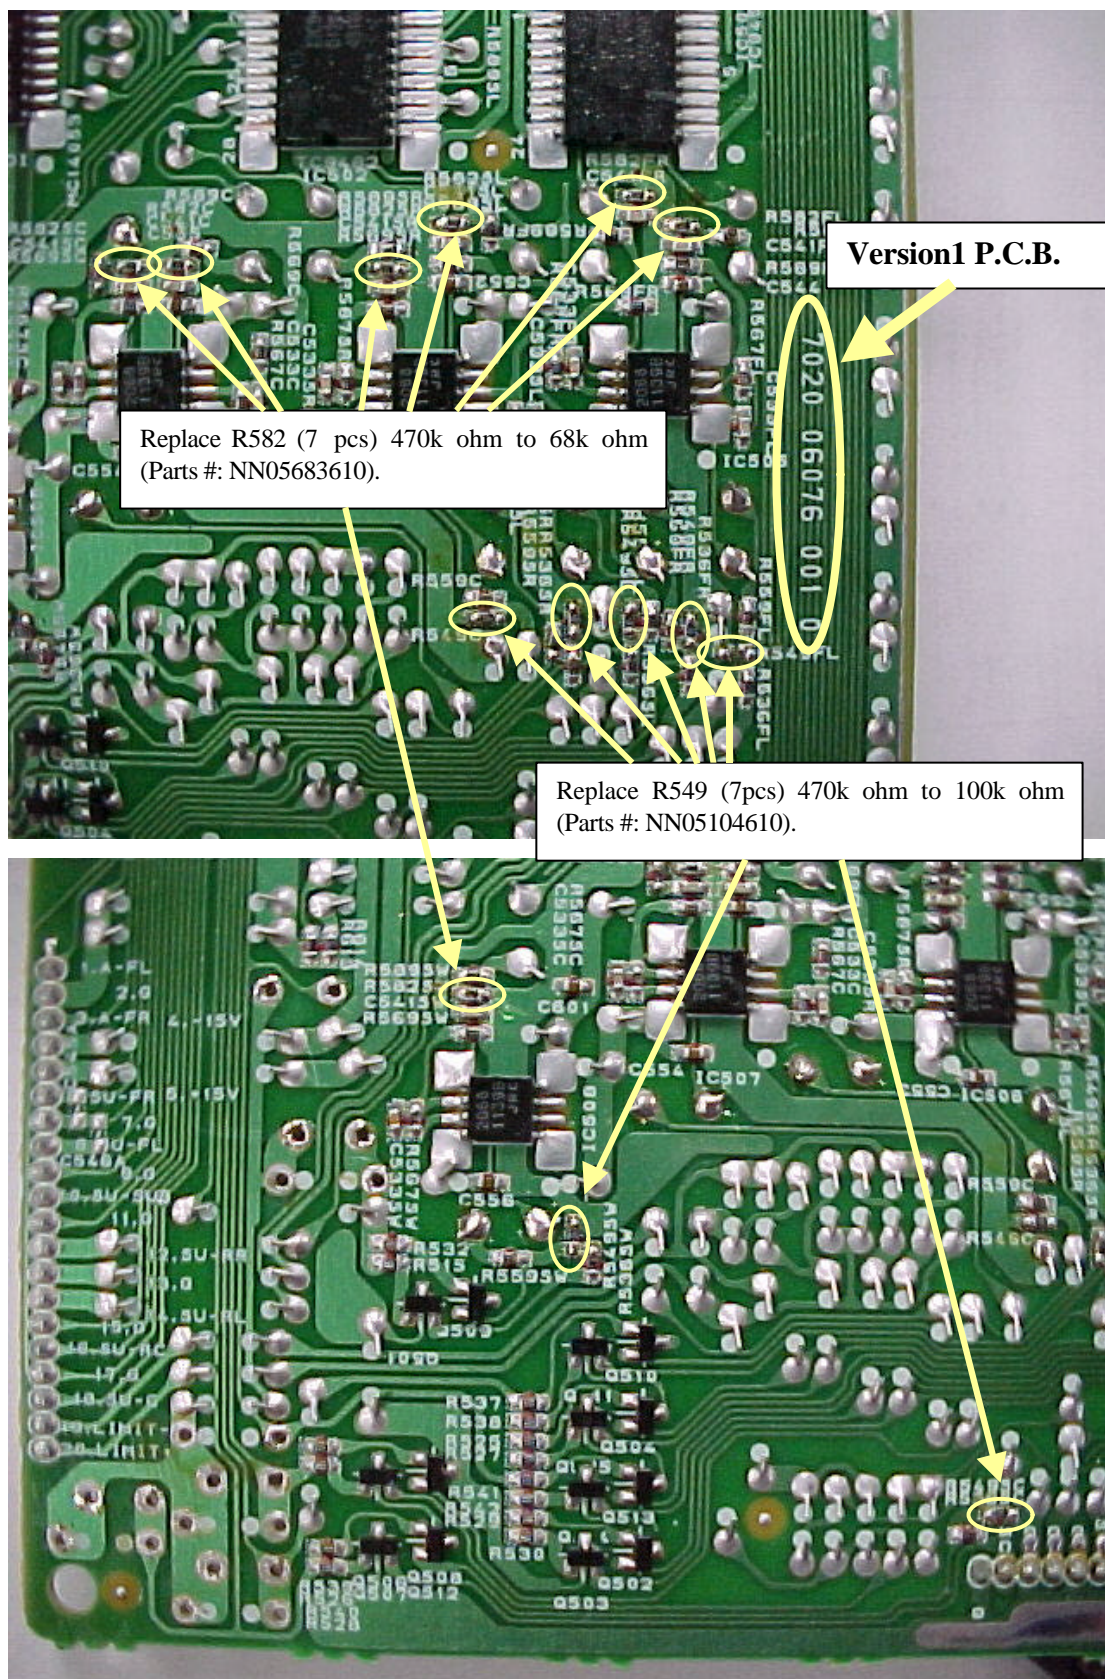
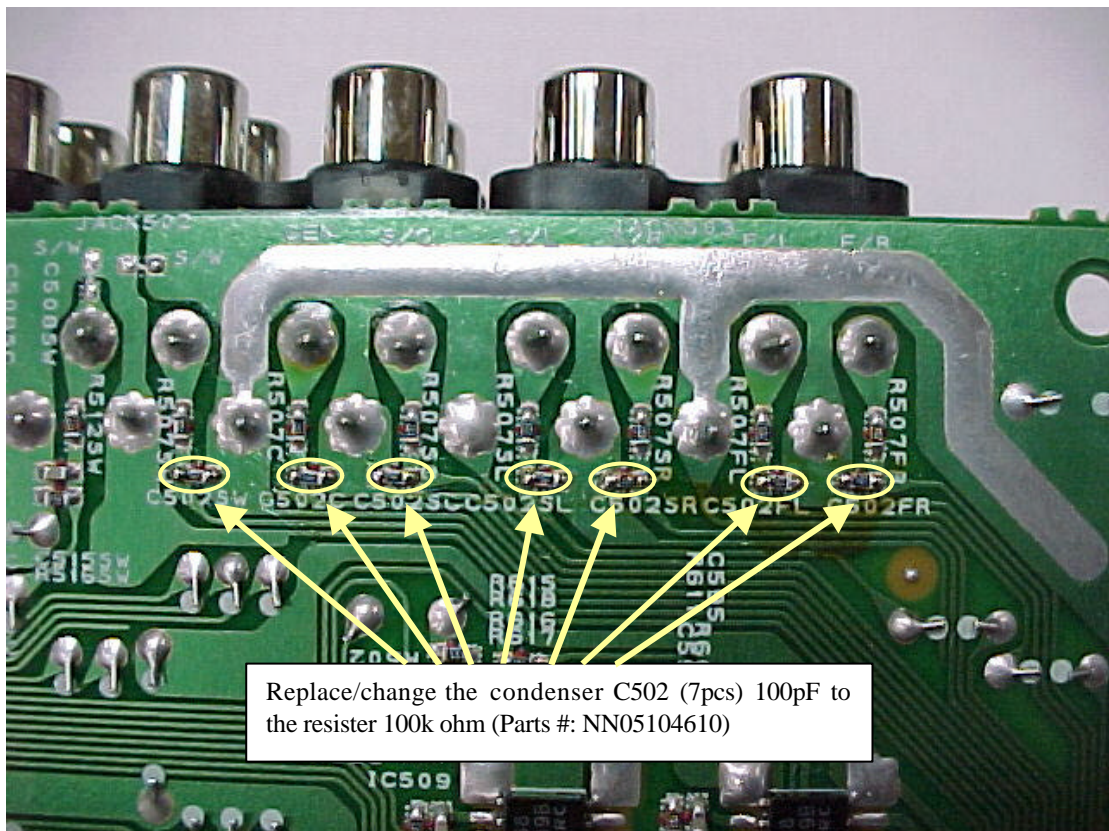
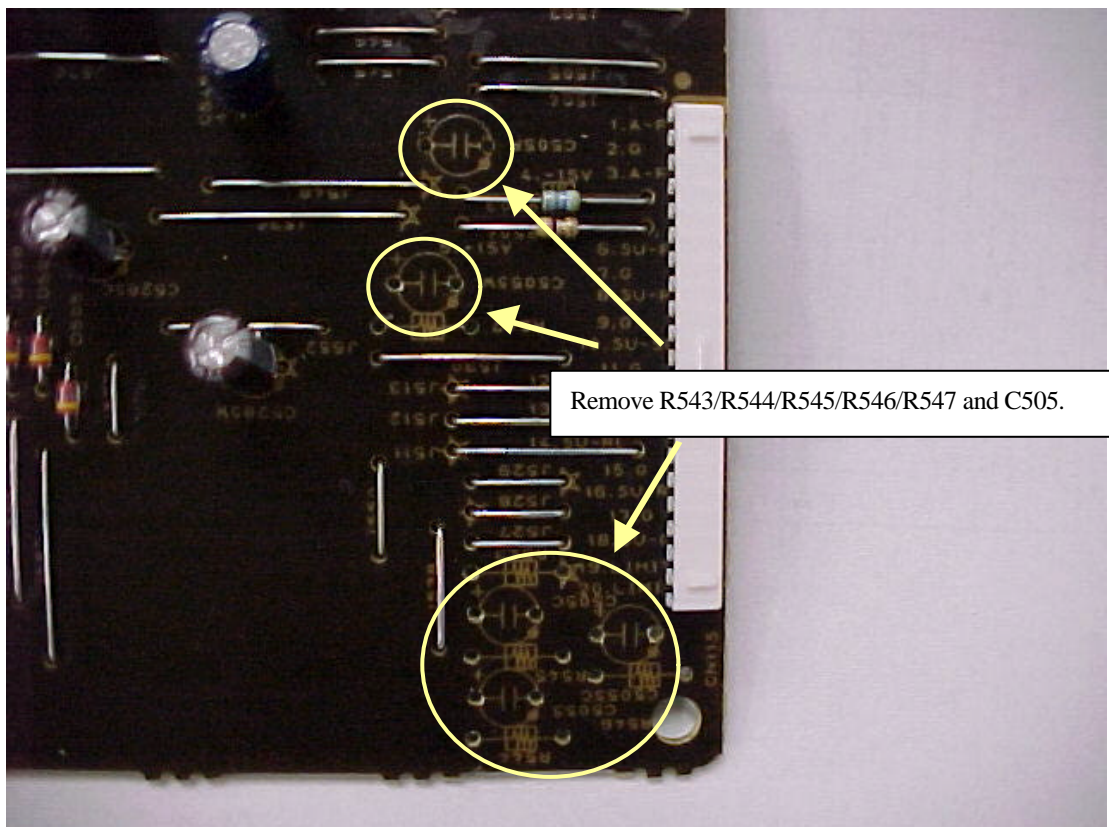
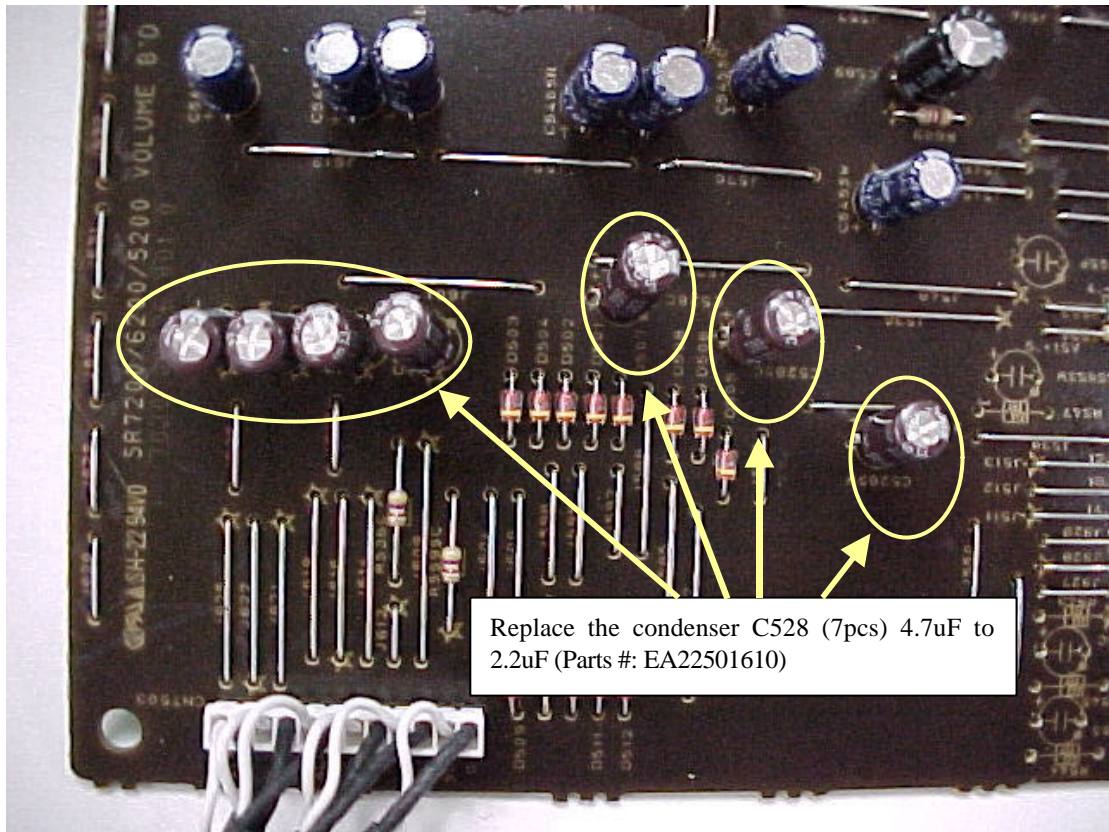
\* Version 1 P.C.Board (7020 06076 001-0) : Please apply the modification mentioned below (Page2 to 4).

Pop noise appears when stop playing or track skip on CD playback with Digital connection.  
Pop noise appears in the condition of the Main volume is changed 74dB to 75dB(Mute) .

\* Version 1 P.C.Board (7020 06076 001-0) : Please apply the modification mentioned on Page2 to 4.

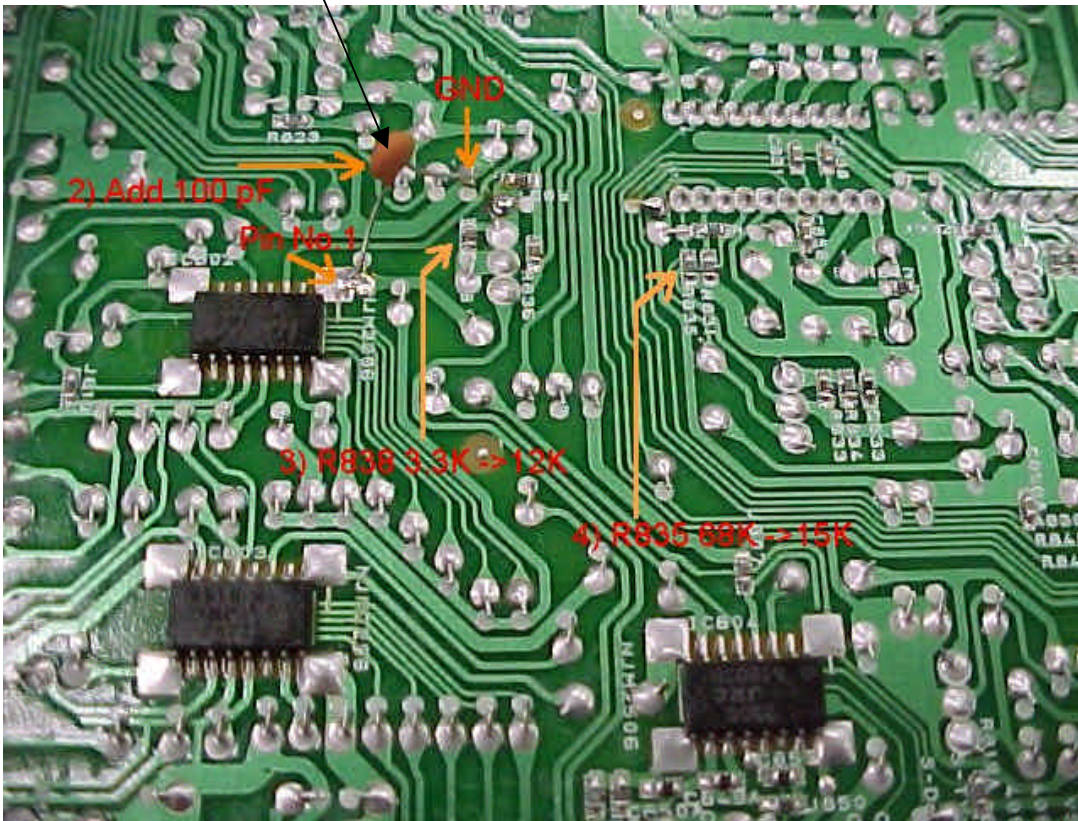
PIC.01

When a output connect with the monitor via the S-VIDEO terminal, noise(stripes) occur at the picture.

The clock from the OSD circuit, it caused interference to VIDEO-AMP circuit.

- 1) The capacitor(C810A 100pF: DK16101300 4822 122 33195) is added between 1P of IC802 and GND(refer to PIC.01).
- 2) The jumper wire(J841) is deleted and a capacitor(C840A 47uF/16V: EA47601620 9965 000 06289) is added to same position (refer to PIC.02).
- 3) The chip resistor(R838) is changed into 12kohm one(NN05123610 4822 051 30123) from the present 3.3kohm one.
- 4) The chip resistor(R835) is changed into 15kohm one(NN05153610 4822 051 30153) from the present 68kohm one.

C810A (100pF: DK16101300

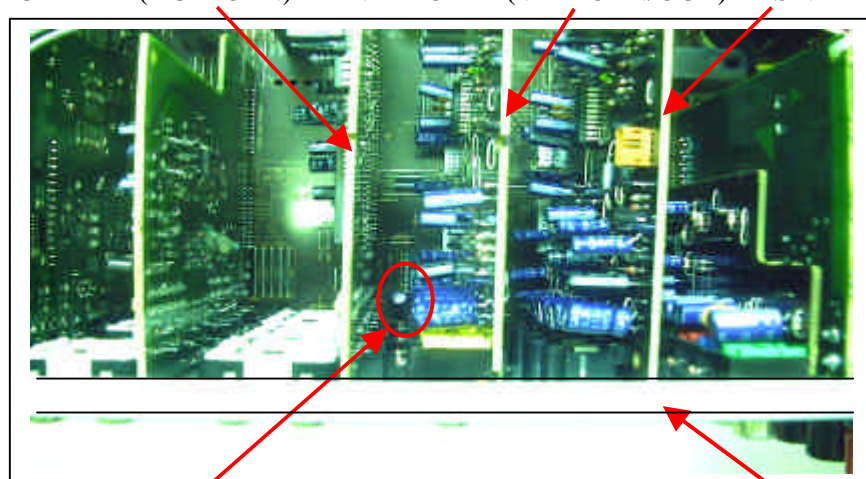
**C146 on the MAIN CIRCUIT BOARD**

The POP noise occurs from Center speaker, Surround L/R and Surround Center speaker when POWER ON.

Because the IC of the speaker drive circuit has time lag , a transistor becomes on under the condition of un-stability to output when POWER ON, and POP noise is occurred.

Electrolytic capacitor **C146(10uF/50V)** is changed to **47uF/16V** on the **MAIN CIRCUIT BOARD**.

POS.NO    **C146**    **EA47601610(47uF/16V)**      **Can be used even 47uF/50V**
