<b>marantz®</b> <b>SERVICE BULLETIN</b>		Date: 5-Mar.-2004	Model: SR5400,SR6400,SR7400
		Page: 1 / 1	REF.NBR: MZ04-019
Circulation:		Subject:	
Application:		By idling, Top cover becomes very hot so that it cannot touch by hand.	
x for information customer complaint in case of service mandatory .....		See below	
		Int.ref:

<b>marantz®</b> <b>SERVICE BULLETIN</b>		Date: 15-Mar.-2004	Model: SR7400
		Page: 1 / 1	REF.NBR: MZ04-025
Circulation:		Subject:	
Application:		Can't decode input signal by the operation of other company HDD RECORDER.	
x for information customer complaint in case of service mandatory .....	See Below		
		Int.ref:

<b>marantz®</b> <b>SERVICE BULLETIN</b>		Date: 9-Jan-2004	Model: SR7400
		Page: 1 / 1	REF.NBR: MZ04-003
Circulation:		Application:	
x for information customer complaint in case of service mandatory .....		See Below	
		Subject:  Sound cut (short-time) of Dolby and dts decoding.	
		Int.ref:

<b>marantz®</b> <b>SERVICE BULLETIN</b>		Date: 9-Jan.-2004	Model: SR7400
		Page: 1 / 3	REF.NBR: MZ04-004
Circulation:		Subject:	
Application:		The synchronization of picture is disturbed. ( Only PAL system video signal )	
x for information customer complaint in case of

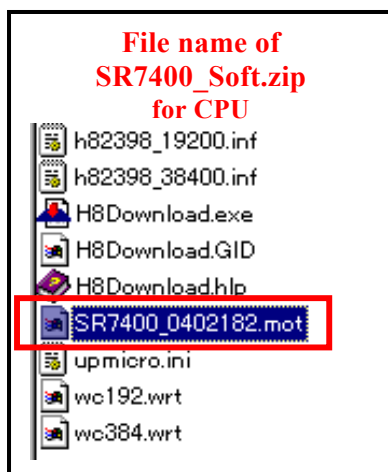
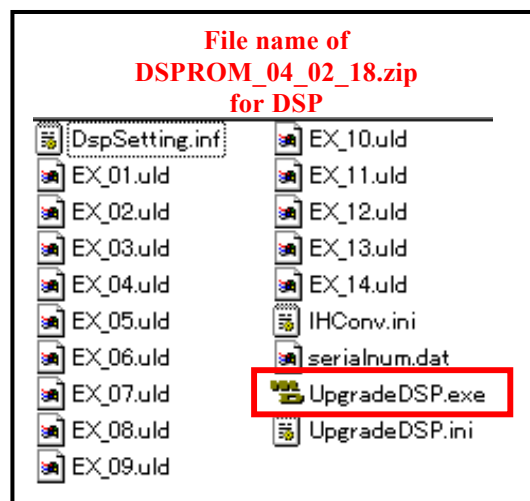
- 1) It occurs when Digital connection of HDD recorder (by Panasonic or Toshiba product).
- 2) The sound output of SR7400 is muted by HDD recorder operation.

- 1) Update the CPU(IC28)'s software version to [ **V040218\_2x** ]
- 2) Update the DSP(IC20)'s CODE ID 02 to [ **CD02\_02010116** ]
- 3) Please refer to the service manual SR7400 page58 to 62, about details of "10.SERVICE MODE" and " 12.UPDATE FIRMWARE ".

Update of the firmware disc **\*SR7400CD2**

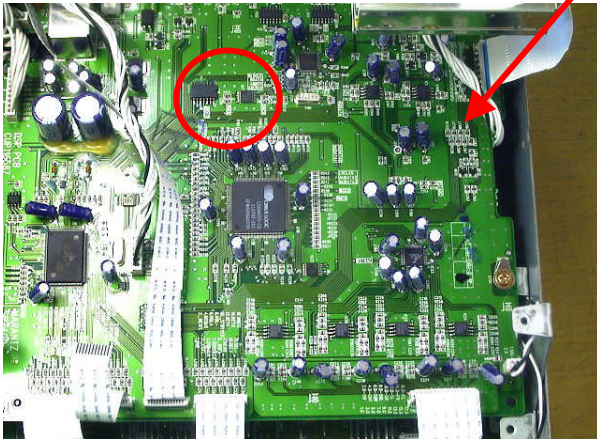
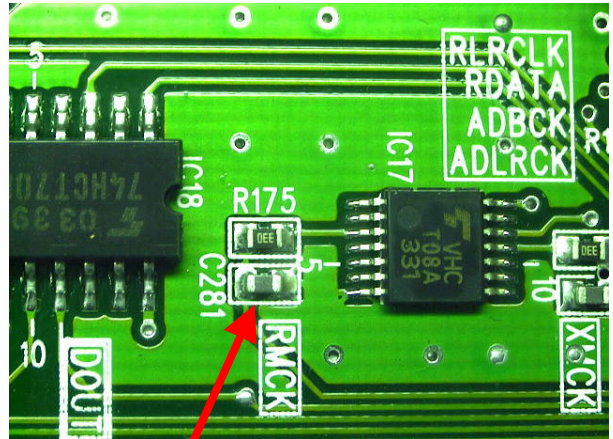
**DSP PCB**

Capacitor C281 (33pF) of the measure against EMC has influenced.  
By the capacitor C281, the standup of a clock pulse becomes late, DSP incorrect-detects the noise, and Auto Mute of DAC incorrect-operates.

**Capacitor C281 ( 33pF) is removed on DSP PCB.**

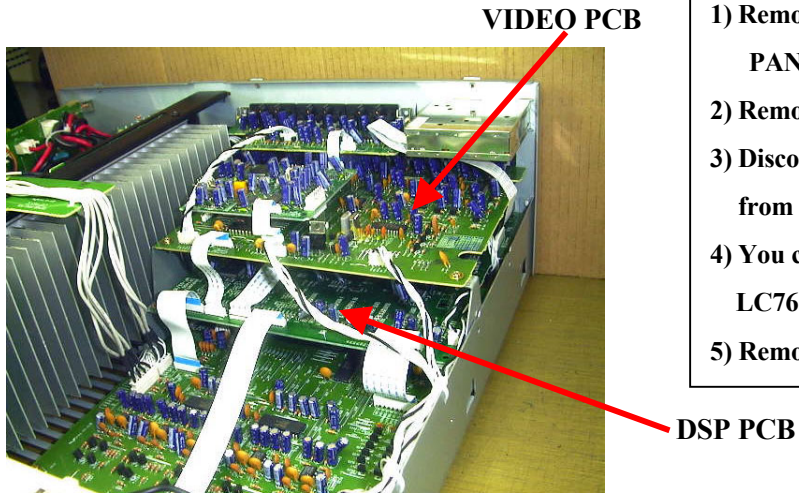
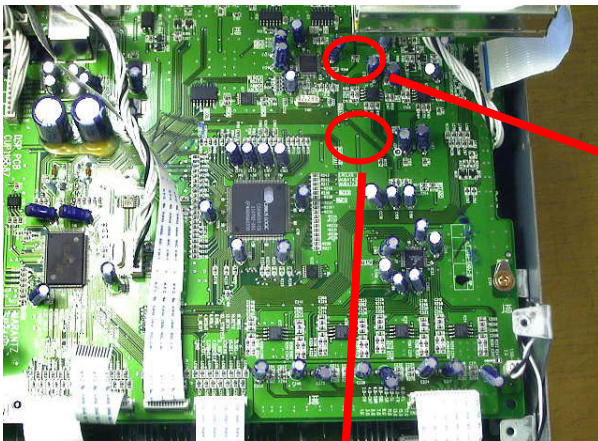
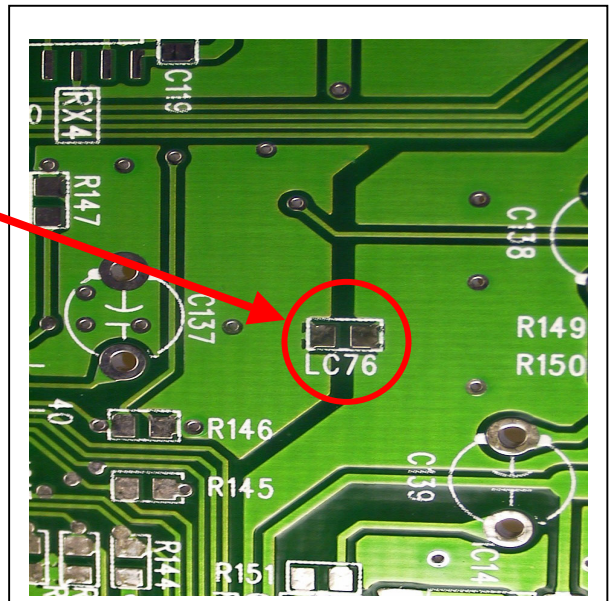
- 1) Noise occurs except 7.1CH INPUT and analog signal S-DIRECT.
- 2) When volume is increased, noise occurs.

- 1) Remove 9 screws of VIDEO PCB from REAR PANEL.
- 2) Remove 2 screws from VIDEO PCB.
- 3) Disconnect the connector and Flexible Flat Cable from VIDEO PCB.
- 4) You can remove VIDEO PCB, then you can see LC76.
- 5) Remove LC76 and Cut a GND-Pattern
