marantz® SERVICE BULLETIN		Date: 15-Jan.-2007	Model: ST6001/N1B/N1S
		Page: 1 / 1	REF.NBR: MZ07-001
Level		Application:	
★ ★		See Below	
		Subject: FL Segment Light Leakage	
		Int.ref:

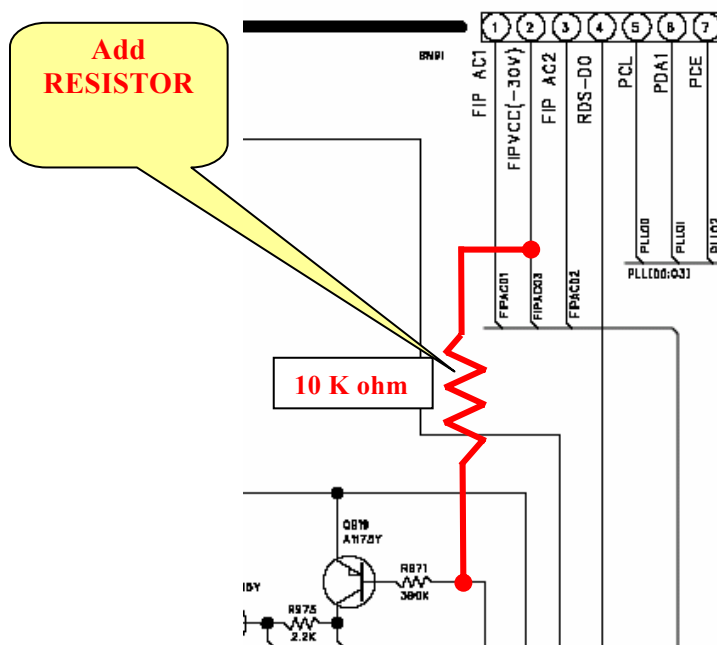
Due to variability in their performance quality of the component, the FL Displays of certain ST6001 units develop light leakage in the left segment when the indicator lights up.

Light Leakage
