## MODIFICATION

**Adding Protection circuit after changing the laser mechanism**

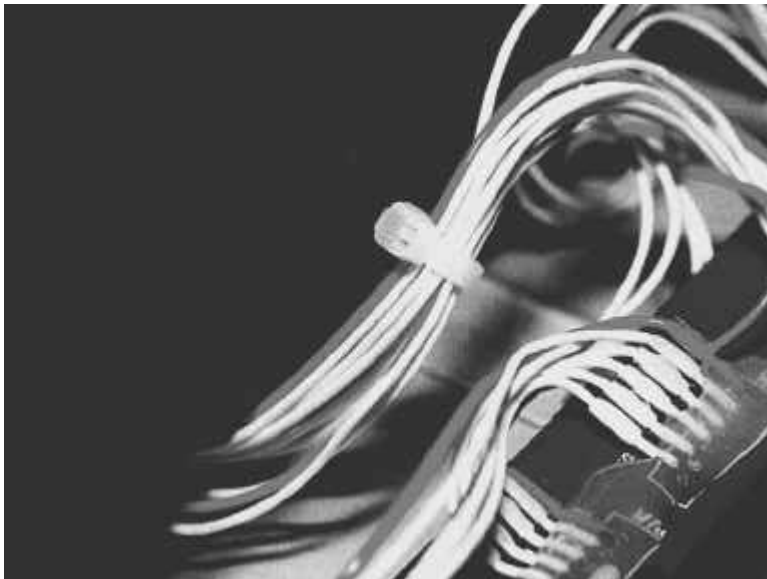
CD Player does not read disc, skips, produces scratching noise.

The cable tie that ties the two cables to the laser together scrapes over the bottom of the unit.

Relocate the cable tie as shown in the below picture, it's advisable to relocate the other cables as well to avoid any contact with the other cables.

It's advisable to perform this modification whenever a unit comes in for service.

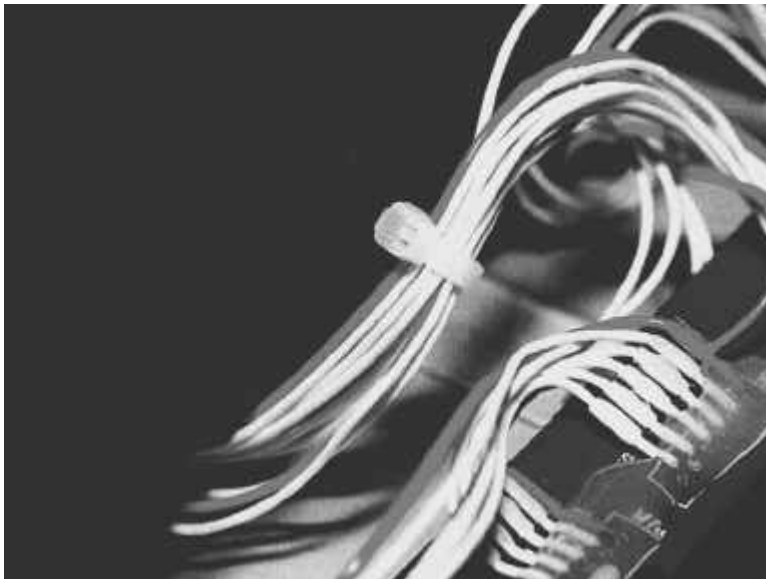
CD Player does not read disc, skips, produces scratching noise.

The cable tie that ties the two cables to the laser together scrapes over the bottom of the unit.

Relocate the cable tie as shown in the below picture, it's advisable to relocate the other cables as well to avoid any contact with the other cables.

It's advisable to perform this modification whenever a unit comes in for service.
