NAD C520/C521

MODIFICATION

for C521/C541,C520/C540,C522/C524

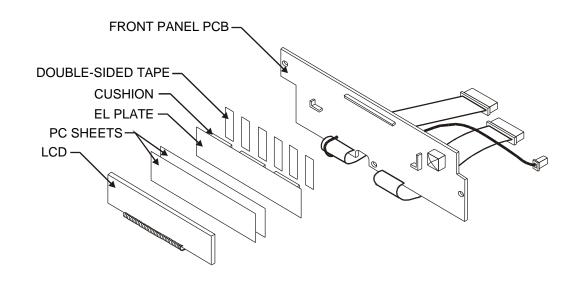
You may receive a complaint of the unit producing a very high whistle noise

The step up transformer for the display circuit is humming

- 1. Insert a transformer with more varnish impregnation
- 2. Apply glue to fix the step-up transformer to the main pcb
- **3.** Add double sided tape between the cushion at the back of the EL display and the front panel pcb. Please refer to the drawing below
