Technical Bulletin C542

Hardware Technical Bulletin: C542-H2005-03

Subject: Laser ribbon cable

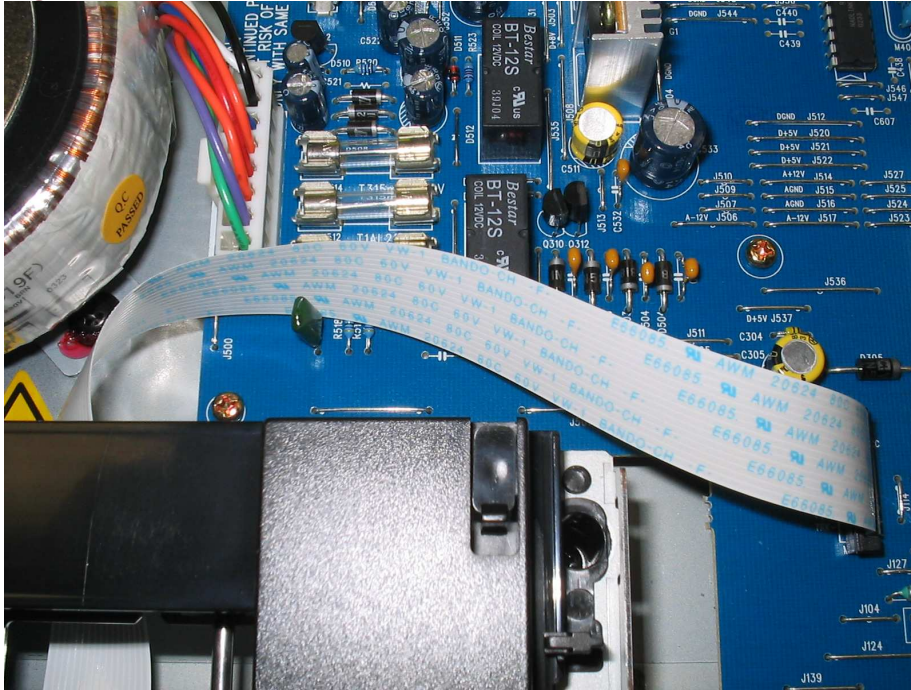
Figure 1

REASON: The laser pick up connects to the main pc board via a flat ribbon cable and is possibly twisted the wrong way . It maybe getting caught on the fuse holders or other parts. just behind the transport mechanism . See figure 1.

INCORRECT

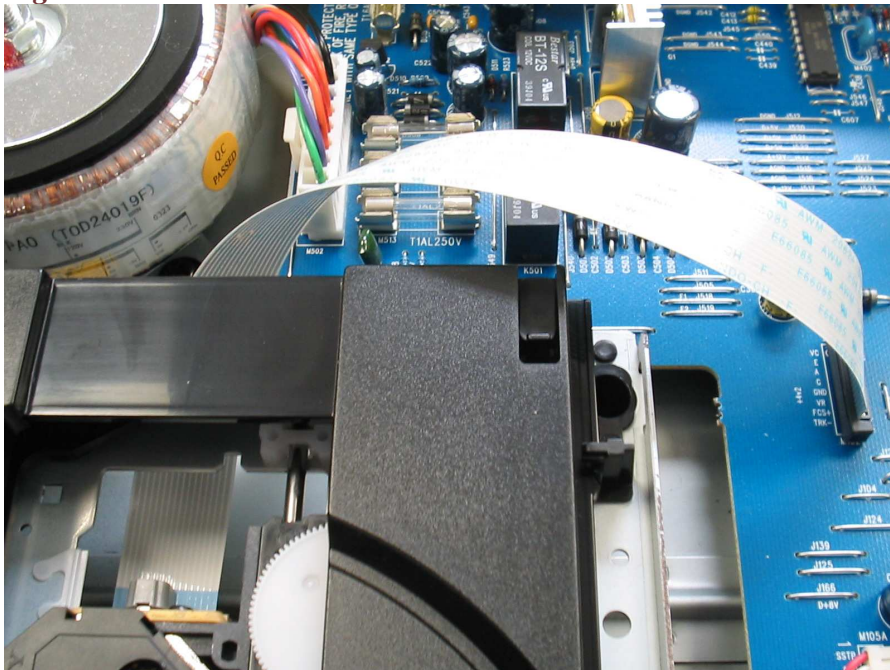
Figure 2

CORRECT

SOLUTION: The ribbon cable needs to be allowed to wrap smoothly as shown in figure 2.
