## Service Tip

***Problem:*** Poor response of AV Receiver to remote commands.

***Affected Models:*** Some T760, T751, T761; not all units are affected.

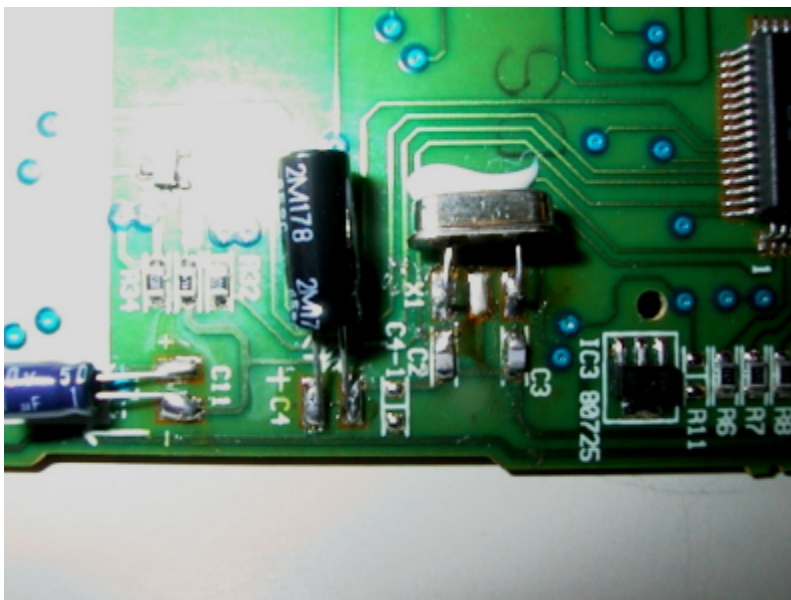
Diagram 2

***Cause:*** Mismatch of IR frequency between Remote and Receiver.

2. With the remote opened, locate X1, C2, and C3 . X1 is a ceramic resonator type and should be replaced with a crystal 9.8304 MHz as shown in Diagram 2. Capacitors C2 and C3 are now required for proper operation. Install capacitors C2 and C3, 22pF (surface mount type 0805 series) as shown in diagram 2.

3. Hot glue X1 crystal to the PC board for stability. Reassemble.
4. Finally, test remote with receiver using the input functions as a test(eg. CD, VIDEO1, VIDEO2 ...etc.) .
