MODIFICATION

Adding Protection circuit after changing the laser mechanism

Signal display circuit change

Circuit Change

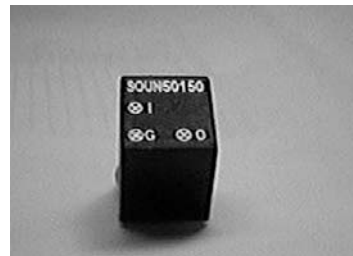
3 PIN TRANSFORMER MODULE

The first transformer was a 3 pin module inverter package. The second transformer is a 9 pin stand alone transformer. The part numbers for the two parts is shown below.

PART NUMBER#1806-2217-0
(original in service manual)
