Service Information L70

Circuit Change

Technical Bulletin L70

Product: DVD Receiver
Hardware Technical Bulletin: L70-H2004-05

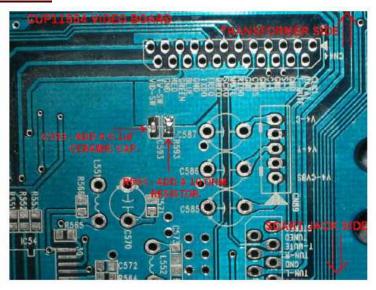
Photo 1

PROBLEM: When using the component out on the L70 you may find the video signal has faint diagonal lines appearing.

CAUSE: The ground plane requires additional coupling.

SOLUTION: Add a 10 ohm resistor to location R593 on the video board.

Add a 0.1uF ceramic capacitor to location C593 on the

video board. See photo below.

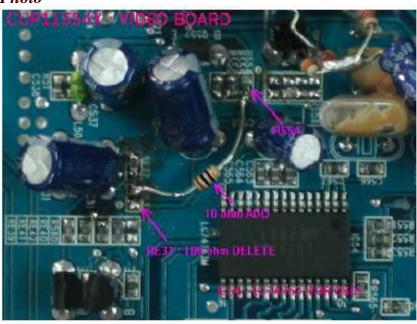
Photo

PROBLEM: You may have the complaint that the TV SCART RGB output is not switching automatically.

CAUSE: The drive current of some television sets is not sufficient to switch the RGB output.

Delete RE31 100 ohm resistor on video board. Add a 10 ohm resistor between PIN 16 of SCART connector (one leg of RE31) and +5V rail(one leg of R554) on video board. See photo and schematic diagram.

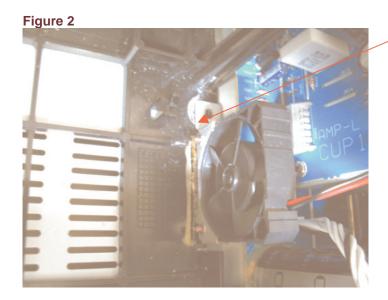
DESCRIPTION: The small ventilation fan located on the DVD mechanism, is noisy or is turning too slowly.

REASON: The fan bearing is worn.

- 1. As shown cut the supplied bracket in order to install it with the new fan.
- 2. Secure fan to the bracket and add some glue to the bottom of the bracket when securing to the chassis. See figure 1 and 2.

Glue bottom of bracket to chassis

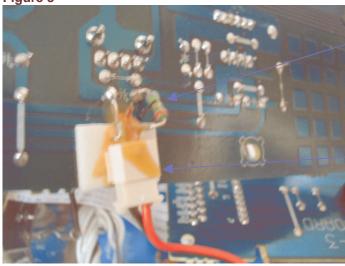
Figure 3

R922 on bottom of pc board 100 ohm changes to 82 ohm.

3. Replace R922 (100 ohms)and solder the 82 ohm resistor supplied, to one leg of the male plug and solder the other to capacitor C 905 + side. This is on the bottom of the main cpu pc board which mounts to the top of the dvd player mechanism.
