**Product:** A/V Receiver

**Hardware Technical Bulletin:** T163-H2005-05R

**Subject:** Static protection for muting transistors

**Product: A/V Receivers**

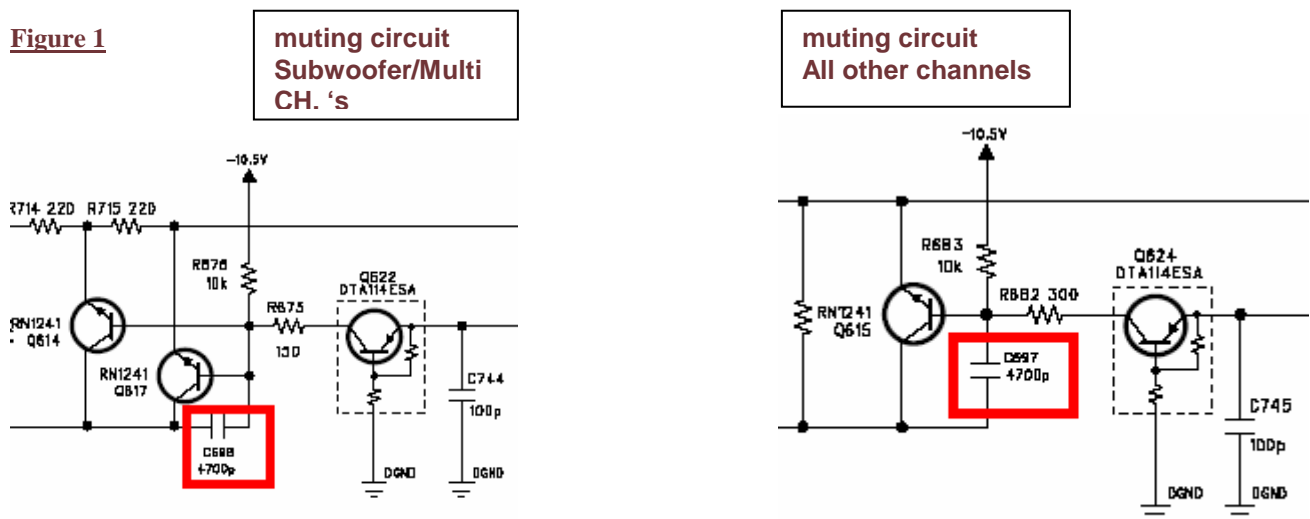
**Figure 1**

**DESCRIPTION:** You may have the complaint that the subwoofer or other channels are popping when switching inputs or when turning on and off.

**REASON:** The channel that is popping may have a muting transistor damaged due to an external source or subwoofer causing static damage to the transistor.

**SOLUTION:** Replace the transistor and install a 4700 pF capacitor between the base and collector on the pre amp pc board, as shown in the following two schematics. The use of a surface mount capacitor is recommended. Placing the capacitor on the bottom of the board between the base and collector of each muting transistor is preferred. See figure 2 on page 2.

**Note:** It is recommended to install this capacitor to each channel's muting transistor. The following are the designations of the muting transistors, Q608, Q609, Q610, Q611, Q612, Q613, Q615, Q617 and Multi source muting transistors Q632, Q633.

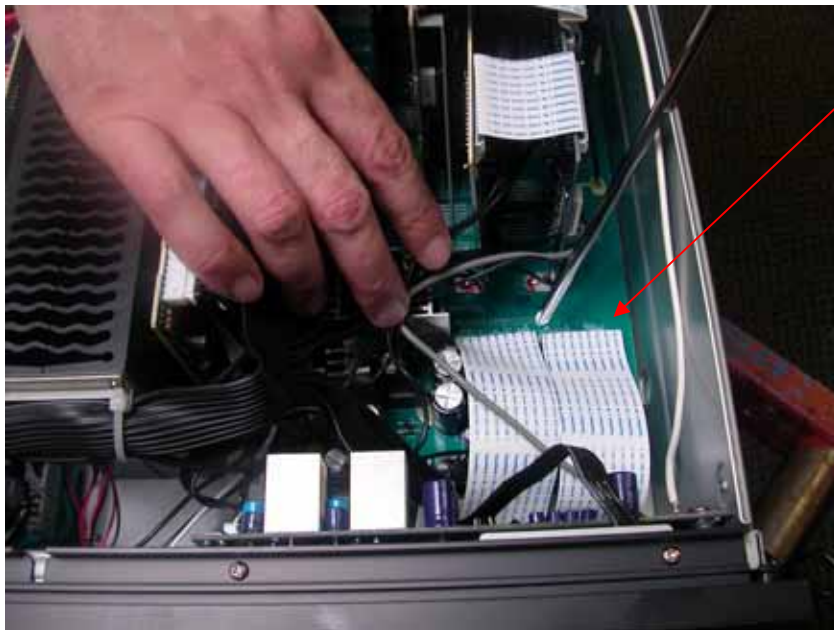
Figure 1

**DESCRIPTION:** *The unit may be experiencing intermittent audio or display. The unit may not always power up.*

**REASON:** *The flat ribbon cables, primarily the ones running from the front panel but may include all flat ribbon cables. They may have intermittent contact due to oxidization.*

**SOLUTION:** *Clean all ribbon connectors using an eraser or preferably a non alcohol based cleaner which will leave no residue. See figures 1, 2 and 3.*

Locate and remove the ribbon cables, front panel cables shown.

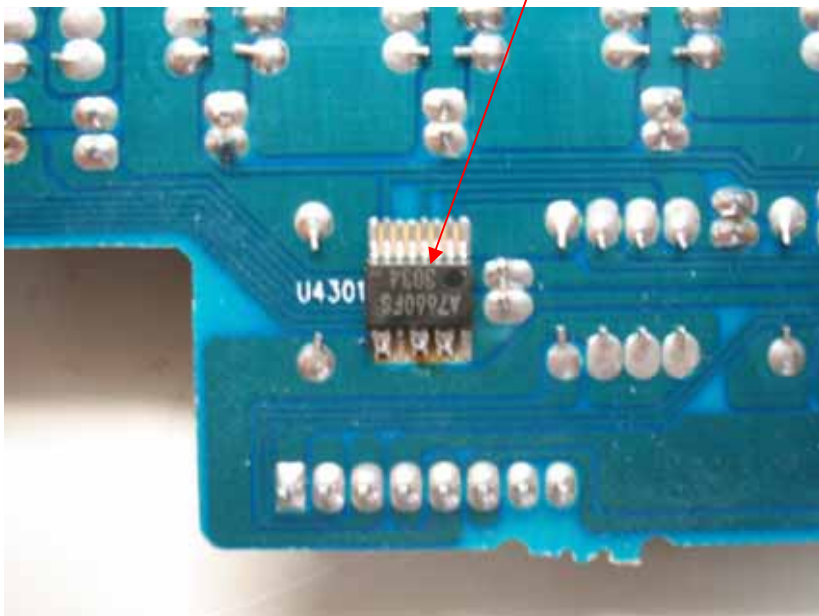
Figure1

**DESCRIPTION:** To improve the compatibility of HDTV signals with some TV/Monitors.

**REASON:** When decoding HDTV signals some TV/Monitors may experience horizontal sync loss.

On the component video PCB U4301

- A) Link the following pins on U4301;
- Pins 9 to 10
  - Pins 12 to 13
  - Pins 14 to 15

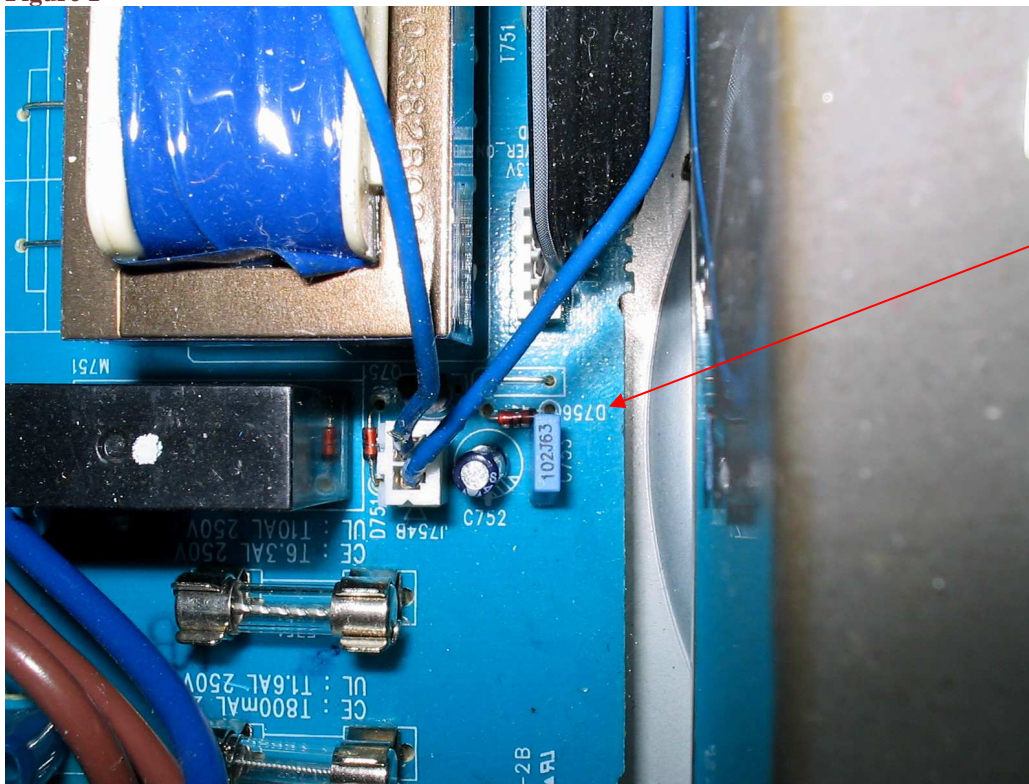
Figure 1

**DESCRIPTION:** Unit may shut down, shortly after turn on.

**REASON:** There is a diode on the standby board that maybe operating intermittantly.

**SOLUTION:** Locate and identify D756 on the standby board. Change only if the diode is a 1N4148. Change from a 1N4148 to a 1N4004 or equivalent. See figure 1 for details.

D756  
CHANGE  
FROM  
1N4148 TO  
1N4004
