Product: A/V Receiver

Hardware Technical Bulletin: T773-H2005-05R

Subject: Static protection for muting transistors

Technical Bulletin T773

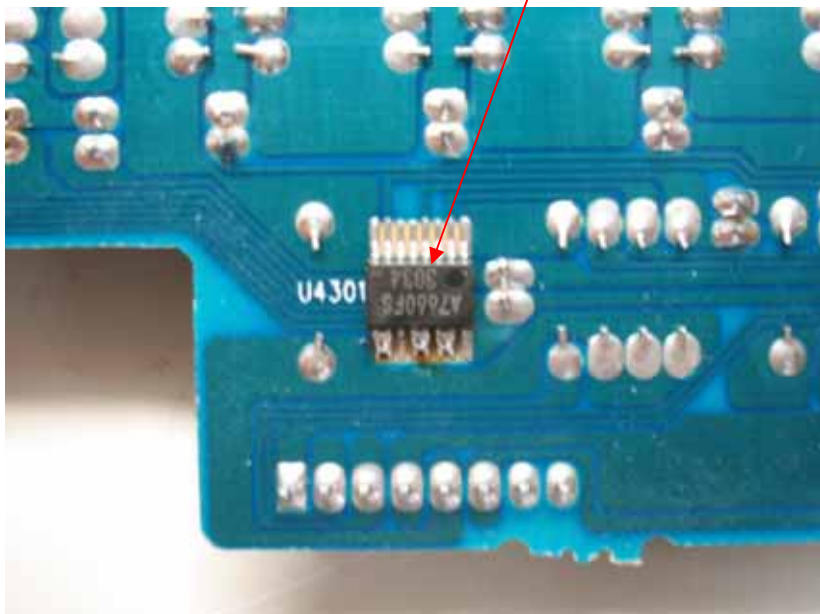
Figure1

REASON: When decoding HDTV signals some TV/Monitors may experience horizontal sync loss.

On the component video PCB U4301

- A) Link the following pins on U4301;
- Pins 9 to 10
 - Pins 12 to 13
 - Pins 14 to 15

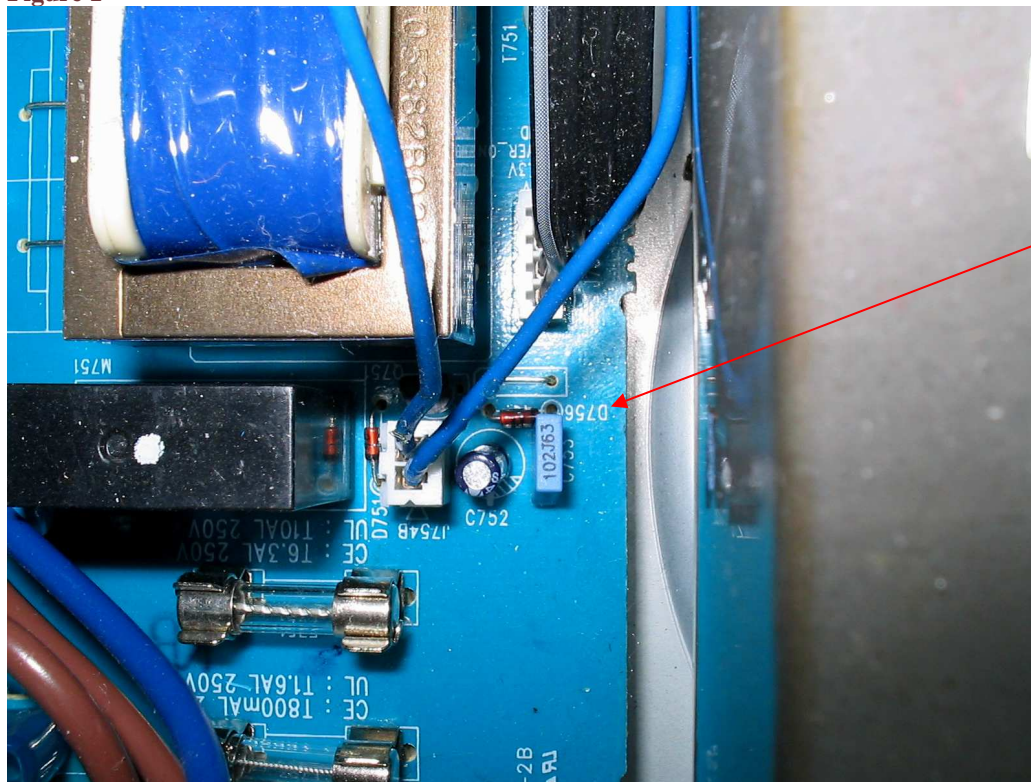
Figure 1

DESCRIPTION: Unit may shut down, shortly after turn on.

REASON: There is a diode on the standby board that maybe operating intermittantly.

SOLUTION: Locate and identify D756 on the standby board. Change only if the diode is a 1N4148. Change from a 1N4148 to a 1N4004 or equivalent. See figure 1 for details.

D756
CHANGE
FROM
1N4148 TO
1N4004
