SERVICE BULLETIN: 02001-2

Date 01/30/02

Models:	TX-DS797 / TX-DS898
Symptom:	Static like Noise (tic, tic,) occurs when in surround mode with a limited possibility of Surround Back not functioning.
Cause:	Power Supply VCC for Q713 may be too high.
Solution:	Reduce VCC or Replace Q713. Must Perform Bulletin 02002-2 For <u>Dolby Digital Audio Drop Out</u> as well.

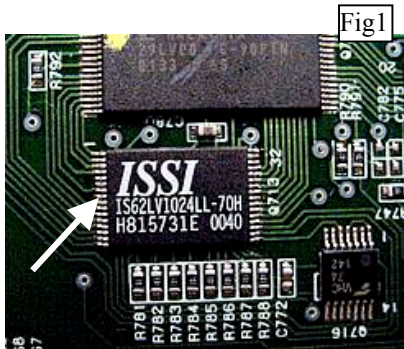
In some units Q713 IC, brand **ISSI**, IS62LV1024LL-70H was used [Fig1], where as in some NEC MPD441000LGU-B70X may be found. For those units using the **ISSI** SRAM and having the above aforementioned problem, you will need to replace the IC Q713 with PN#22241793R3 having NEC MPD441000LGU-B70X or Mitsubishi M5MV108DKV-70H brand label. If above part is to be replaced L753 need not be replaced. See Note.
