Title: TX-DS989

Application: Service Tip

Symptom: No audio, Intermittent shut down, poor reproduction, poor video and vary distorted audio.

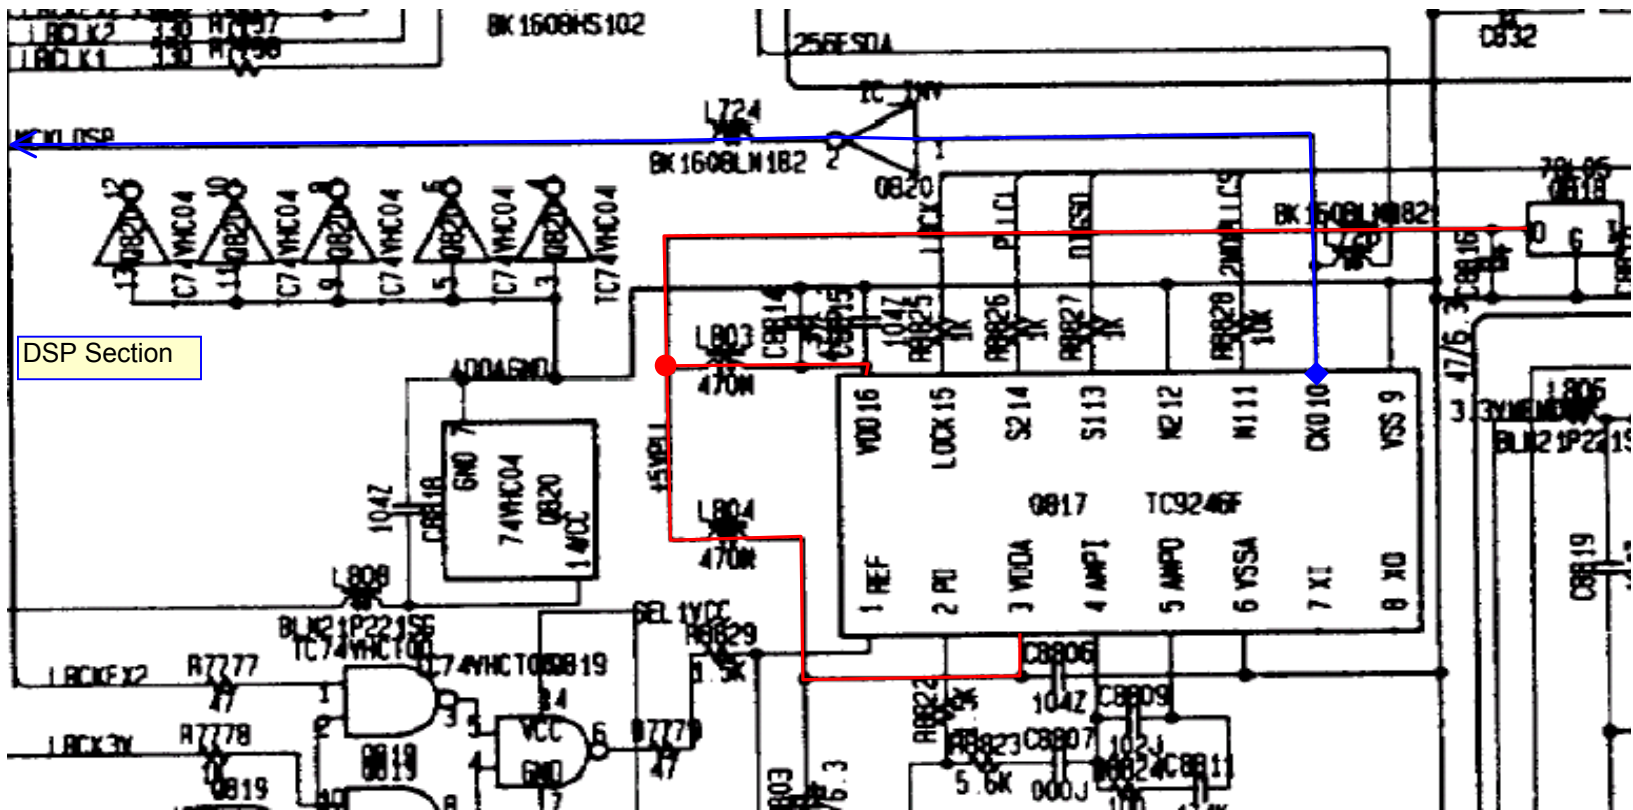
The failure of this section of the DSP is very critical and that the reproduction experience as stated by a consumer can differ from one customer to the next. Therefore it is very important that one makes all the appropriate touchups on all regulator components and inter connecting wires in the case of NCPS-6839 and NCPS-6838 power supply PCB's.
