## SERVICE BULLETIN NO:00007

**MODELS : TX-DS989**

**SUBJECT : The sound of fan is large.**

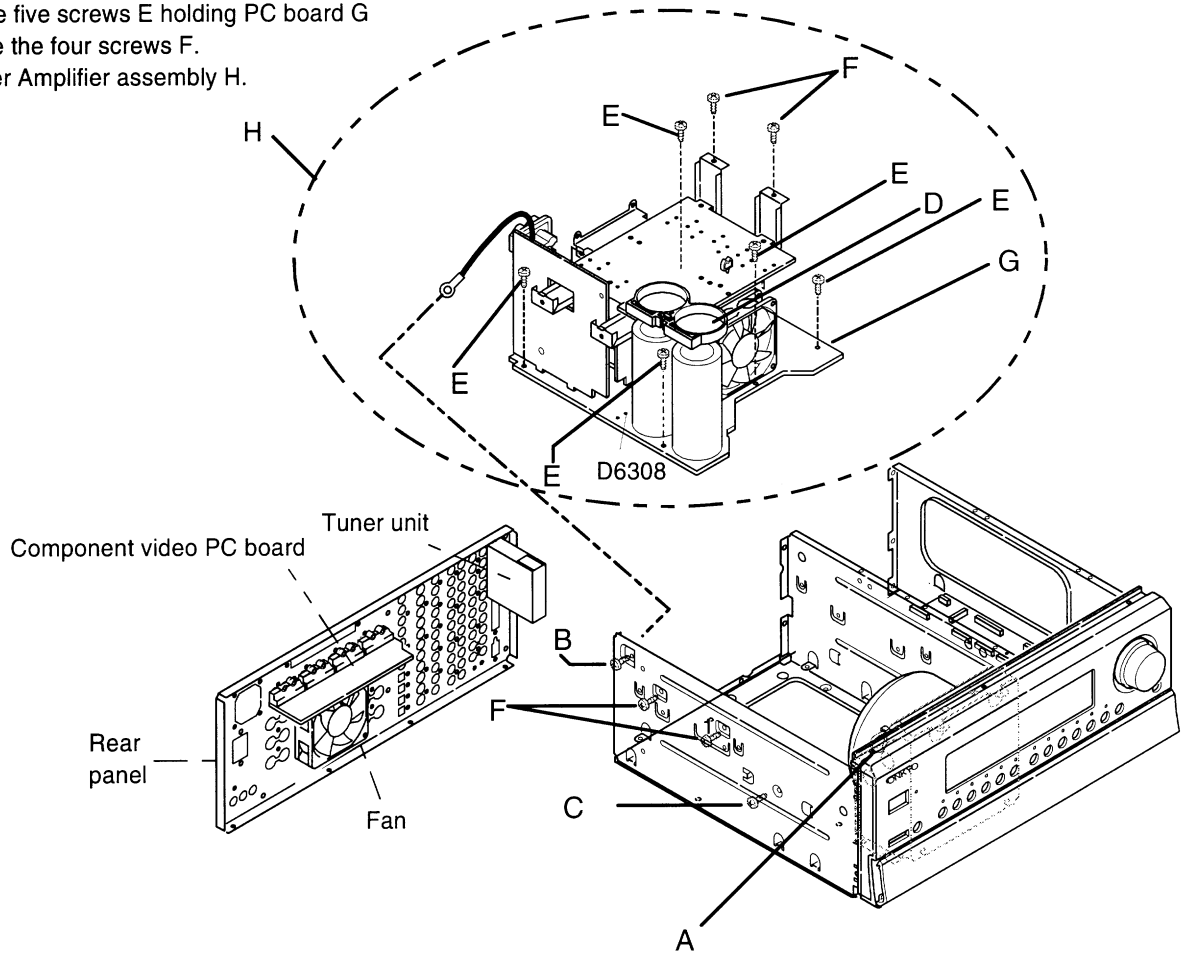
**Symptom:** The rotation sound of the fan is large.

1. Remove the top cover.
2. Remove the screws holding PC boards except the fan, the component video PC board, and the tuner unit on the rear panel.
3. Cut the binder A of the left side on the bracket PT.
4. Remove a screw B.
5. Remove a screw C holding the holder D and remove it.
6. Remove the five screws E holding PC board G and remove the four screws F. Lift up Power Amplifier assembly H.

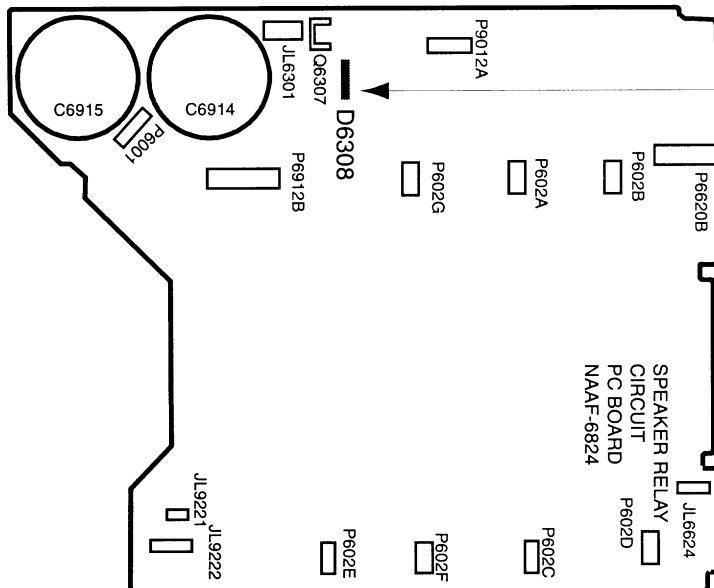
**Counter-measure:** The drive voltage of the fan is decreased from 13V to 10V so that the operation sound when rotating is decreased.

Replace the zener diode D6308 to MTZJ10C on the PC board below.

Change the zener diode to MTZJ10C.  
(Part No.224471003)
