SERVICE BULLETIN

Ref. CE-013

Subject: MODIFICATION OF THE POWER CIRCUIT
 Model: 2000A

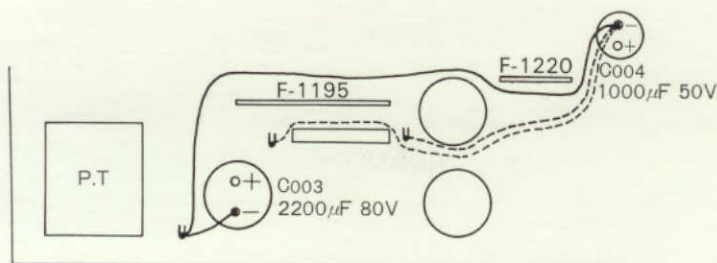
1. If noise (input shorted) is noticeable in the power amplifier sections, change the connecting wire and grounding point in the power circuit.
 See Fig. below:

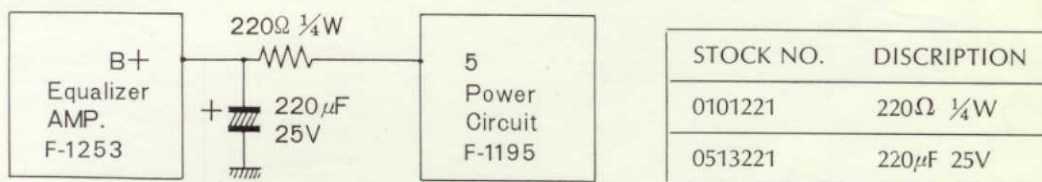
2. If Hum level is noticeable on PHONO 1 or 2 of the SELECTOR, insert the ripple filter between the equalizer amplifier "F-1253 (+B) and power circuit" F-1195 (5).
 See Fig. below:
