Service Information Bulletins

1997

GRUNDIG
made for you

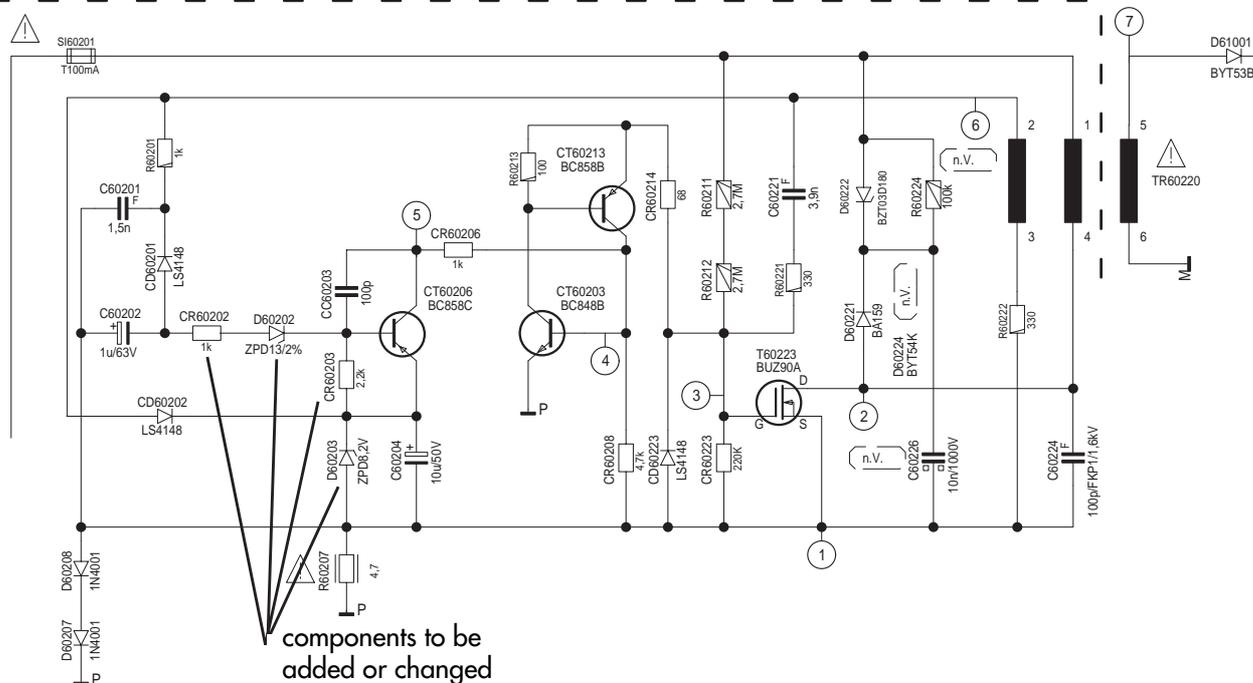
Television No. 1/97

Brown colouration of the circuit board near the diode D 60222 BZT 03D180. Simultaneously the "+Eco" voltage is approx. 5V too high.

Coincidence of unfavourable component tolerances.

Carry out the following changes in the stand-by mains stage:

- Change the Z-diode D 60203 from ZPD 9.1V to 8.2V.
- Change R 60202 from 68 kΩ to 1 kΩ.
- Connect an additional Z-diode ZPD 13 in series with R 60202. Connect the cathode of the diode to the base of the transistor CT 60206.
- Check the rating of the resistor CR 60203 to be 2.2 kΩ.

Check the "+Eco" voltage. Carry out the changes if this voltage is higher than +17 V.

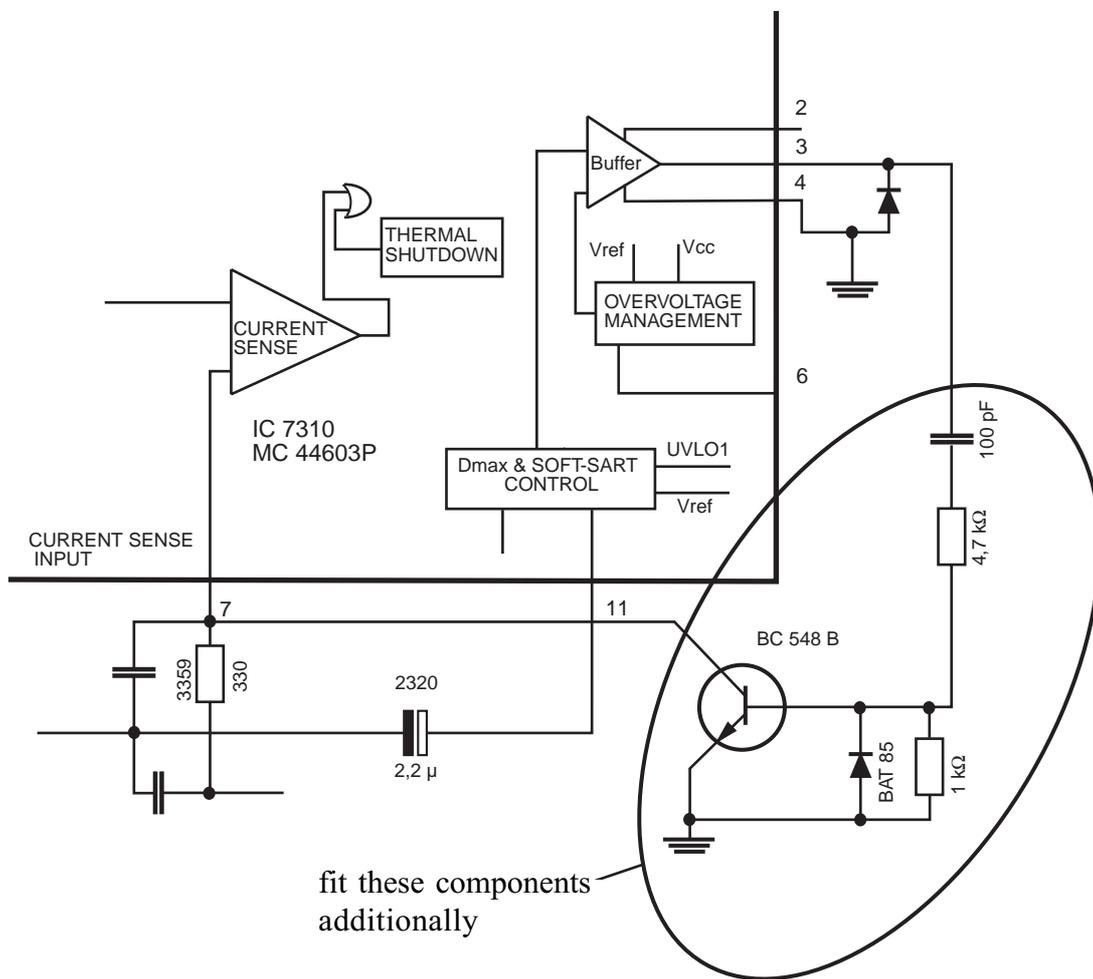
Television No. 2/97

Mains voltage dependent chirp audible in stand-by mode.

Fit an additional transistor stage as shown below into the power supply unit at IC 7310 (MC 44603 P).

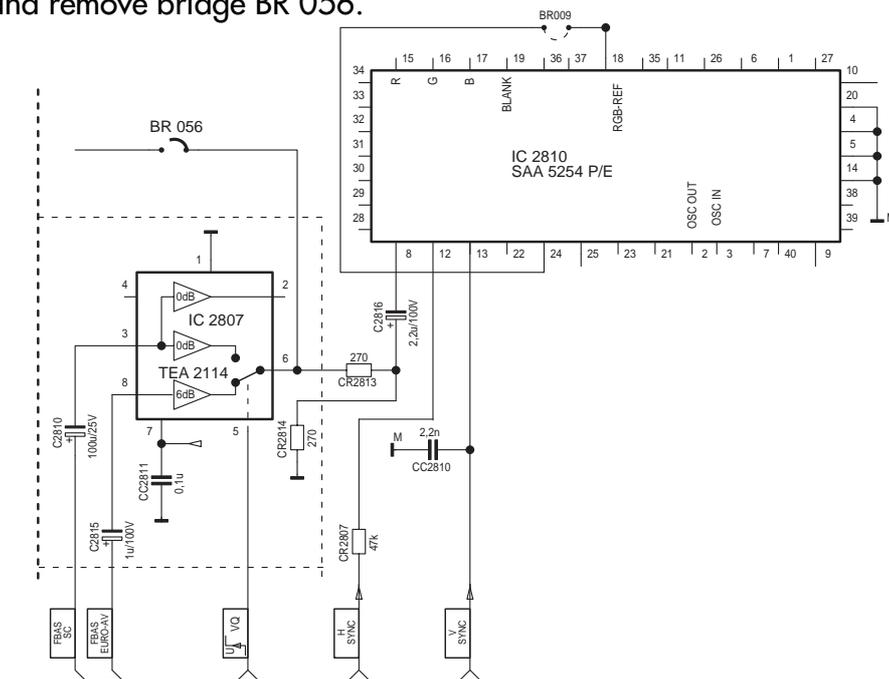
Television No. 3/97

Teletext operation is not possible in "AV" programme position.

The video switch-IC 2807 (TEA 2114) is not fitted in 37 cm television receivers.

Retrofit the following components:

- IC 2807 TEA 2114
- C 2815 1 μ F
- C 2810 100 μ F
- C 2811 0.1 μ F
- CR 2813 270 Ω
- CR 2814 270 Ω

In addition, change the polarity of 2.2 μ F electrolytic capacitor C 2816 (negative terminal to pin 8 of IC 2810) and remove bridge BR 056.

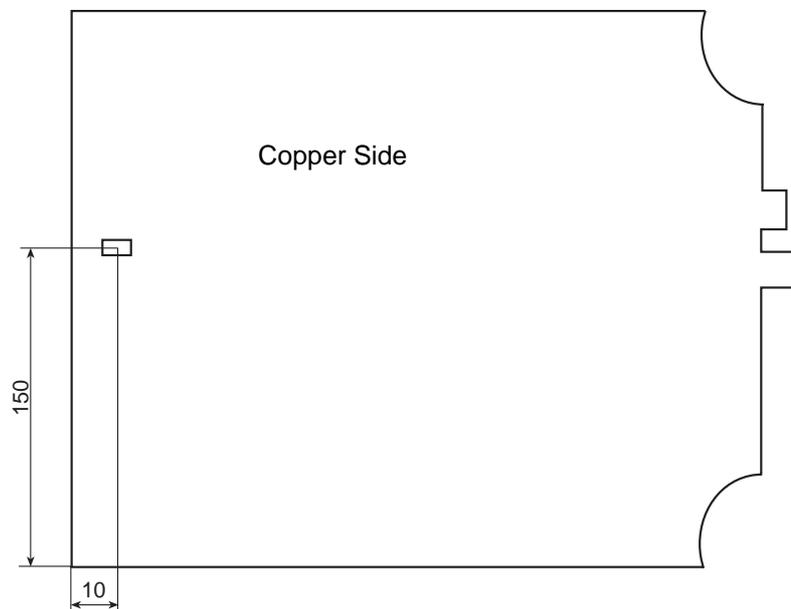
Despite the modifications carried out according to our TV Service Information 9/96 the television sets switch occasionally to Standby after a prolonged time of operation.

Temperature drift of the +E operating voltage by about 0.2 to 0.3V caused by Z-diode CD 61023. Consequently, IC 34015 TDA 8374 switches off with sudden black/white changes in the picture content or changing scenes.

The position of the Z-diode is X=10, Y=150. Unsolder this diode and insert a SMD resistor 1206 1.2Ω 1% in this place.

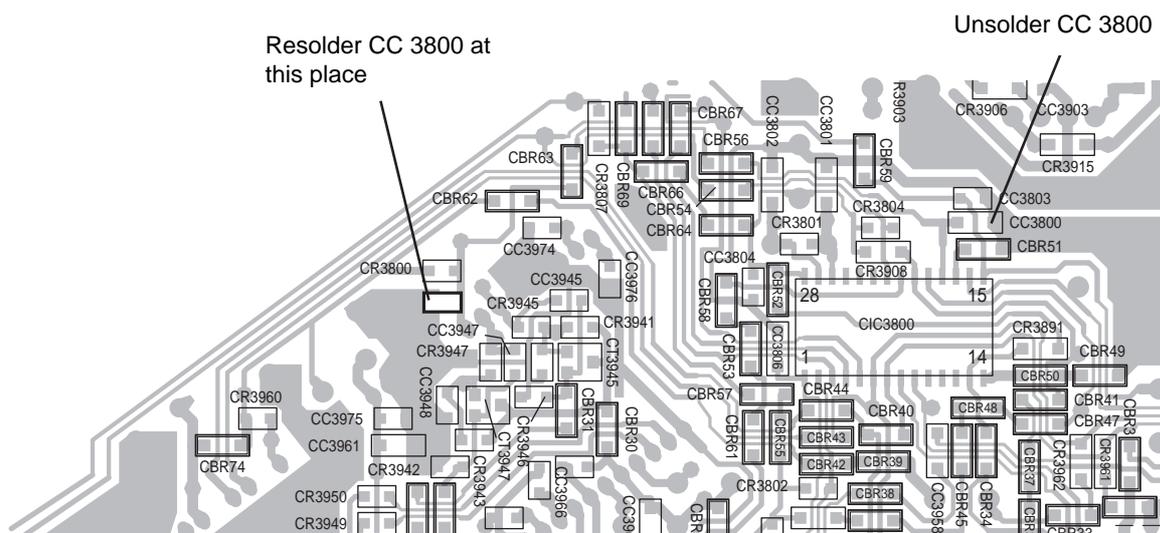
The sound disappears suddenly during the reception of a satellite programme and is audible again only when changing the programme or switching the TV off and on again.

IC MSP 3400 on the SAT Module hangs up by static charges entering the Reset input of the IC.

Unsolder the SMD capacitor CC 3800 from its place on the SAT Module and resolder it at the place indicated on the figure below.

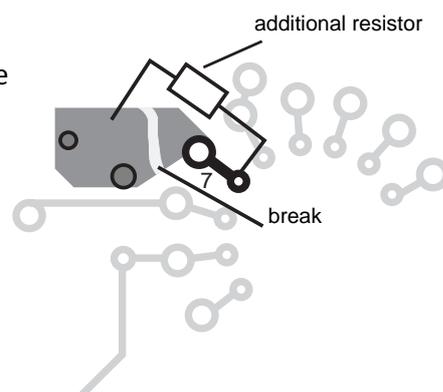
Failure of the RGB output stages (picture tube panels 29305-022.16 and -022.17) or of the teletext function.

The semiconductors are destroyed by high-voltage sparks within the picture tube.

On the picture tube panels -022.16/-022.17, insert an additional 1.5 kΩ composite carbon resistor (do not use a carbon film resistor!) into the circuit path to the screen grid connection of the picture tube socket. Ensure that the break is 2mm wide at least (see figure) to avoid sparking.

Refit the resistor in any case if the above mentioned semiconductors failed.

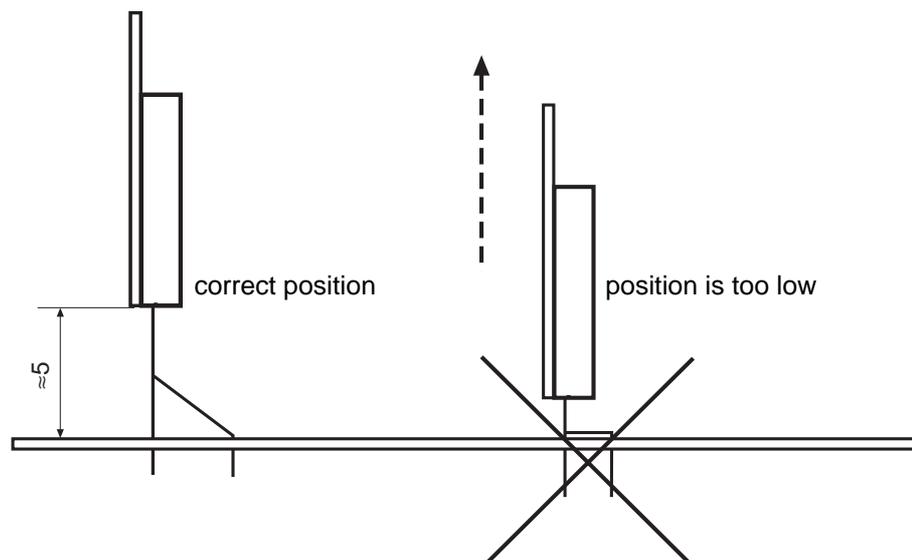
Vertical output stage TDA 4173 fails or thin white lines similar to retrace stripes are visible.

Inherent instability of the vertical output stage IC TDA 4173 AF.

- Should above mentioned symptoms appear do not fail to exchange TDA 4173 AF and solder additionally a 1 nF foil capacitor from pin 1 and from pin 7 each to pin 4 (-K voltage) on the copper side.
- Check the mounting position of the vertical output-IC. If the position of the IC is too low, the pins may temporarily come into contact with the chassis connection on the upper side causing the IC to fail. Additionally, the circuit may already be damaged by the building up force of pressure resulting in a long-term failure. Therefore replace TDA 4173 AF also if it has not been fitted correctly!

When fitting the new IC TDA 4173 AF take care of the correct position of the holding clamp and solder in the additional capacitors!
This change has been generally introduced.

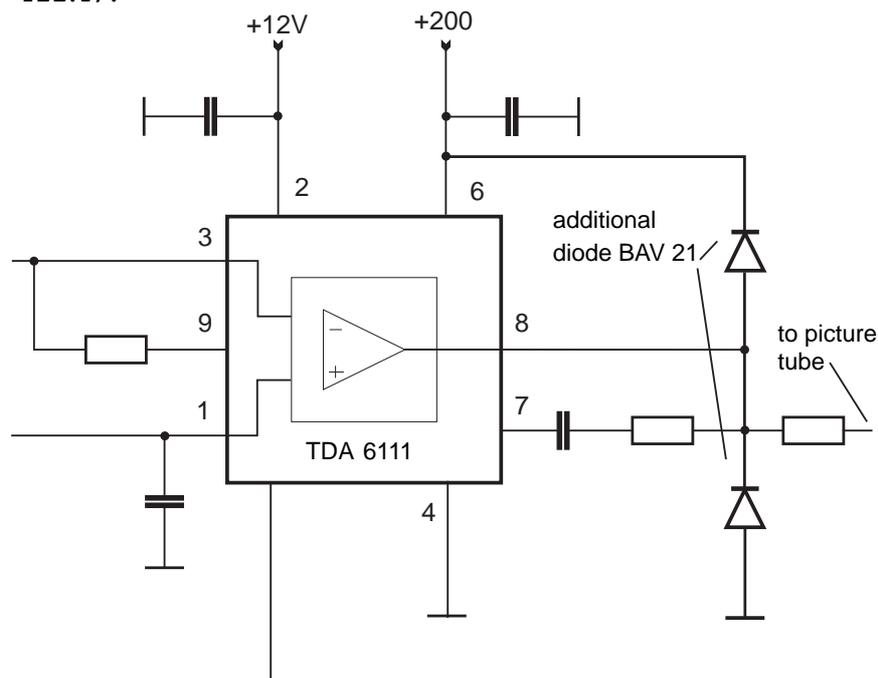
Failure of the RGB output IC's TDA 6111.

The RGB output IC's are destroyed by high voltage sparks.

Directly from the outputs (pin 8) of the three output IC's TDA 6111 connect one additional diode BAV 21 each to chassis and one diode each to the +200 voltage (see figure).

The insertion of the three diodes which are to be connected to +200 is already prepared on the picture tube panel by the diodes D 734, D 754 and D 774.

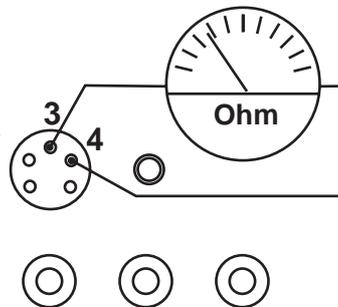
Check the 5-pin Edit socket (from pin 3 to pin 4)

Good = 1-2 MOhm approximately

Bad = 5 kOhm approximately
