GRUNDIG

**SERVICE
INFORMATION
BULLETINS
1999**

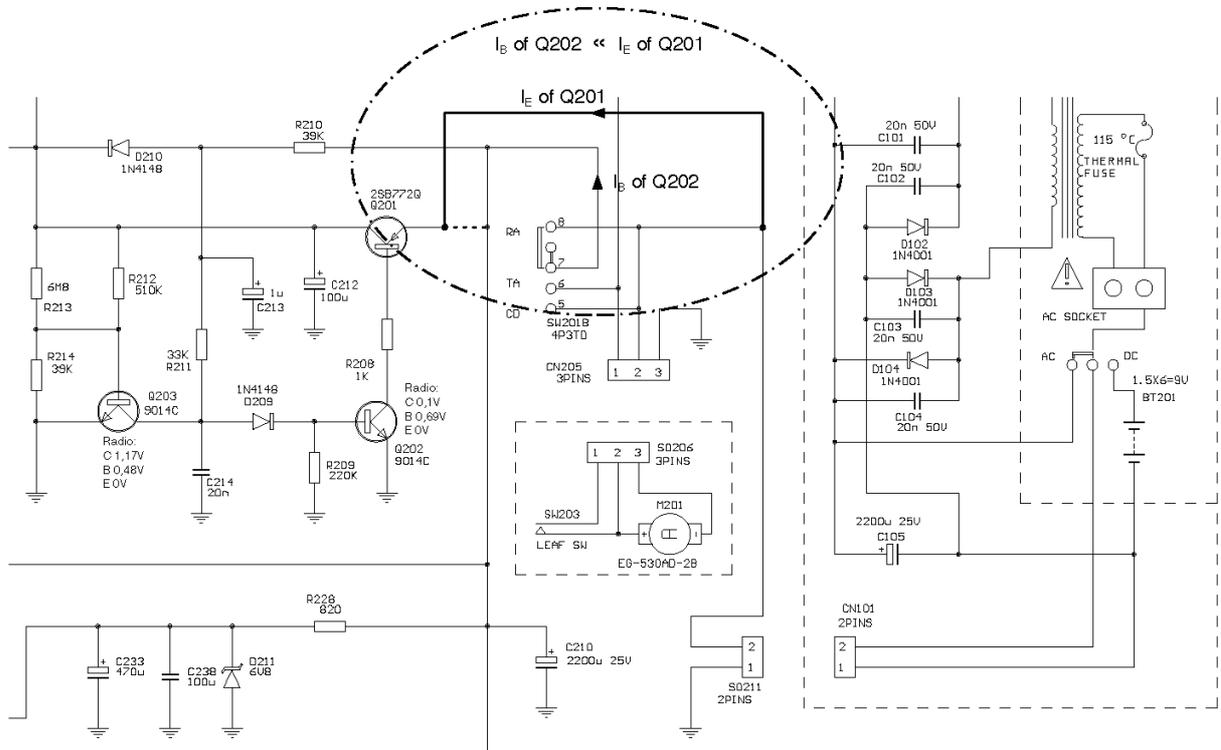
Figure 1

The contacts (7-5) of switch SW 201B become charred so that they do no longer contact.

The switching contact provides the voltage for both the CD servo system and the audio power amplifier.

Connect the emitter of Q 201 directly to the voltage supply. The switch is only used for controlling the base current which is much lower than the emitter current. Fig. 1 (see page 2)

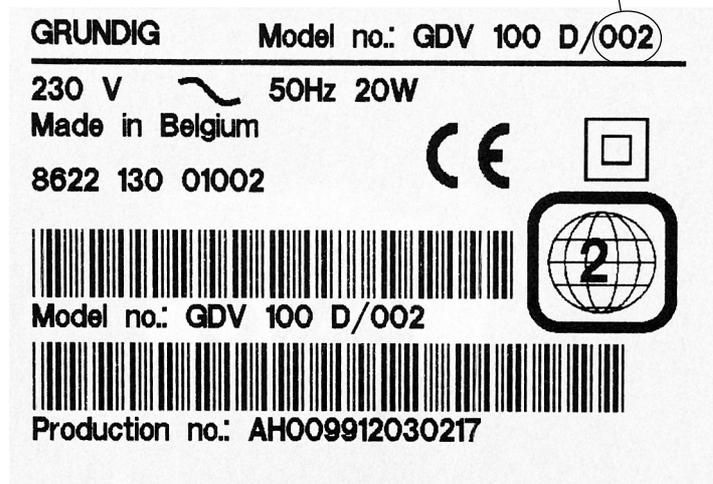
earlier version GDV 100 D
new version GDV 100 D/002

Both versions of the GDV 100 D Player are identifiable outside only by the label (on the rear side).

The two versions of the GDV 100 D Player work internally with different operating voltages. This is especially critical because the modules of both versions fit mechanically into each other.

When replacing modules take care to use only the appropriate modules for the version.

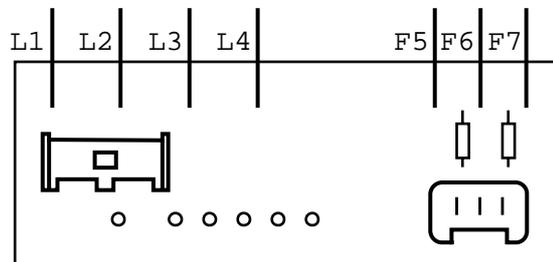
The picture tubes A 68 ESF 002X11, A 68 ESF 002X011 (without coating) and A 68 ESF 202X11, A 68 ESF 202X011 (with coating) fitted into television receivers with above mentioned chassis are no longer available. These picture tubes are not fully compatible with the replacement tubes A 68 ESF 002X111 / A 68 ESF 202X111.

The figure below shows the connections of the deflection unit for the new picture tubes A 68 ESF 002X111 and A 68 ESF 202X111.

<p>A 68 ESF 002X11 A 68 ESF 202X11</p>	<p>A 68 ESF 002X111 A 68 ESF 202X111 An existing seagull correction board is to be removed. The yoke connecting leads are soldered directly to the deflection unit (see figure).</p>
<p>A 68 ESF 002X011 A 68 ESF 202X011</p>	<p>A 68 002X111 A 68 202X111 No change. Connect the picture tube as shown in the figure.</p>

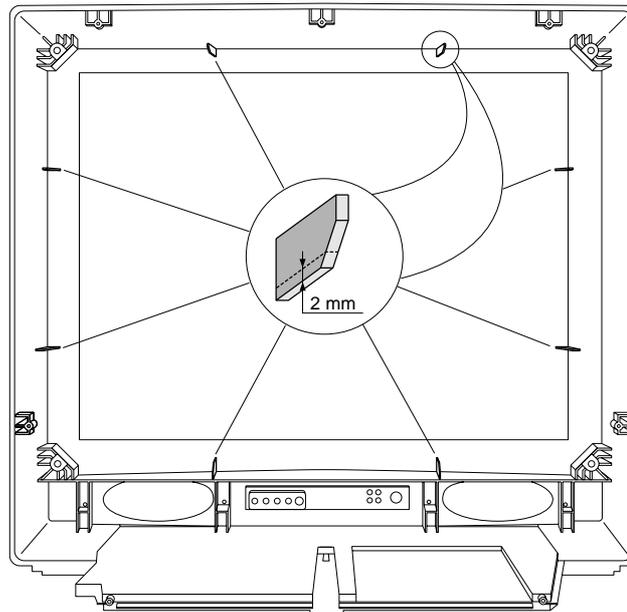
The picture tubes A80 EFF 002X11 (ST 84-796/9 TOP/LOG) and A80 EFF 002X42 (M 84-210/8 IDTV/LOG, M 84-210/8 A IDTV/LOG) fitted to a.m. models are no longer available. These tubes are mechanically not fully compatible with the replacement tubes A80 EFF 272X11 / A80 EFF 272X43.

Due to the slightly larger overall dimension, the picture tube touches the fixing ribs within the cabinet. Consequently, when changing the tube, these ribs must be cut by about 2mm (see figure).
