VD Mechanism
for D-550/720/850/900
SDT-9600/9610/7785

SERVICE MANUAL

No. 1081

July, 1978

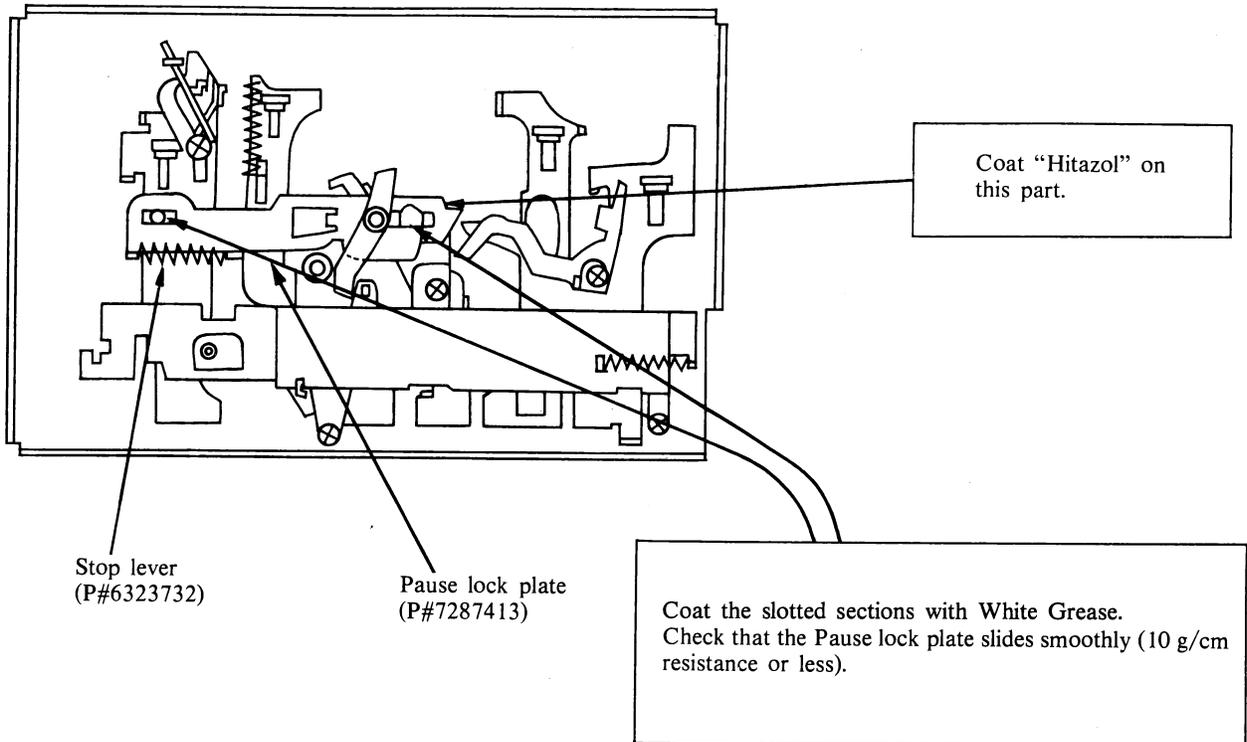
Fig. 1 Adjustment of Pause Lock Plate

5.	Resonant sound produced when head plate operates.	• Resonance of PLAY slider spring.	• Coat 'Froil' onto external circumference of SPR.
6.	Head plate does not lock and repeats vertical movement.	• Sliding movement of P lock plate faulty.	• Correct deformation of P lock plate and lubricate with oil. (See Fig. 1)

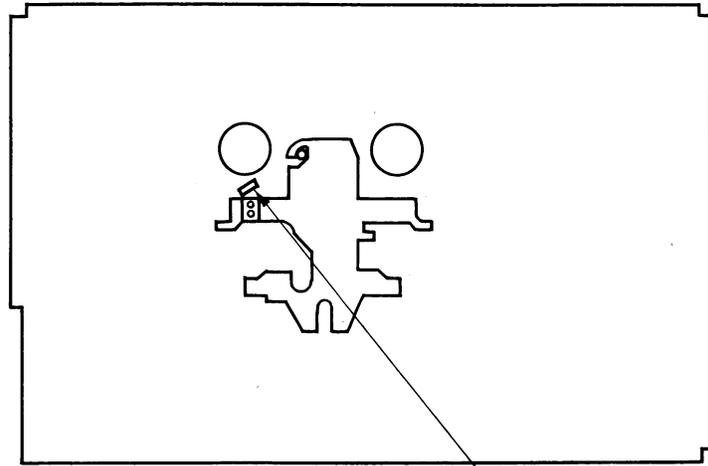
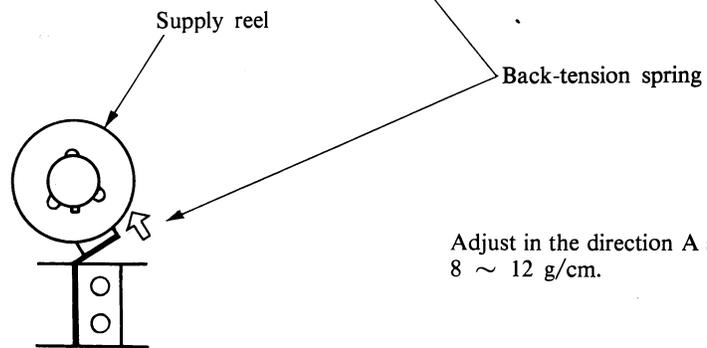
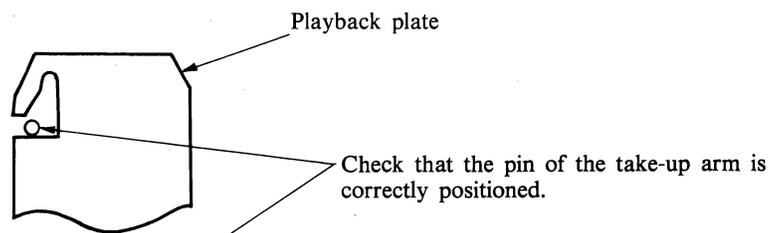
Fig. 2 Back-tension Adjustment
(Related check item: B-4-1, C-5-1)

ITEM	SYMPTOM	CAUSE	REMEDY
B. Play (REC) Operation Check			
4.	Tape is scratched. Tape transport uneven.	1) Supply-side back-tension too small. 2) PAUSE lever and pressure roller arm touch each other, so tape drive force too small. 3) Pressure-roller arm ass'y faulty.	1) Correct back-tension plate (8 ~ 12g/cm) Fig. 2. 2) Replace PAUSE lever and P changeover arm. 3) Replace pressure-roller arm ass'y.

5.	Take-up reel rotates during REW operation.	<ul style="list-style-type: none"> • Take-up arm pin displaced from PAUSE lever notch. 	<ul style="list-style-type: none"> • Insert it in normal position. (See Fig. 2.)

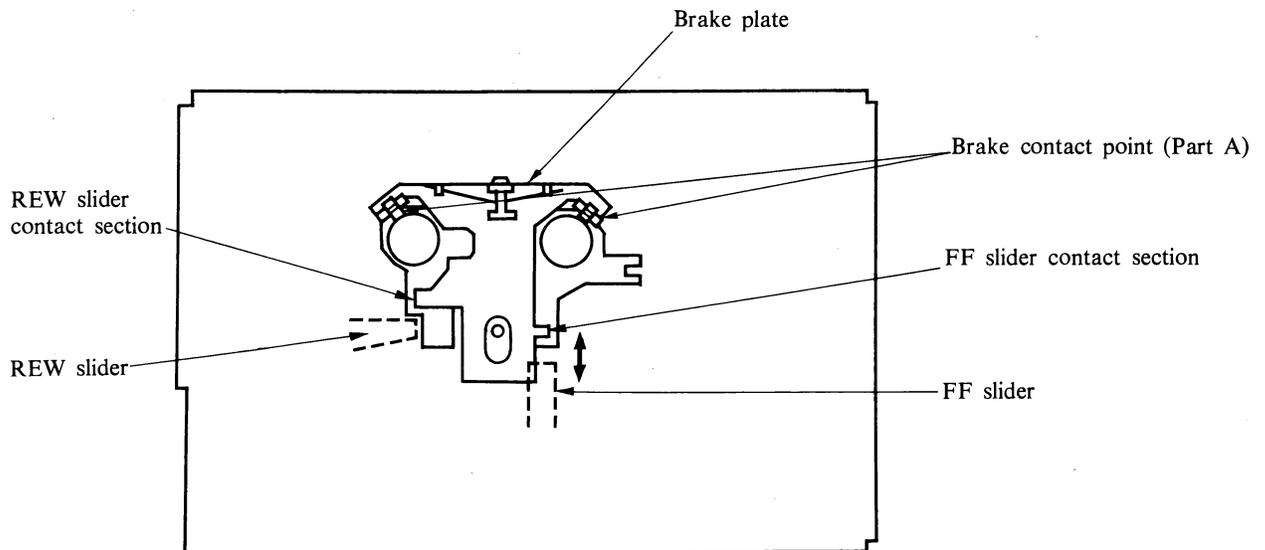
Fig. 3 Adjustment of Brake Plate
(Related check item: C-4-1)

4.	Rotation speed changes during FF/REW operation.	1) Brake plate deformed and touches reel 2) Mounting of cassette faulty, causing slippage between clutch and hub.	1) Correct brake plate. (See Fig. 3) 2) Same as in B-5-1. (See Fig. 5.)

Check whether or not the parts of the brake, which are compressed and bent up by the FF slider, and REW slider are deformed. If deformed, remove them and correct. When the FF or REW button is depressed, there should be a gap of more than 0.5 mm at part A. Therefore check, that with a gap at part A and with the FF or REW button depressed, actuation of the STOP mode brings part A into positive contact.

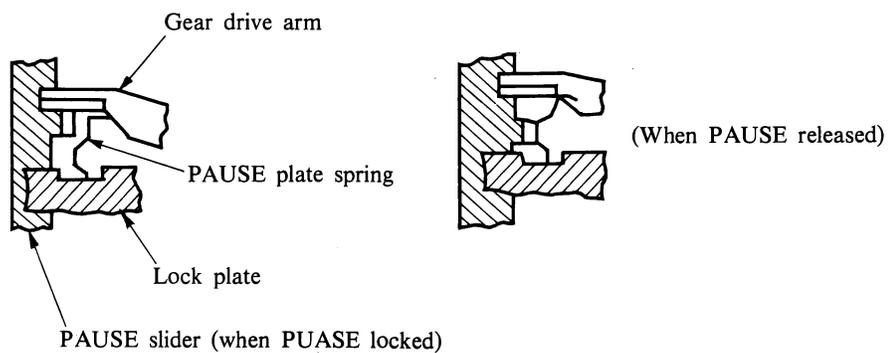
Fig. 4 Pause Plate Spring Adjustment
(Related check item: A-2-1)

2.	Head plate and all operation buttons are locked.	1) PAUSE plate spring faulty. 2) Power assist mechanism operation faulty. 3) Sliding of lock plate (1) faulty.	1) Adjust PAUSE plate spring. 2) Same as in A-1-3. 3) Correct deformation of lock plate (1), lubricate with oil, correct slide cover installation (Is the collar inserted?, Is there any deformation caused by over-tightening?).

The PAUSE plate spring must come away and the gear drive arm must be made inoperative temporarily.

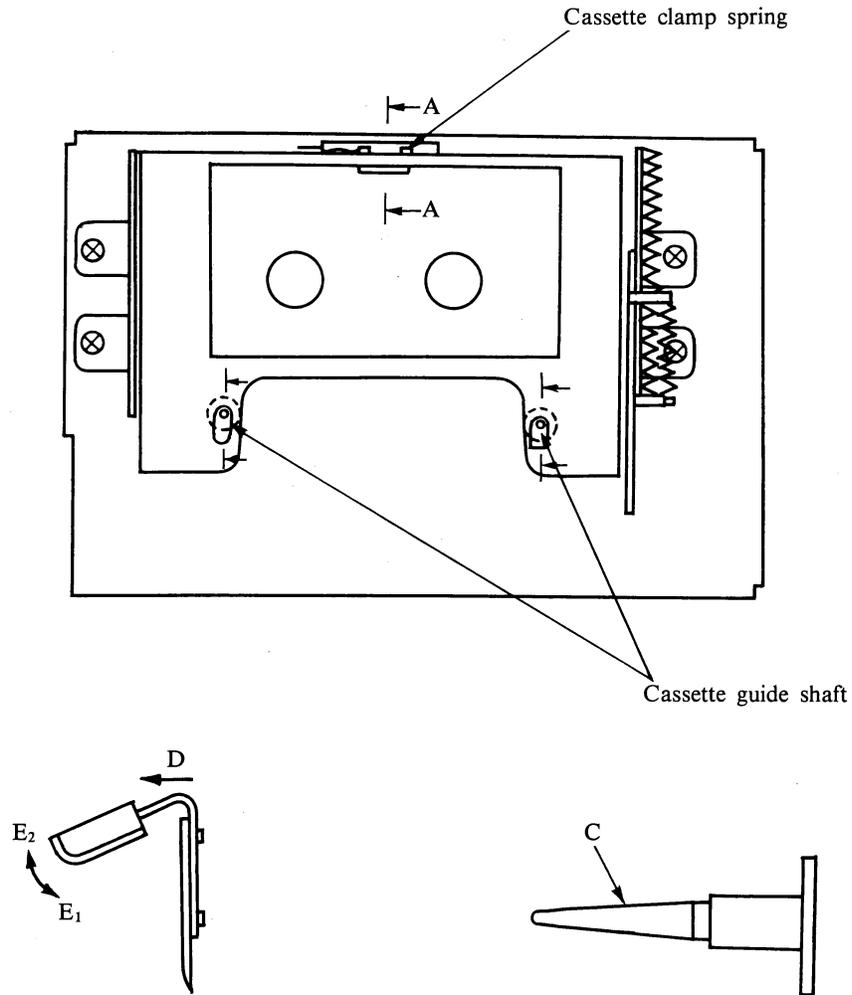
Fig. 5 Cassette Tray Adjustment

5.	Tape crushed.	1) Cassette holding faulty. 2) Pressure-roller arm ass'y faulty.	1) Correct cassette clamp spring. Fig. 5. 2) Same as in B-4-3.
6.	Squeaky sound produced in PAUSE ON/OFF.	<ul style="list-style-type: none"> • PAUSE changeover timing faulty. 	<ul style="list-style-type: none"> • Replace PAUSE lever, P changeover arm.

3.	Cassette cannot be inserted completely and is lifted up.	1) Cassette clamp spring positioned incorrectly. (Right side displaced upward.) 2) Cassette guide shaft surface finish	1) Same as in B-5-1. (See Fig. 5.) 2) Coat a little silicone grease onto upper surface of guide shaft. See Fig. 5.)

When the top of the cassette cannot be inserted completely into the tray, bend the spring while lifting the cassette clamp spring in direction D.

When the cassette is caught by the cassette clamp spring and is retained during the EJECT operation with the cassette still inserted, this is because the spring is bent too much in direction E₁. Bend it slightly in direction E₂.

When the bottom of the cassette catches on the cassette guide shaft, grease part C, which the cassette touches, very lightly with gauze using silicone grease and wipe it off leaving only a trace of grease.

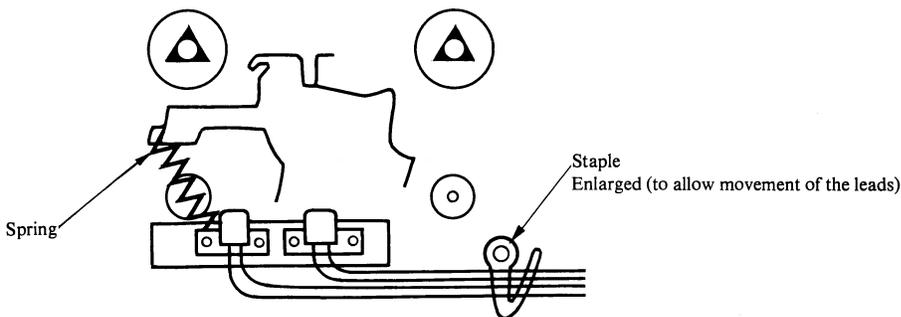
SUBJECT Modification of the Head Plate Spring on the VD Mechanism

Due to hardening of the head lead wires at low temperatures some heads do not advance to the normal position on pressing the playback button, therefore the head plate spring has been changed. In addition, at the same time as spring replacement, the wiring clamp shown in the figure below has been enlarged to allow freedom of movement of the leads.

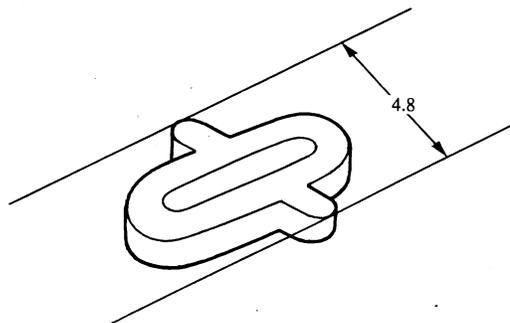
SUBJECT VD Mechanism Brake Adjustment

During prolonged used of the pause function, low brake torque causes tape slackness to occur; therefore the
brake rubber has been modified.

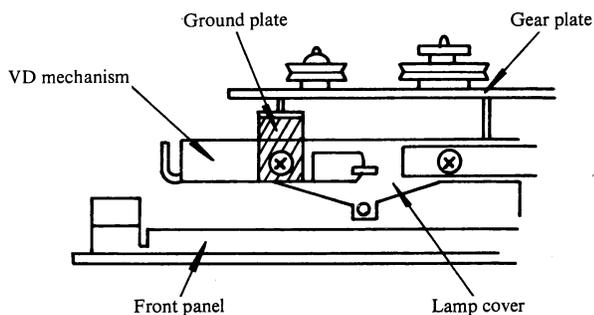
SUBJECT Discharge Noise Created by the VD Mechanism — Countermeasures

Electrical discharge noise which is caused by the charge generated by friction produced during rotation of the take-up pulley and fly-wheel belt pulley, etc. is cured by installation of a ground plate, as detailed below.

To mount the ground plate: Remove the screw at the left side of the lamp cover, and insert the ground plate between the VD mechanism and the lamp cover. Tighten the new assembly.

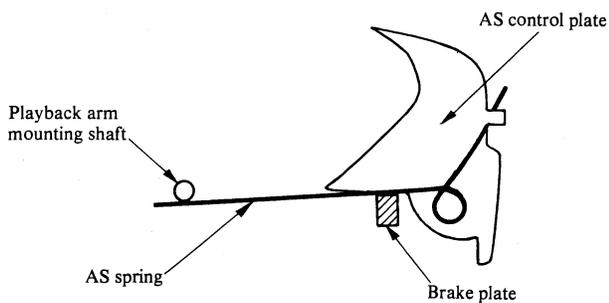
SUBJECT Modification of the AS Control Spring for the VD Mechanism

To improve the efficiency of installation and to prevent the spring shipping out of its location.

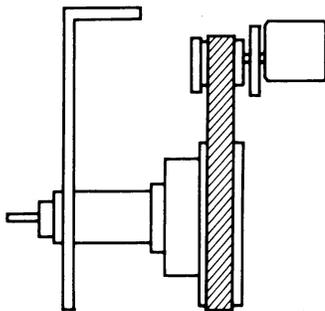
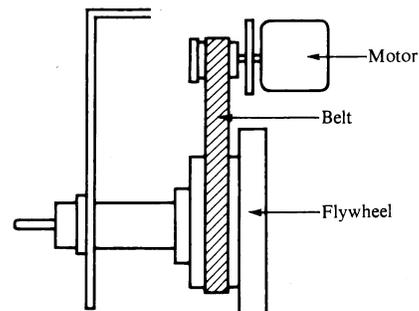
SUBJECT Improvement of wow-flutter.

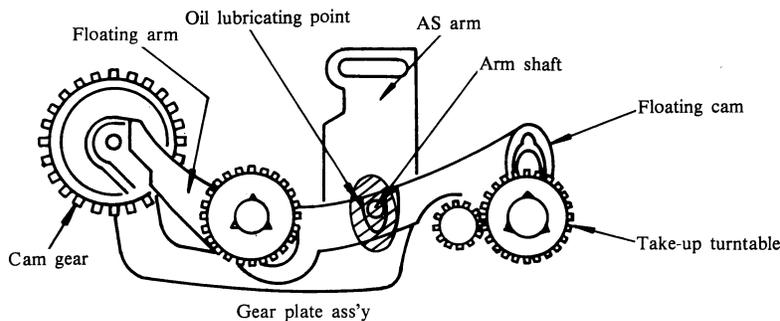
SUBJECT Improvement of Auto Stop Malfunctioning

Tape transportation is stopped by operation of Auto stop mechanism in playback mode. To improve it the following modification has been made.

1. Remove gear plate ass'y. Lubricate pan motor oil to contact surface of floating arm and arm shaft and AS arm.
2. Make sure that AS arm moves smoothly.
