SERVICE

Date: 15-May-2003
 Model: SR5200/SR6200/SR7200

Page: 1/2
 REF.NBR: MZ02-033

Hum noise can be heard from Headphone out

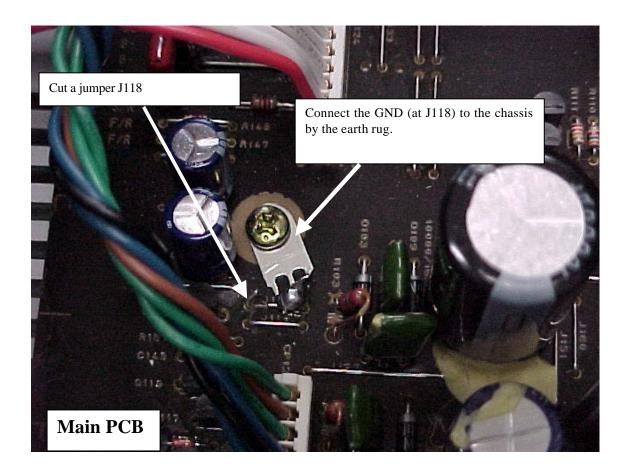
Caused by ground loop of the headphone out.

Please apply the following solution.

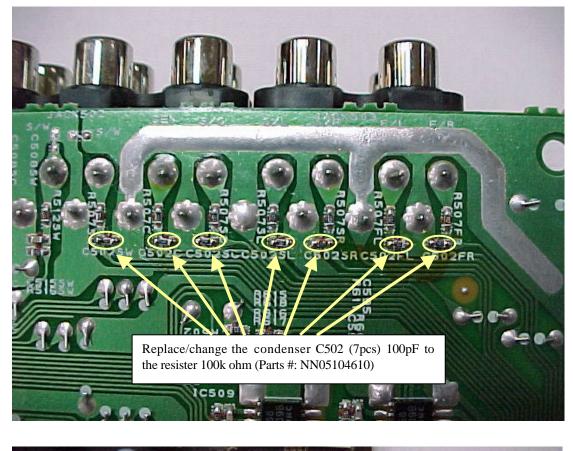
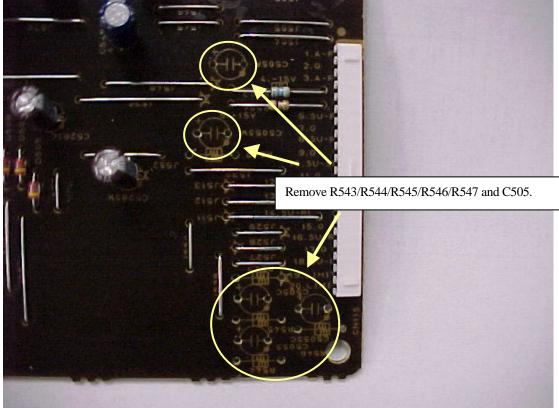
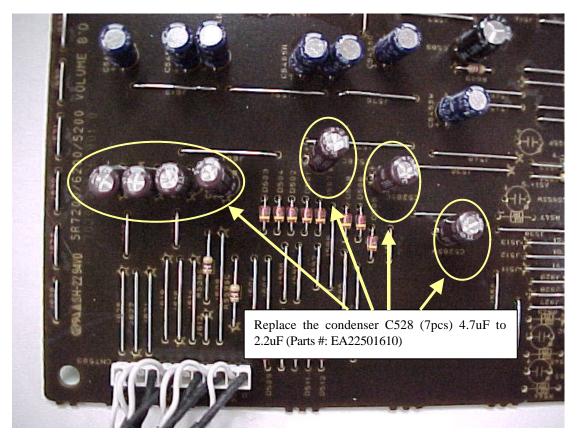
Pop noise appears when stop playing or track skip on CD playback with Digital connection. Pop noise appears in the condition of the Main volume is changed 74dB to 75dB(Mute).

\* Version 1 P.C.Board (7020 06076 001-0) : Please apply the modification mentioned below (Page2 to 4).

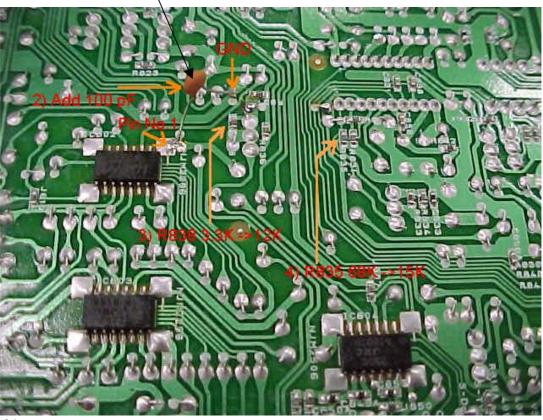
PIC.01

When a output connect with the monitor via the S-VIDEO terminal, noise(stripes) occur at the picture.

The clock from the OSD circuit, it caused interference to VIDEO-AMP circuit.

- 1) The capacitor(C810A 100pF: DK16101300 4822 122 33195) is added between 1P of IC802 and GND(refer to PIC.01).
- 2) The jumper wire(J841) is deleted and a capacitor(C840A 47uF/16V: EA47601620 9965 000 06289) is added to same position (refer to PIC.02).
- 3) The chip resistor(R838) is changed into 12kohm one(NN05123610 4822 051 30123) from the present 3.3kohm one.
- 4) The chip resistor(R835) is changed into 15kohm one(NN05153610 4822 051 30153) from the present 68kohm one.

C810A (100pF: DK16101300 4822 122 33195)
