<b>marantz®</b> <b>SERVICE BULLETIN</b>		Date: 15-May-2003	Model SR7300
		Page: 1/1	REF.NBR: MZ03-003
Circulation:		Subject:	
Application:		Broken Knob	
x for information customer complaint in case of service mandatory .....		Int.ref:	
MZxxxxx01xxxx to MZxxxxx13xxxx

<b>marantz®</b> <b>SERVICE BULLETIN</b>		Date: 15-May-2003	Model SR7300
		Page: 1/2	REF.NBR: MZ03-006
Circulation:		Subject:	
Application:		Improvement of high tone noise	
x for information customer complaint in case of service mandatory .....		Int.ref:	
ALL

<b>marantz®</b> <b>SERVICE BULLETIN</b>		Date: 15-May.-2003	Model: SR7300,SR6300
		Page: 1 / 1	REF.NBR: MZ03-018
Circulation:		Application:	
x for information customer complaint in case of service mandatory .....		See Below	
		Subject: The problem that the remote controller can't lean other the remote controller .	
		Int.ref:

<b>marantz®</b> <b>SERVICE BULLETIN</b>		Date: 10-July-2003	Model: SR7300.SR7300F
		Page: 1 / 1	REF.NBR: MZ03-030
Circulation:		Subject:	
Application:		RS232C control is changed to “ new protocol ”.	
x for information customer complaint in case of service mandatory .....		Int.ref:	
		MZxxxxxx01xxxx to MZxxxxxx16xxxx

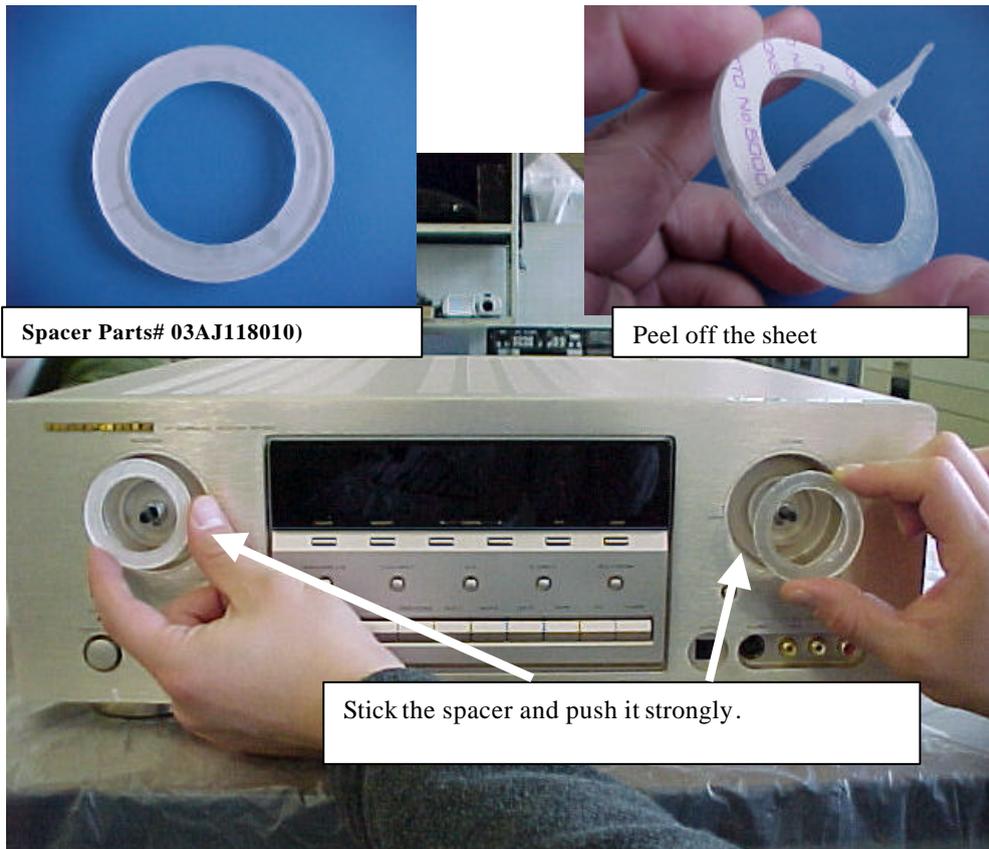
Spacer Parts# 03AJ118010)

Broken Volume or Selector knob by transportation.

A clearance between the front panel and knob were a little large and get stress to the volume shaft.

Add the spacer to the front panel as follows.  
( Spacer : parts No. 03AJ118010)

Peel off the sheet

Stick the spacer and push it strongly.

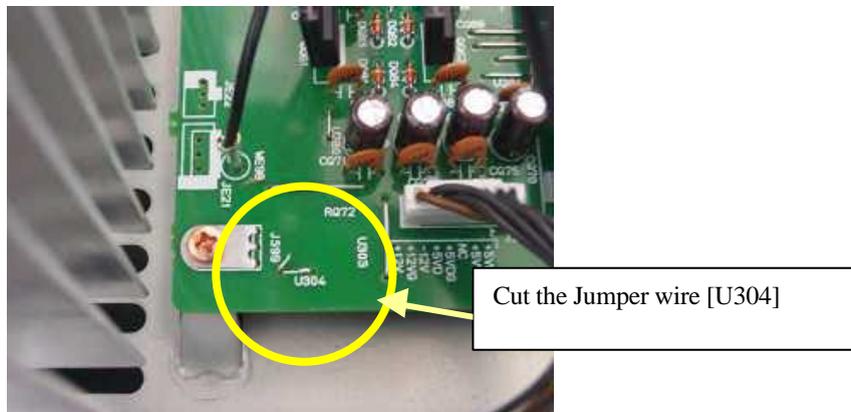
High tone noise can be heard a little from speaker.

- 1) Cut a jumper wire [U304] on the PS04 board.

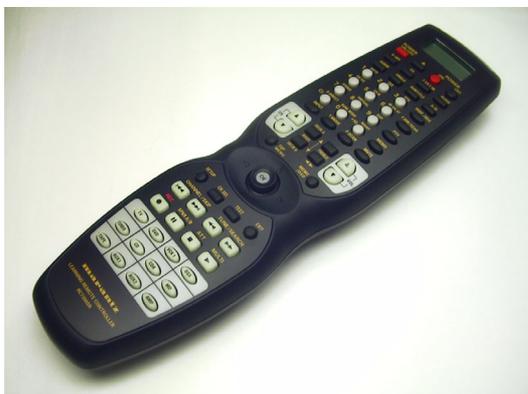
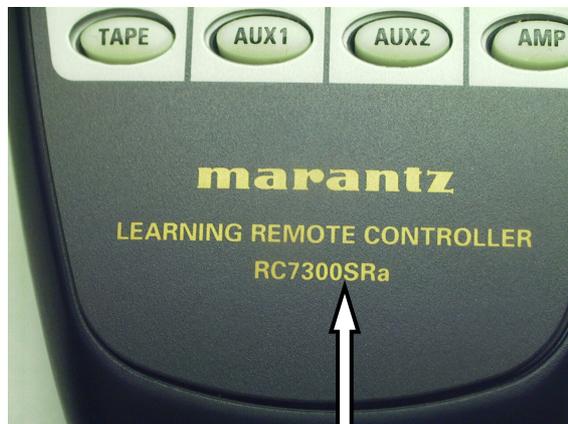
**Model name RC7300SRa**

When learning and memorizing the remote control codes used by Set-top Box of Time Warner Inc., A part of cursor button can't be learned.

RC7300SR is exchanged for the improvement the remote controller RC7300SRa.

Improvement the remote controller part no. **ZK03AJ0012**

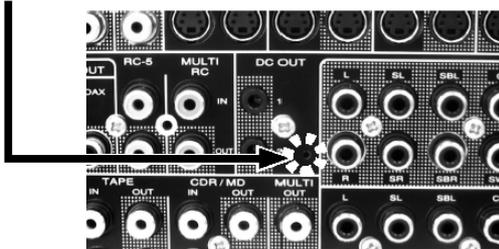
The change of CPU’s software. The specifications of the Set become the same as SR9300.

1. Put the "CPU upgrade" folder into anywhere on your PC's hard disc.
2. Connect PC and the unit with the RS-232C cable.
3. Insert a thin rot to the hole and push the switch (SA50) inside to turn on the switch.

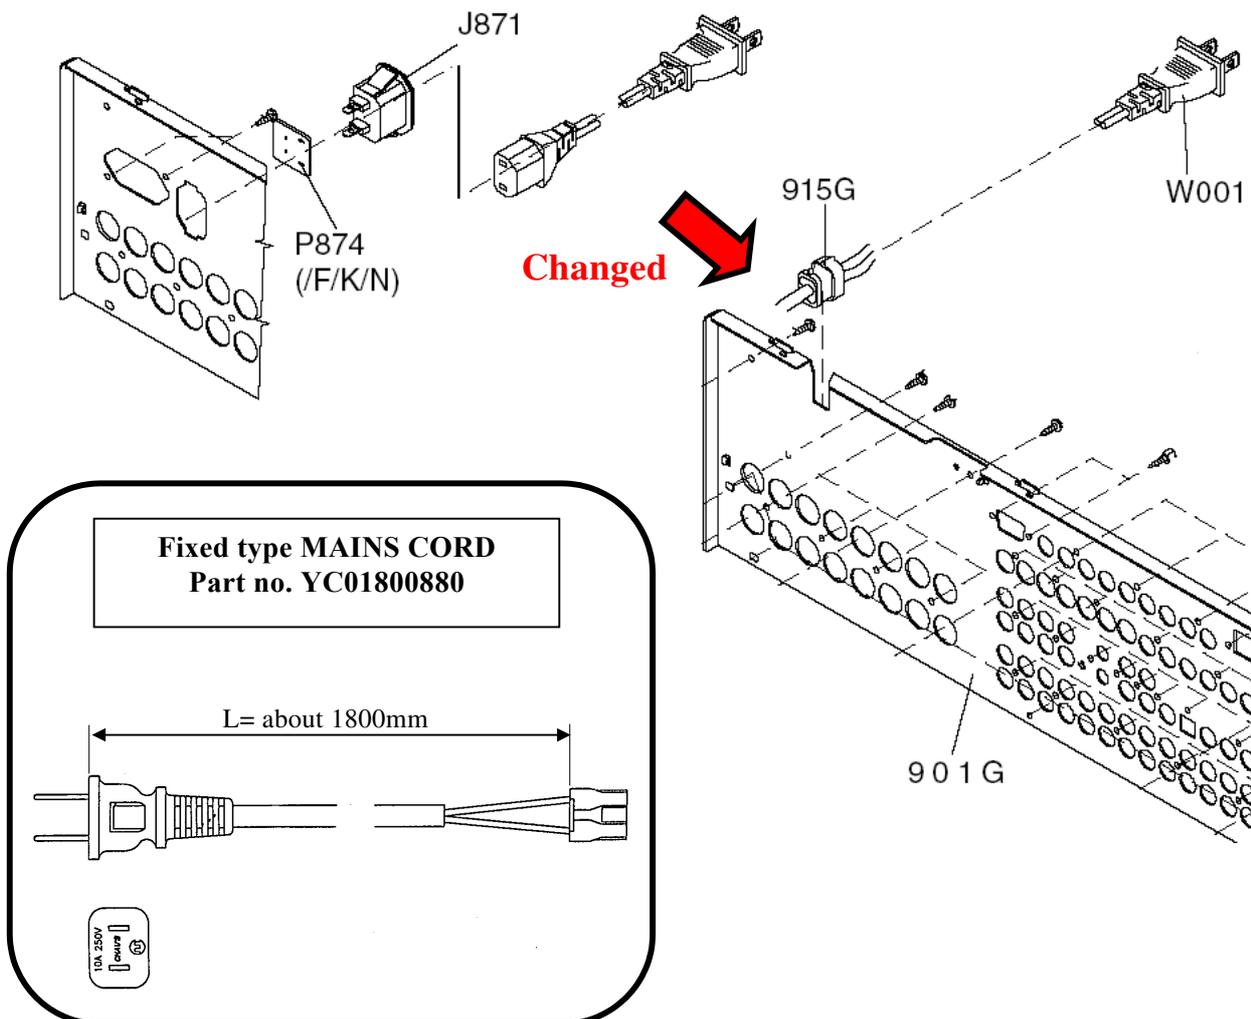
It depends on the Chinese safety standard requirement.

1. MAINS CORD is changed from (Z011) part no. ZC01803090 to (W001) part no. YC01800880 .
2. MAINS CORD BUSH ( 915G ) part no. 450H259010 ( NIFCO #2271) is added.
3. REAR PANEL ( 901G ) is changed.(This is not supply of the service spare part)
4. AC IN socket is deleted.
