Technical Bulletin L53

Product: DVD Receiver

Hardware Technical Bulletin: L53-H2005-01

Subject: SRS Distortion

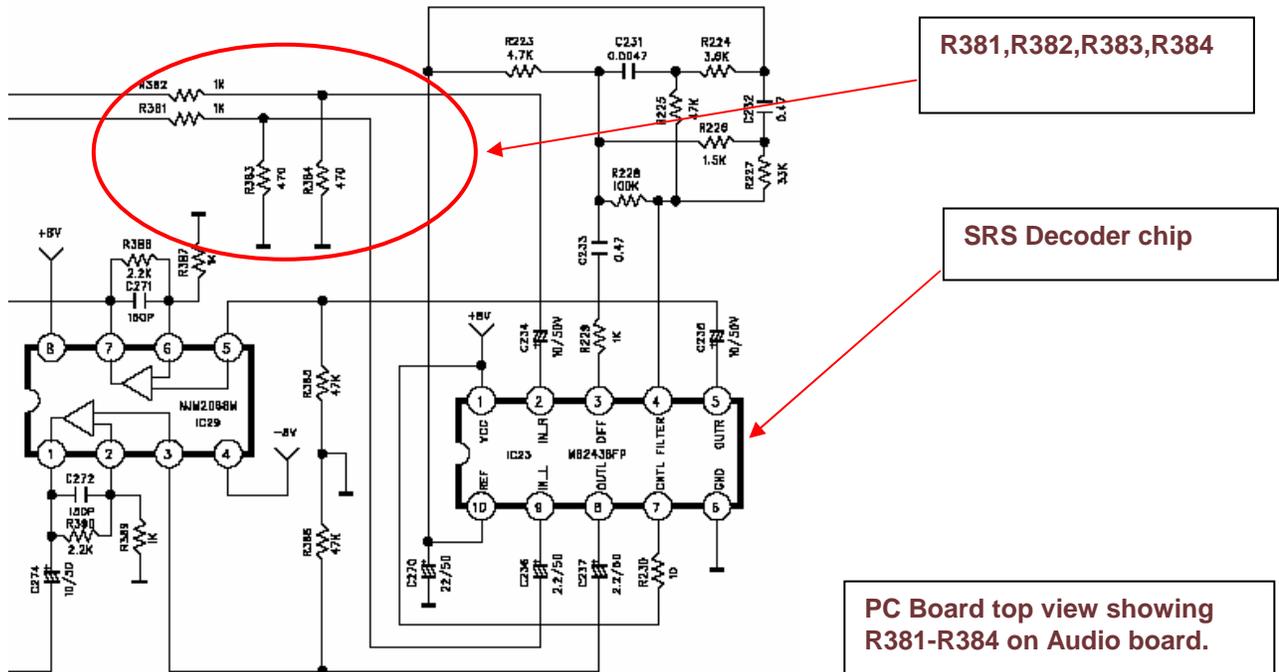
Figure 1 (schematic of Audio board)

REASON: The input level to the SRS decoder chip is to high.

SOLUTION: In figure 1 the red circle is the part of the circuit to change. R383 and R384 are 470 ohms. By lowering these resistor values , distortion in SRS mode will be corrected.

The resistors that require lowering are R383 and R384 , 470 ohms each. The addition of another 470 ohm resistor in parallel with each resistor will give an overall resistance of 235 ohms each.. To do this lift the board and turn over to access the foil side . Mount the two resistors (470 ohm 1/6w) from the negative side of C234 and C236. to ground at pin-1 on BN23. See figure 4 .

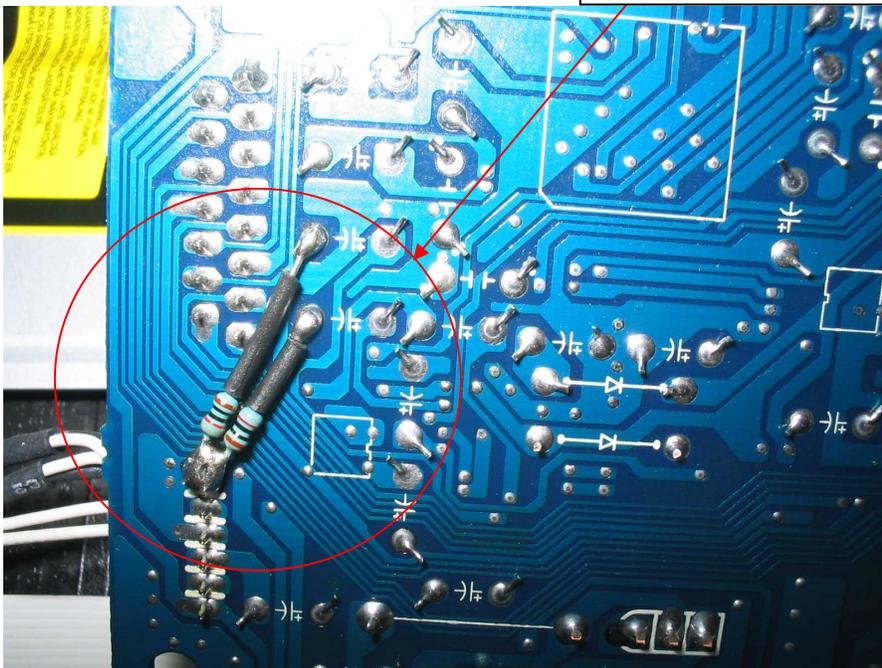
Figure 4

Bottom of Audio board showing addition of 470 ohm resistors
