Product: Int	egrated Amplifier	
	Hardware Technical Bulletin: C372-H2005-01		
Date:	June 1/05	Subject: Power supply capacitors	
Note:	Implemented in pr	Implemented in production from serial number: H54C37210151	
Previous T.B.'s required:			
	YES		
	NO

Technical Bulletin C372

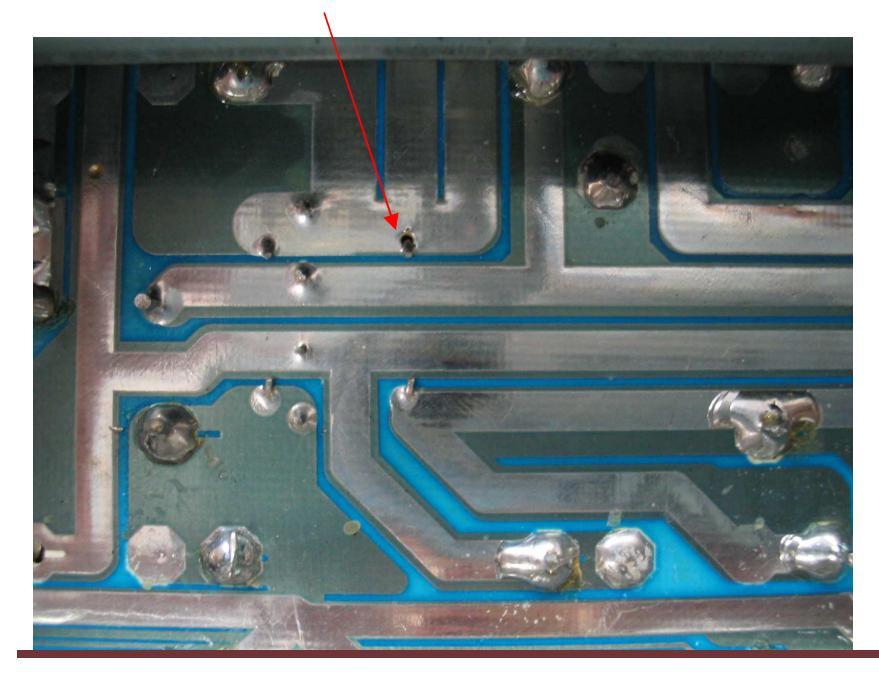
DESCRIPTION: Please perform the following modification when in for service for any reason .Power supply capacitors maybe stressed(top of caps are expanded) due to insufficient soldering on pc board trace. A very small percentage of units are affected, but severe damage is possible due to the high voltage and current in this part of the circuit.

REASON:Solder pads around jumper wires have higher than normal resistance causing power supply ripple to increase across filter capacitors. See figure 1.

<u>Figure 1 (Original layout, showing cracked solder on jumper wire)</u>

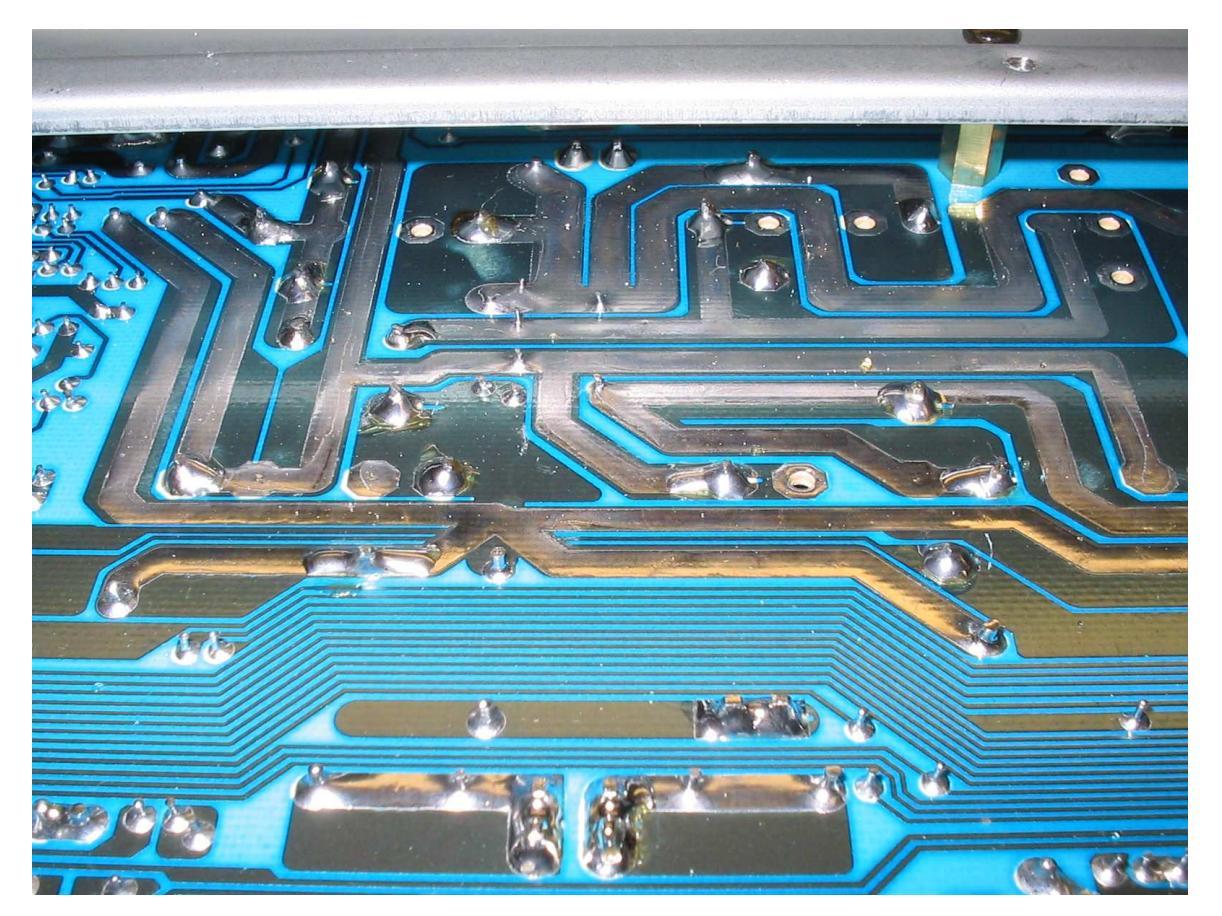
Figure 2

Area of PCB to be modified

SOLUTION:Add 18 gauge wires to thePCB to lower the circuit resistance.To install this modification, first remove the bottom service plate. Look for the PCB area shown in figure 2. In figure 3, the addition of black jumper wires to lower the resistance of these pc board traces is shown. Capacitors showing any signs of stress or damage should also be replaced at the same time.
