marantz® SERVICE BULLETIN		Date: 8-Dec-2004	Model: LC3050/N1B
		Page: 1 / 1	REF.NBR: MZ04-079
Level		Application:	
★ ★		See below	
		Subject: Wipe effect.	
		Int.ref:

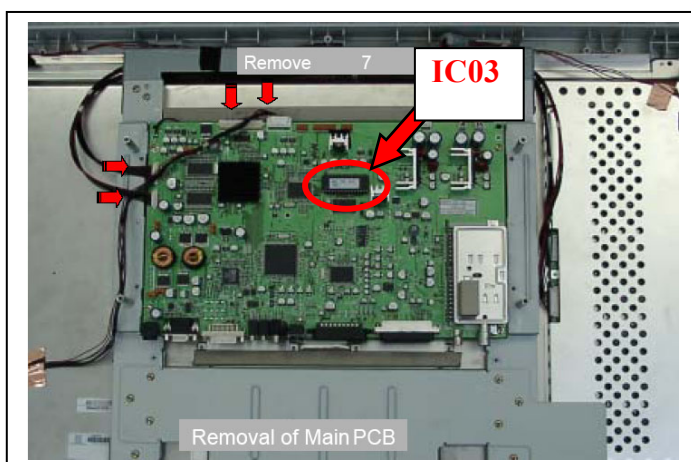
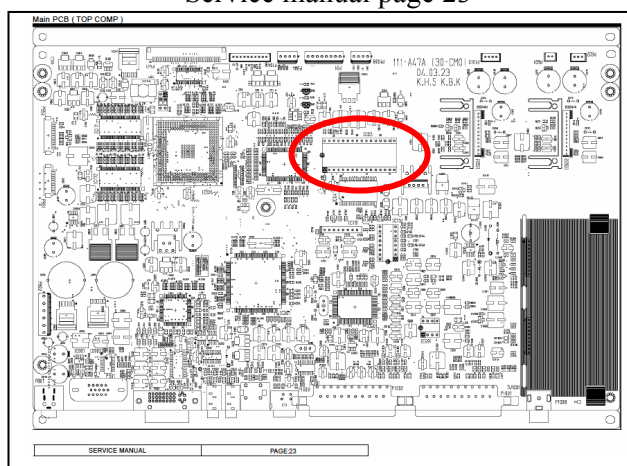
Service manual page 23

When you have on the screen a picture example of a face and the picture is moving slowly, it is like out of focus and you also get double contours.

1) Replace IC03 on the MAIN PCB.

POS.NO IC03 (EPROM programmed): **90M-HJ000010R**

Factory Spare part no.: 1ICST80B60BS (M27W201-80B6 EPROM)
