| marantz® SERVICE BULLETIN | | Date: 28-Aug-2004 | Model: SR5400, SR6400 |
| | | Subject: 1. Noise from Surround L/R Speaker. 2. The Sound is MUTE by operation of HDD Recorder. 3. The output level changes. | |

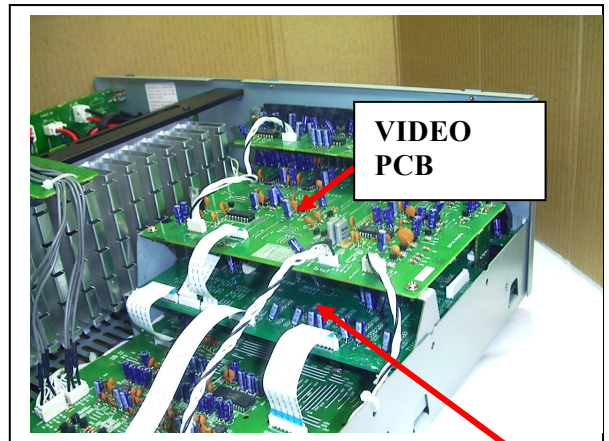
DSP PCB

1. Replace the microprocessor **IC28** on the **DSP PCB**. Version to [**V040412 1**]
2. Replace the DSP **IC20** on the **DSP PCB**. DSP Code ID to [**CD02 02010116**]
Please see to the service manual page 60 about details of "10. SERVICE MODE".

VIDEO PCB

- 1. POS. No. IC28** **Part no. 90M-HS27AWH2R** **(HVIHD64F2398F20 programmed flash ROM)**
[OLD part no. * HS27AWH0R]
- 2. POS. No. IC20** **Part no. 90M-HS27AWX2R** **(HVIMX29LV400TTC programmed flash ROM)**
[OLD part no. * HS27AWX0R]
