| marantz® SERVICE BULLETIN | | Date: 28-Dec-2004 | Model: SR7400/SR7500/SR8500 |
| | | Subject: FL Display does not light up. | |

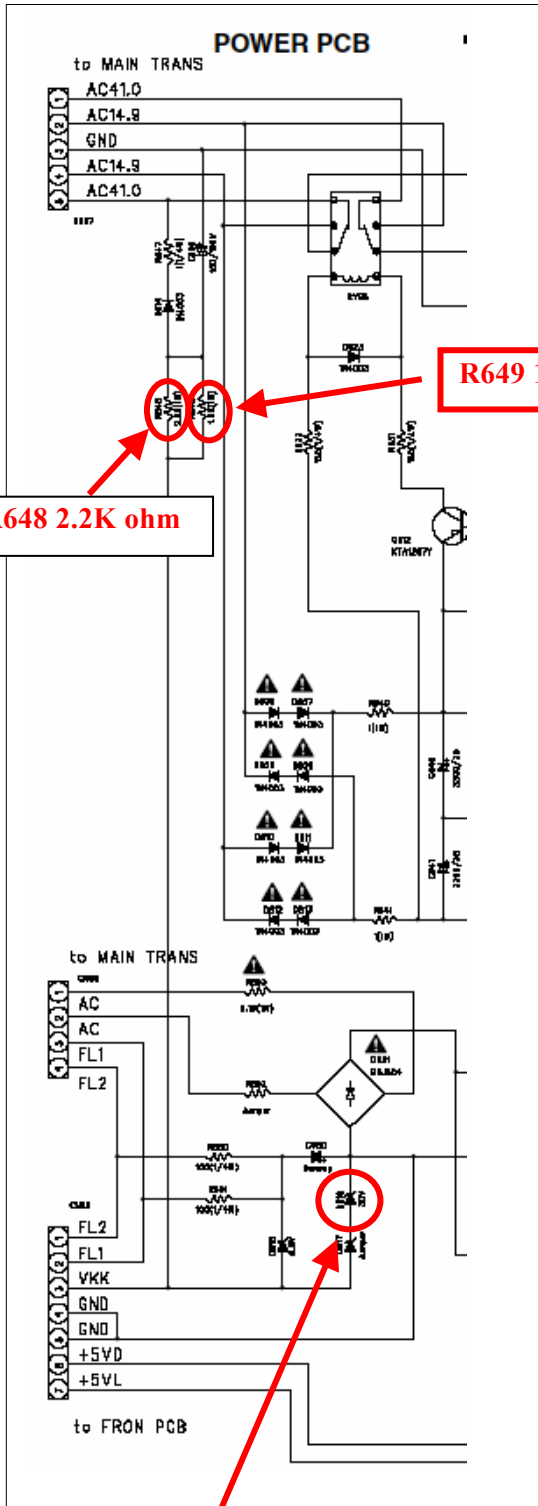
SR7400

1. In condition, AC input is about 10% overvoltage than Rated voltage and the sound is not outputted for a long time.
2. The DIODE (POS NO.D616) may short-circuit. R648 and R649 are broken by this short-circuit.

D616 Zener Diode part no. 90M-HD302190R

1. POS.NO **R649** RESISTOR (**1.5K OHM**) is changed to RESISTOR(**2.2K OHM**) on the POWER PCB

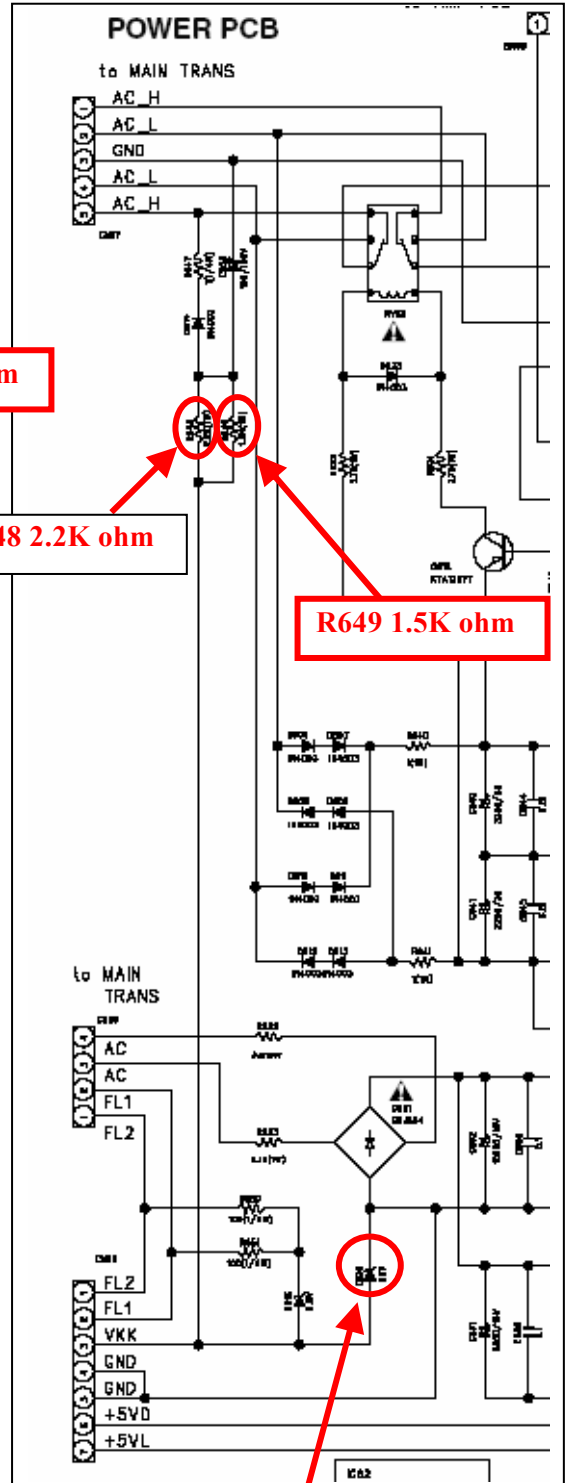
SR7500 / SR8500

D616 Zener Diode part no. 90M-HD302190R
