marantz® SERVICE BULLETIN		Date: 28-Dec-2004	Model: SR7400/SR7500/SR8500
		Page: 1 / 1	REF.NBR: MZ04-085
Level		Application:	
★ ★		See below	
		Subject: FL Display does not light up.	
		Int.ref:

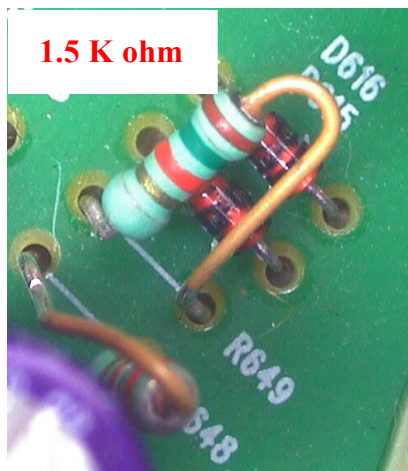
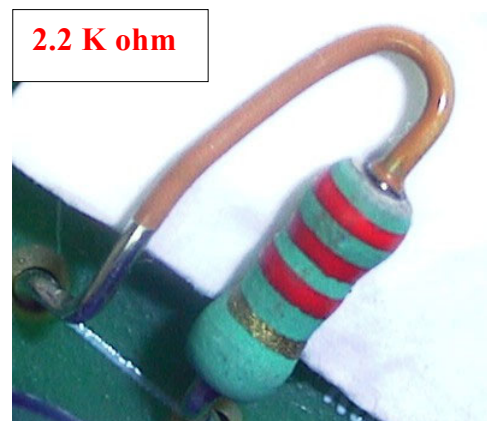
1. In condition, AC input is about 10% overvoltage than Rated voltage and the sound is not outputted for a long time.
2. The DIODE (POS NO.D616) may short-circuit. R648 and R649 are broken by this short-circuit.

1. POS.NO **R649** RESISTOR (**1.5K OHM**) is changed to RESISTOR(**2.2K OHM**) on the POWER PCB

POS.NO. R649 nsp (RESISTOR 2.2K OHM 1WJ) Factory code number KRG1SANJ222RT
