# Service Information Bulletins

# 1998

**GRUNDIG**

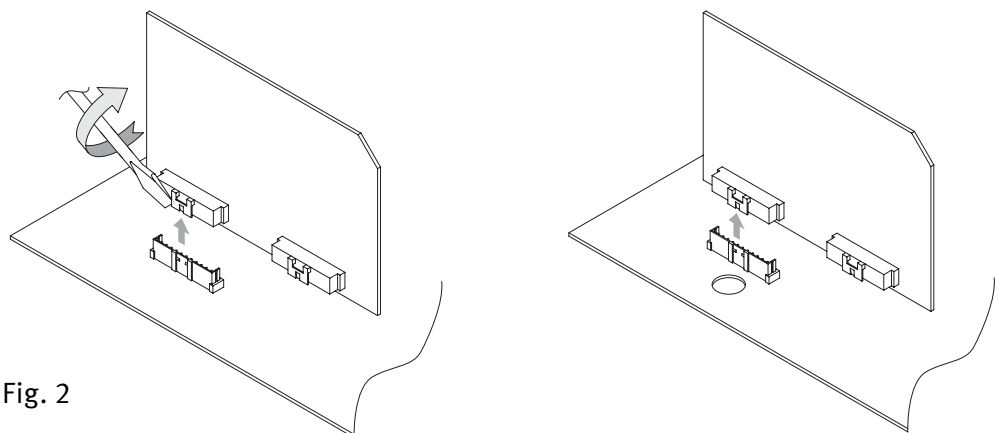
Fig. 2

2. The modules of the colour television receivers with chassis CUC 20xx are fitted with a new plug-in system. They can be dismantled by disengaging the locking lug with a screw driver. In future, it will also be possible to release the lugs from below through additional drilled holes in the chassis.

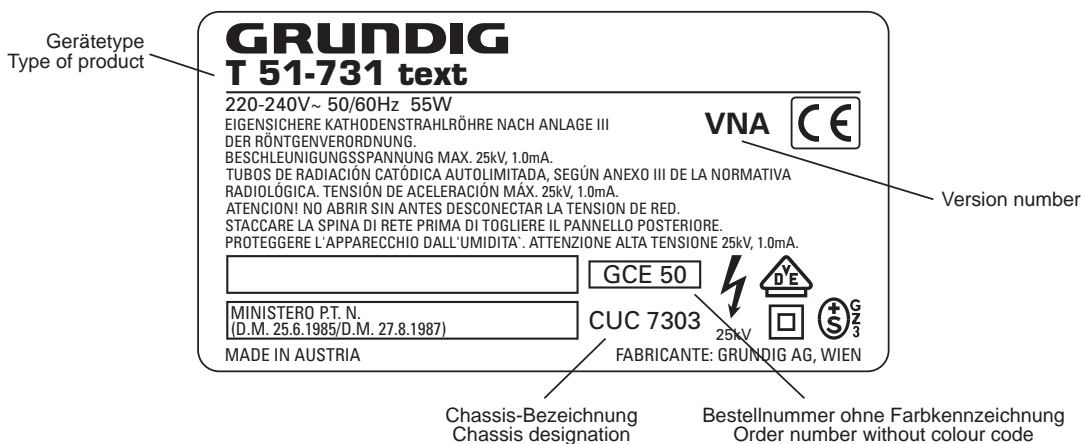
From September 1998 onwards, colour television receivers with the CUC 7303 chassis have been fitted with a reworked chassis CUC 7303. It is provided with a new processor and a few changes were made in the peripheral circuit of the computer.

The television receivers with the reworked chassis are marked with a Version Number „VN...“ printed on the label on the back of the receiver (see figure).

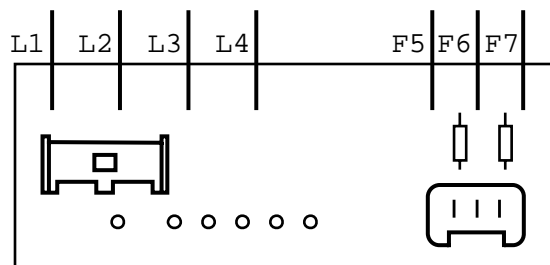
The picture tubes A 68 ESF 002X43 (without coating) and A 68 ESF 202X43 (with coating) fitted into television receivers with above mentioned chassis are no longer available. These picture tubes are not fully compatible with the replacement tubes A 68 ESF 002X143 / A 68 ESF 202X143.

The figure below shows the connections of the deflection unit for the new picture tubes A 68 ESF 002X143 part no. 8300 068 24300 and A 68 ESF 202X143 part no. 8300 068 20400.

- L1 - red yoke connecting lead (horizontal)
- L2 - black yoke connecting lead (horizontal)
- F5 - green yoke connecting lead (vertical)
- F7 - white yoke connecting lead (vertical)
