SERVICE

Date: 15-May-2003
 Model: SR5200/SR6200/SR7200

Page: 1/2
 REF.NBR: MZ02-033

Hum noise can be heard from Headphone out

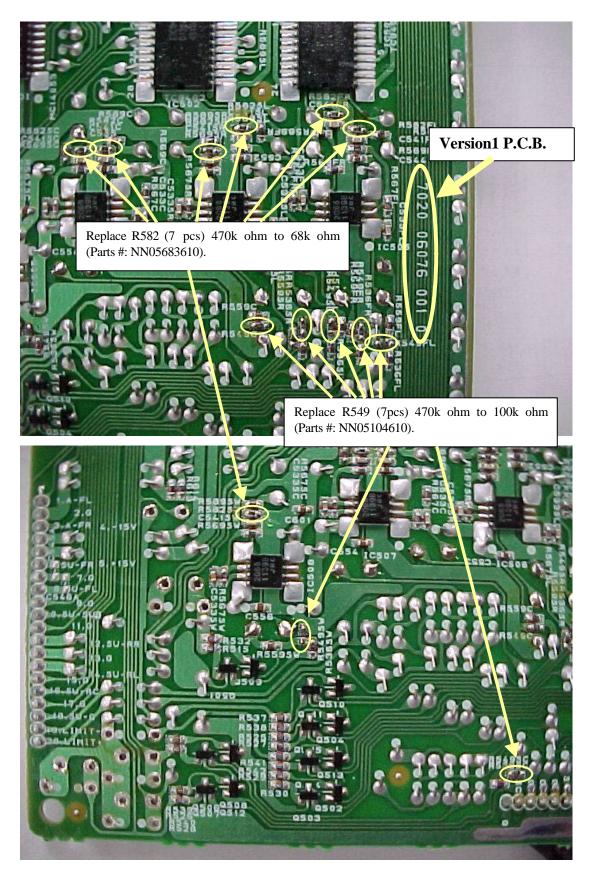
Pop noise appears when stop playing or track skip on CD playback with Digital connection. Pop noise appears in the condition of the Main volume is changed 74dB to 75dB(Mute).

Please apply the modifications as mentioned in page 2 to page 6.

\* Version 1 P.C.Board (7020 06076 001-0) : Please apply the modification mentioned below (Page2 to 4).
