# ML 2C LOUDSPEAKER SYSTEM

# SERVICE INFORMATION

SERIAL NO. L1COO1 TO L3C224

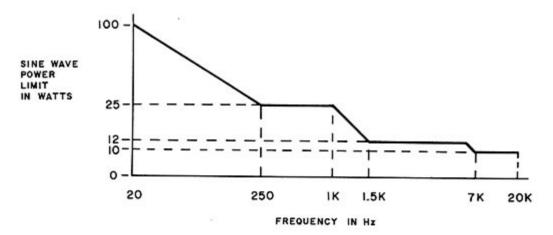
POWER HANDLING: Sine Wave steady state

Avoid operating the speaker system with sustained sine wave signals at power levels greater than the indicated limits. Permanent damage may result.

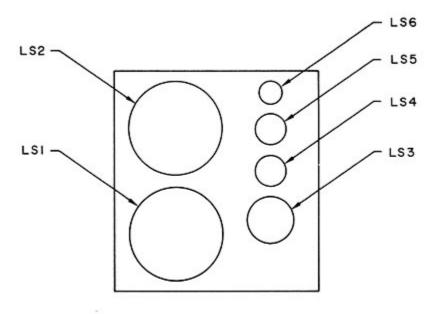
# SPEAKER LOCATION

REMOVE REAR PANEL TO SERVICE CROSSOVER NETWORK

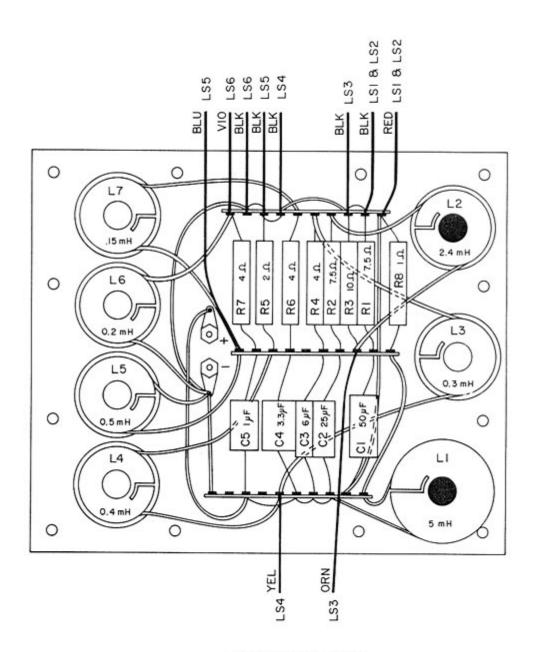
# CROSSOVER NETWORK

ASSEMBLY 044-222

# SCHEMATIC NOTES

1. In early units LS6 is 036-005 15 $\Omega$  impedance. LS6 can be replaced with 036-012 8 $\Omega$  impedance. Acoustic output will be the same.

The crossover network must be inspected when burned out speaker elements are replaced. The network must also be inspected if a speaker element produces sound with the battery test but does not play when connected in the system. The woofer must be removed to get to the crossover. Check for bad connections, broken wires, etc. Be sure to check the resistors mounted on the plate underneath the printed circuit board. A broken lead on these resistors can also be the cause of intermittent or partial failure of the system.

When a system has been driven excessively hard by a "clipped" amplifier for long periods of time, the dome mid-range may appear to have weak or no output. In addition to a burned out mid-range, the 7µF capacitor may also be damaged. This will be evident if a new mid-range has been installed and also appears to have weak or no output.
