# **MODIFICATION**

# Service Information L75

# **Circuit Change**

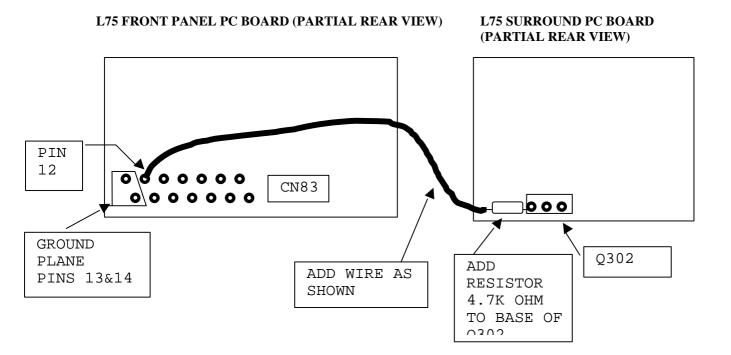
# Diagram 1

When the headphones are plugged in the subwoofer is not muting.

Mute line on subwoofer does not activate when the headphones are plugged in.

The headphones, On line(h/p on) from the control (front panel) board can be connected via a wire and a 4.7k ohm resistor to the base of Q302 on the surround pc board. See diagram 1,2 and 3. Glue resistor to surround pc board after to prevent wire and resistor from moving.
